## Enforcement Case Report

**Enf case reference:** ENF/25/0187

**Alleged Breach:** Removal of barn and the creation of a new dwelling

**Address:** Scottow Barn, North Walsham Road, Scottow, NR21 5BZ

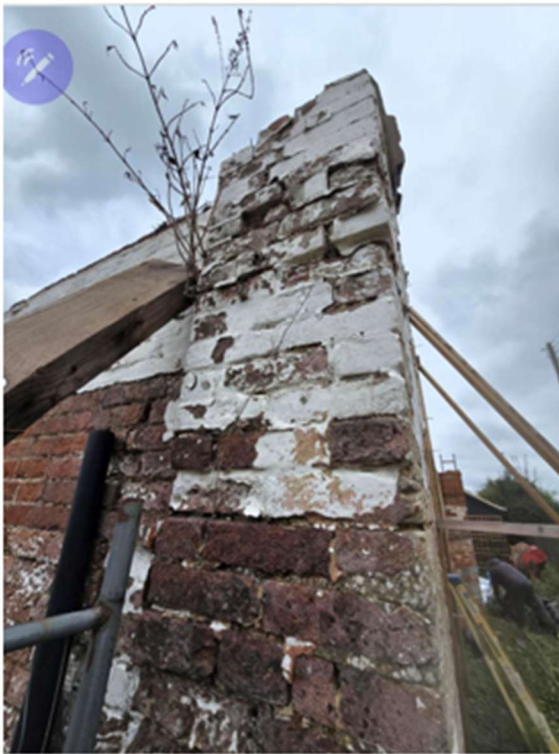
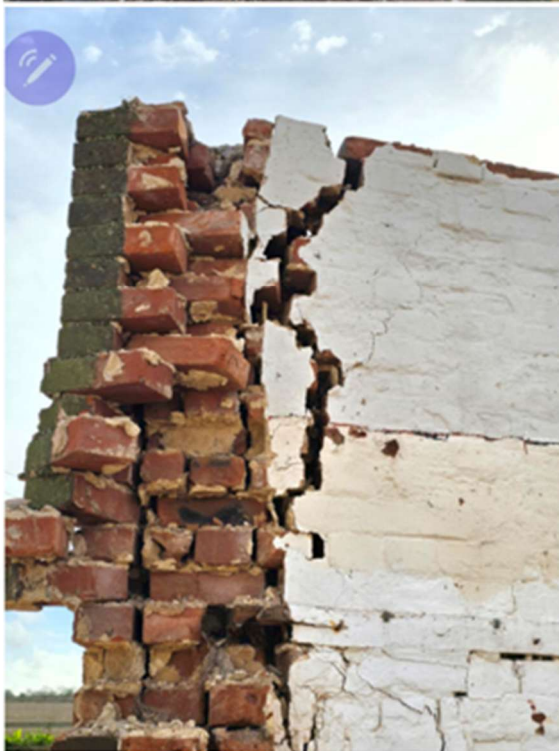
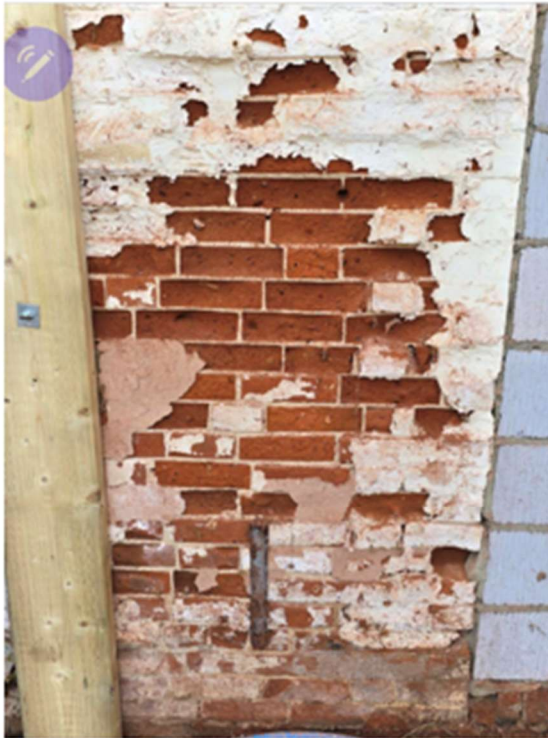
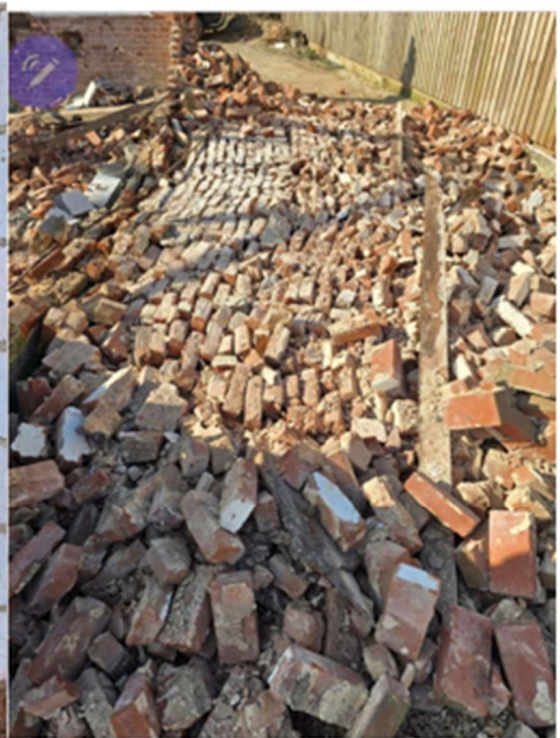
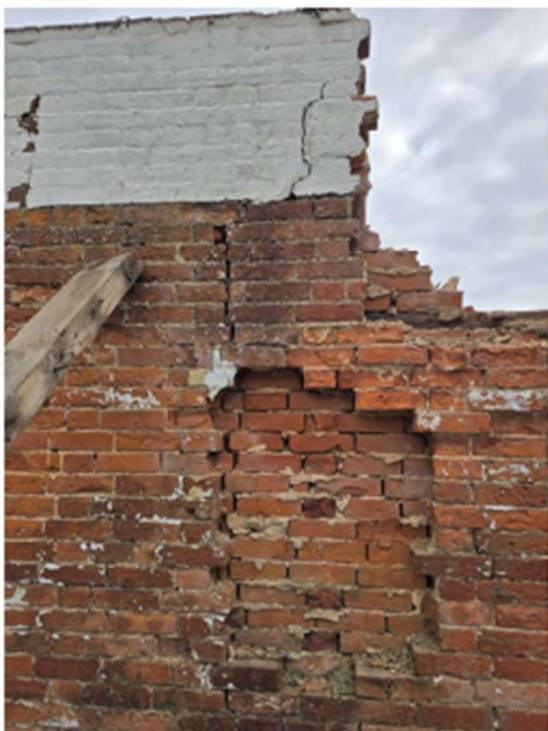
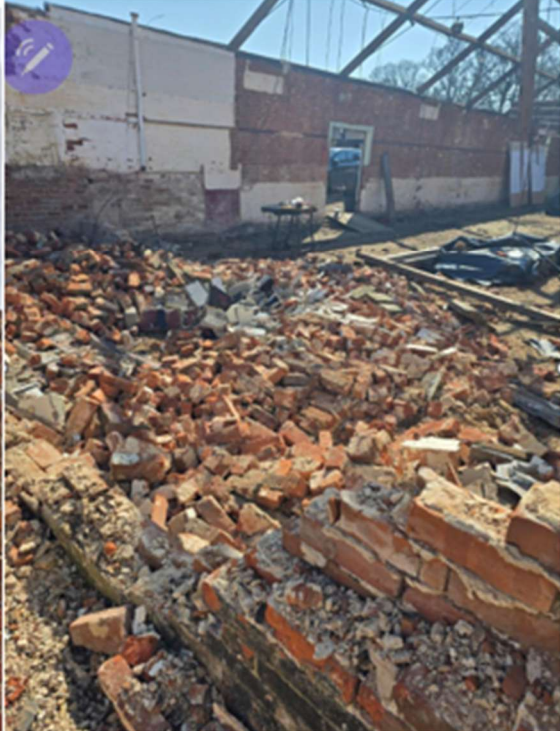
## Appendix 2: Owner's Photographs of collapse and building in poor structural condition

- **16 -21 October 2025 |** The owners provided structural calculation sheets and photographs detailing the poor state of the original building structure ***(Appendix 2).***

*As requested, I'm sending a summary of the situation to date. When we bought the property, we had no idea how bad the brickwork actually was and it wasn't until the asbestos roof was removed and the rotten boards underneath, that we realised actually how bad the walls were. The bricks were extremely eroded in certain areas, both on the outside and inside and literally crumbled to the touch. A lot, particularly on the South gable were so eroded that there was not even half a brick's thickness left which concerned us a great deal.*

*It became apparent that it was the roof structure which had been holding up the badly eroded walls, due to many years of neglect.*

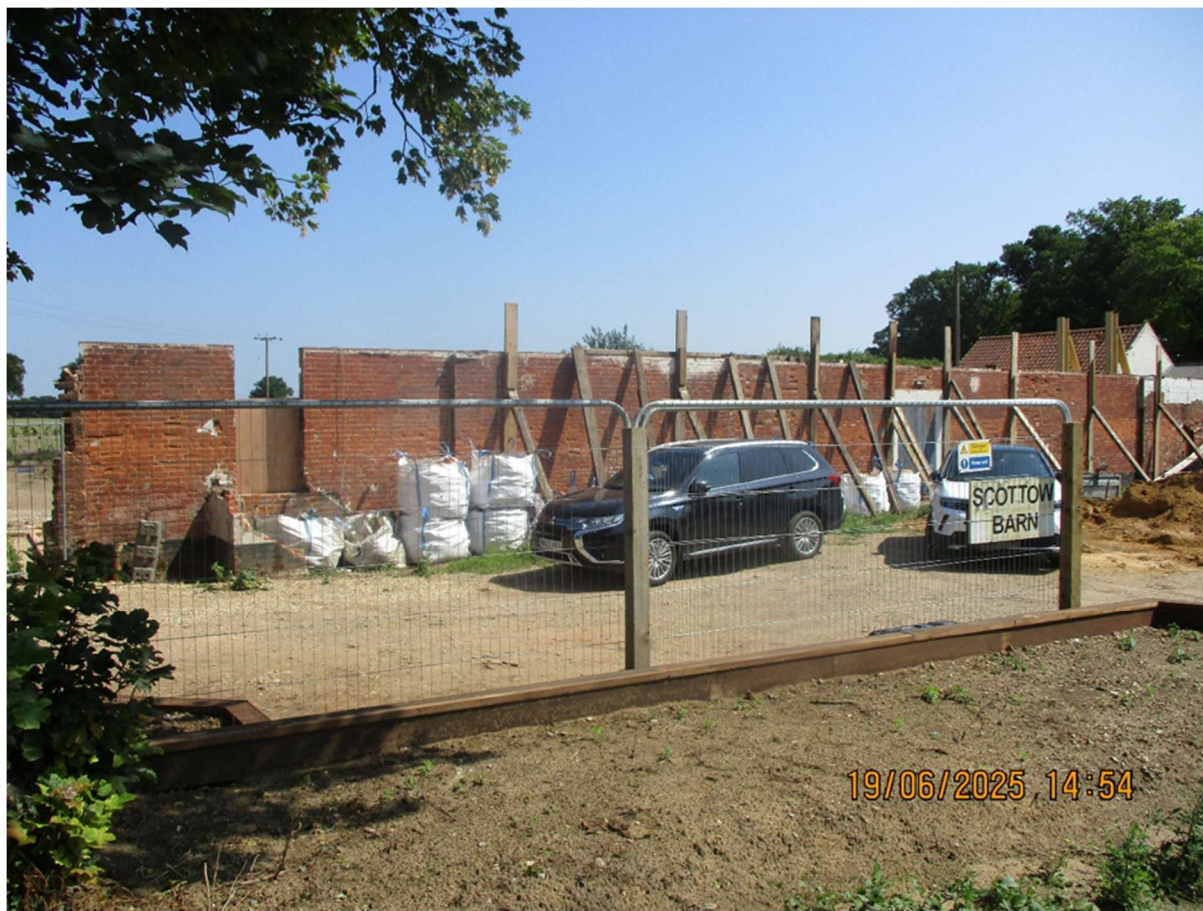
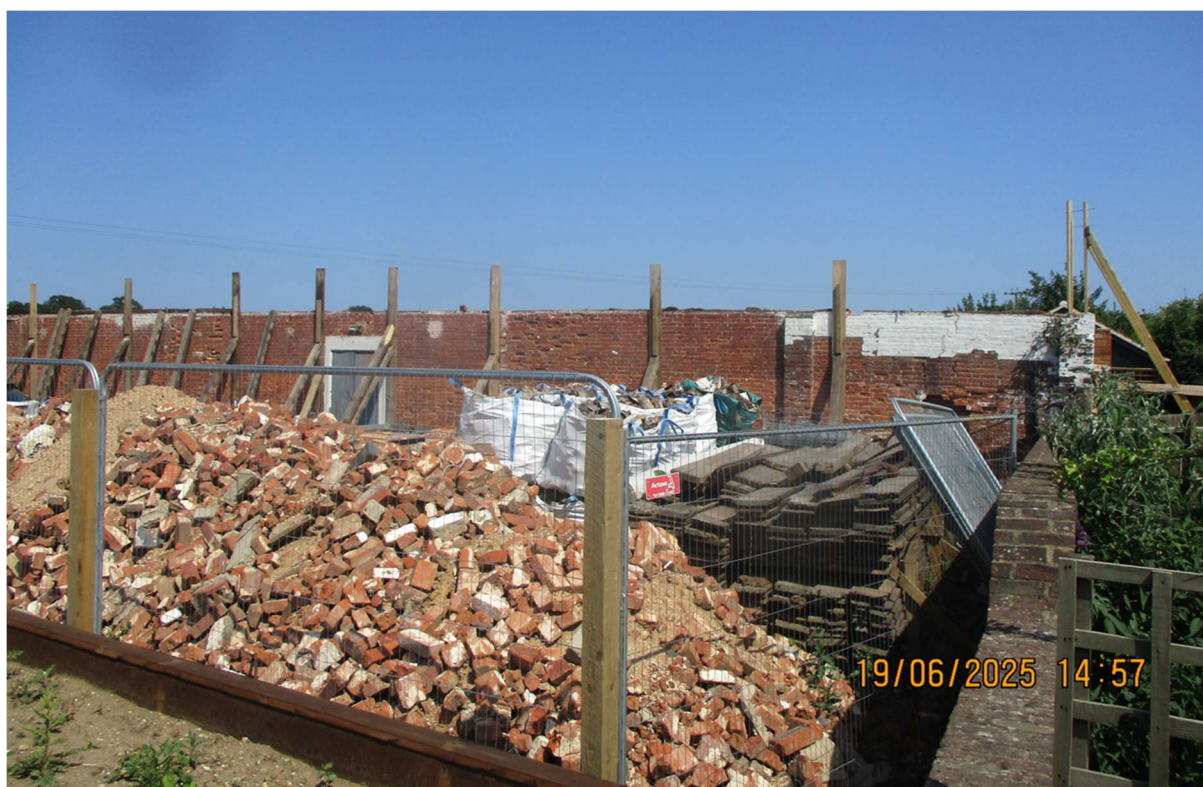
Western elevation (Front)

- **June 2025 | Initial Notification:** The Council received a report alleging that the substantial majority of the barn structure had been removed, leaving only the front elevation wall standing. Photograph supplied with report shown at **Appendix.6**.
- **16 June 2025 | Initial Site Visit:** The Enforcement Officer inspected the site and confirmed that the side and rear elevations, along with the roof structure, were entirely absent. Only the front wall remained, which was structurally compromised and held up by temporary wooden shoring. No personnel were present on site. *(Photographs at Appendix 3).*

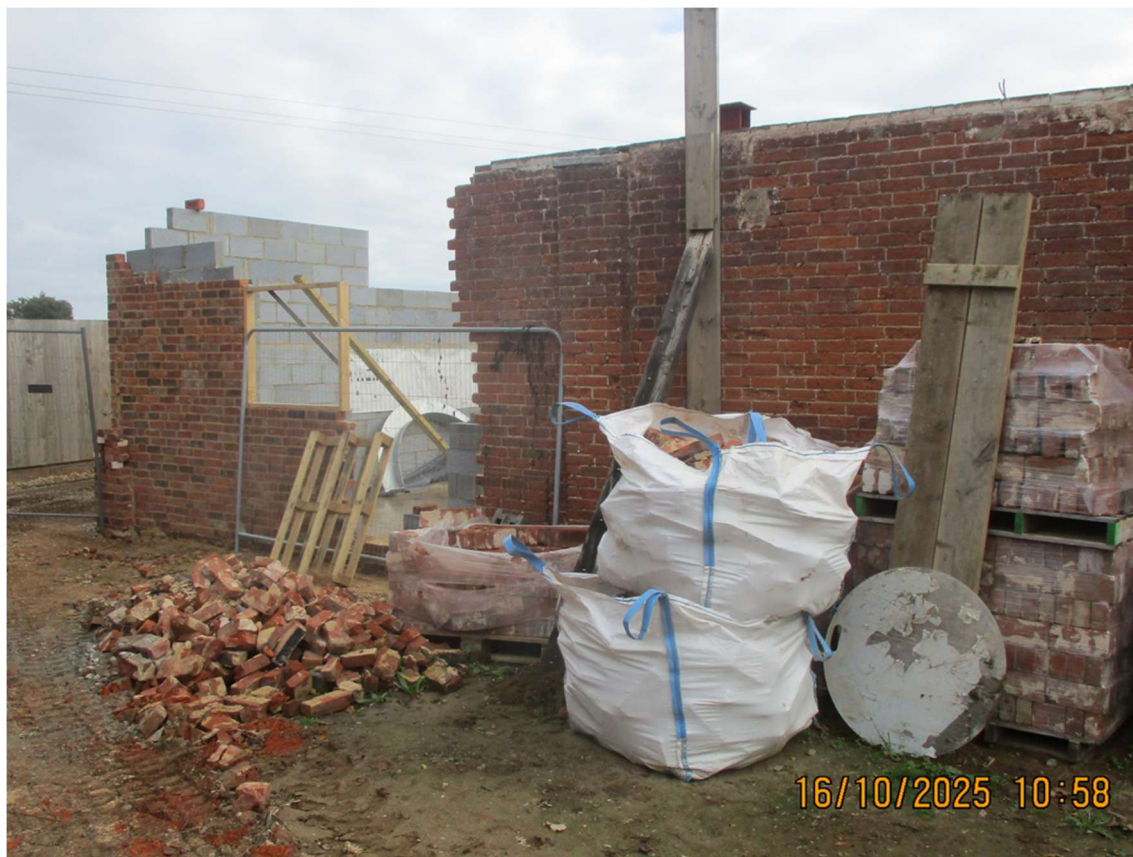
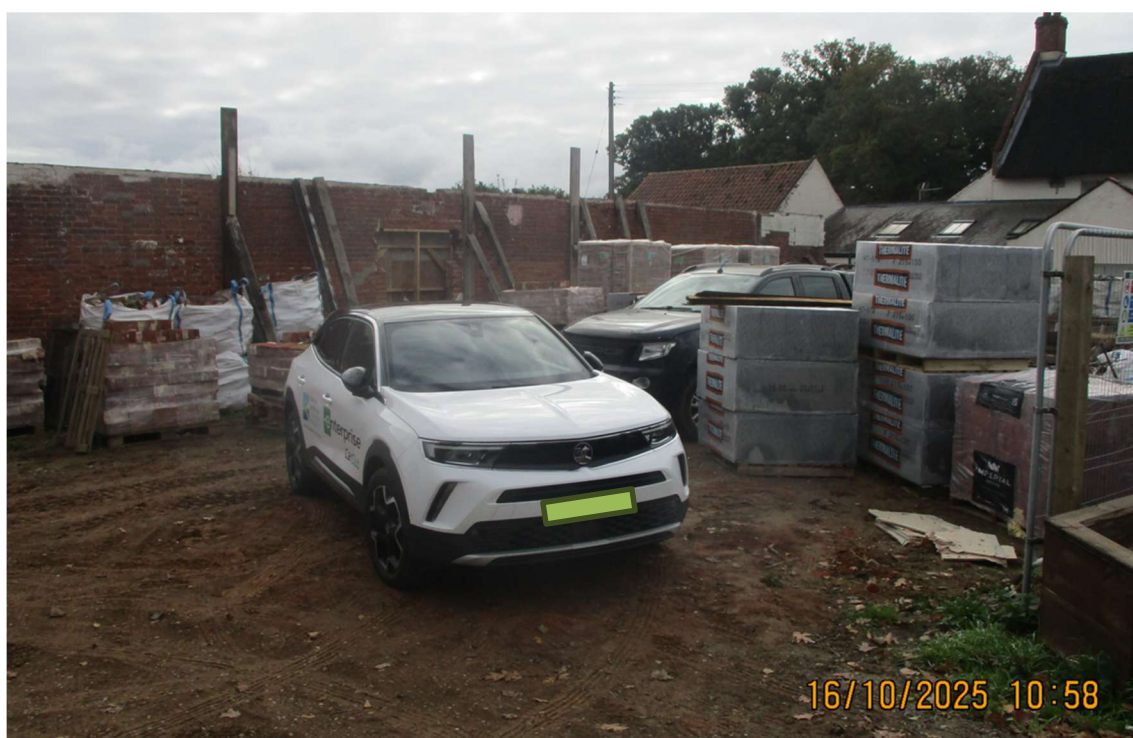
Western elevation (Front)

- **Officer Assessment:** The Enforcement Officer was concerned that inadequate structural shoring had been implemented prior to removing the roof. The owner confirmed that 9 pallets of original bricks had been salvaged to rebuild the structure in visual conformity with the previously approved plans. The Officer advised the owner that due to the extent of the demolition, the original conversion permission had likely been lost. ***(Photographs at Appendix 4).***

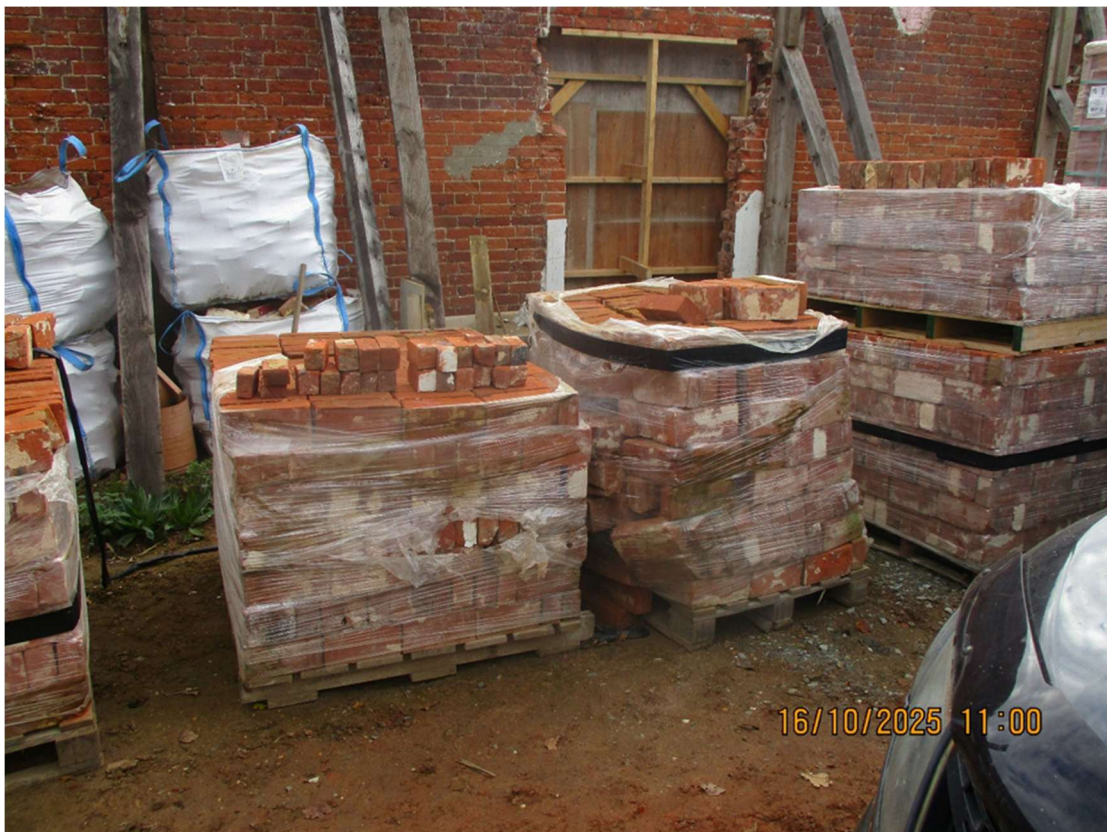
Evidence of retained bricks

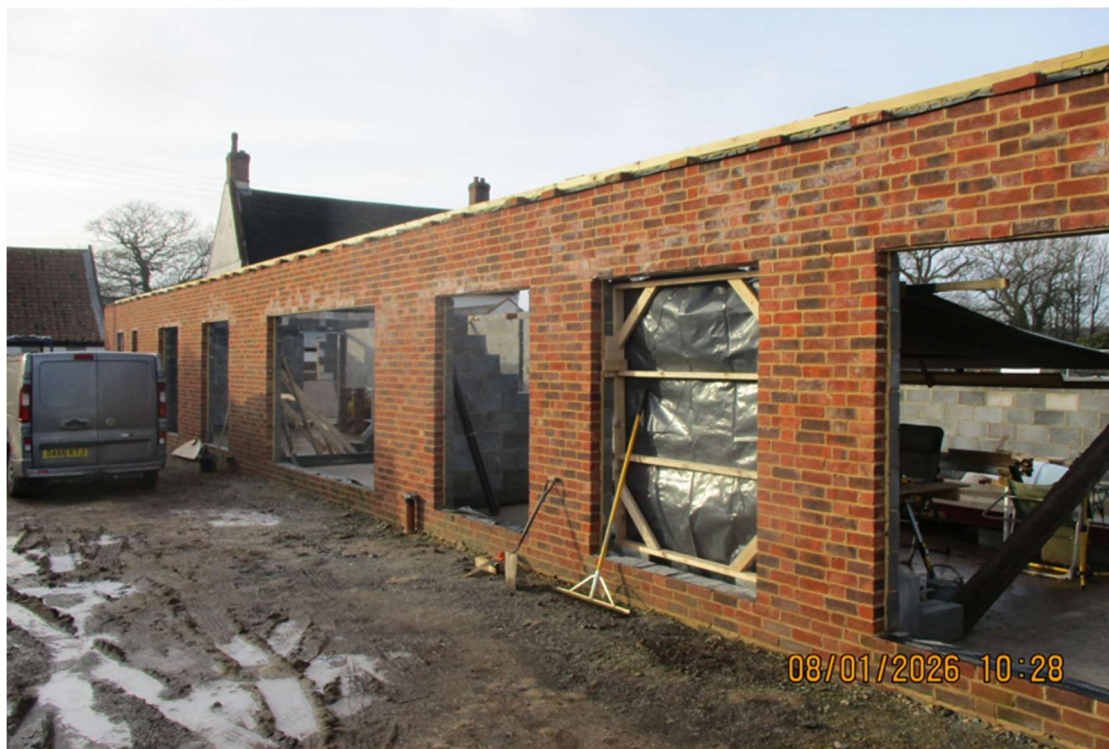
Eastern elevation (Rear)

- **December 2025 – Present | Monitoring:** Regular monitoring visits have been undertaken by the Enforcement Team. No further works have been detected, and the Council is satisfied that the site remains inactive. The enforcement case is currently held in abeyance pending the determination of the planning application. **Appendix.5** shows further photographs from site visit in 2026.
