SVC-300 – corrosion issue.

Dell Materials Science Laboratory
Global Supply Chain Quality Engineering

Report 7568
Materials Analysis

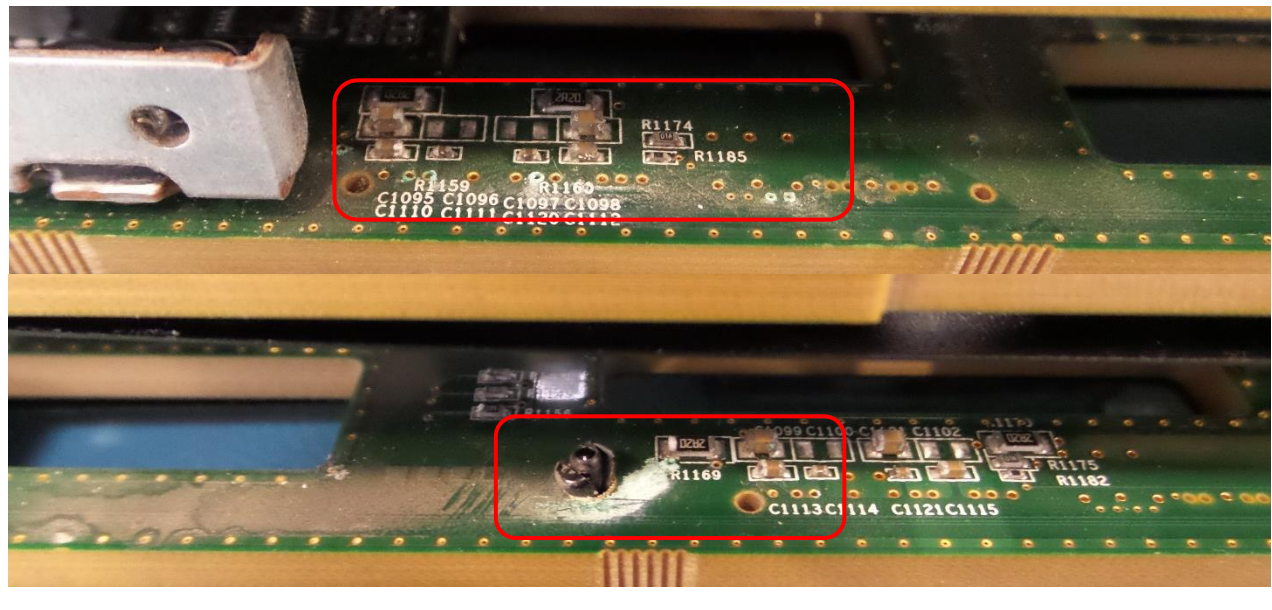
Photo 2. Representative image of the SVC-300 midplane assembly with evidence of corrosion visible without disassembling the device.

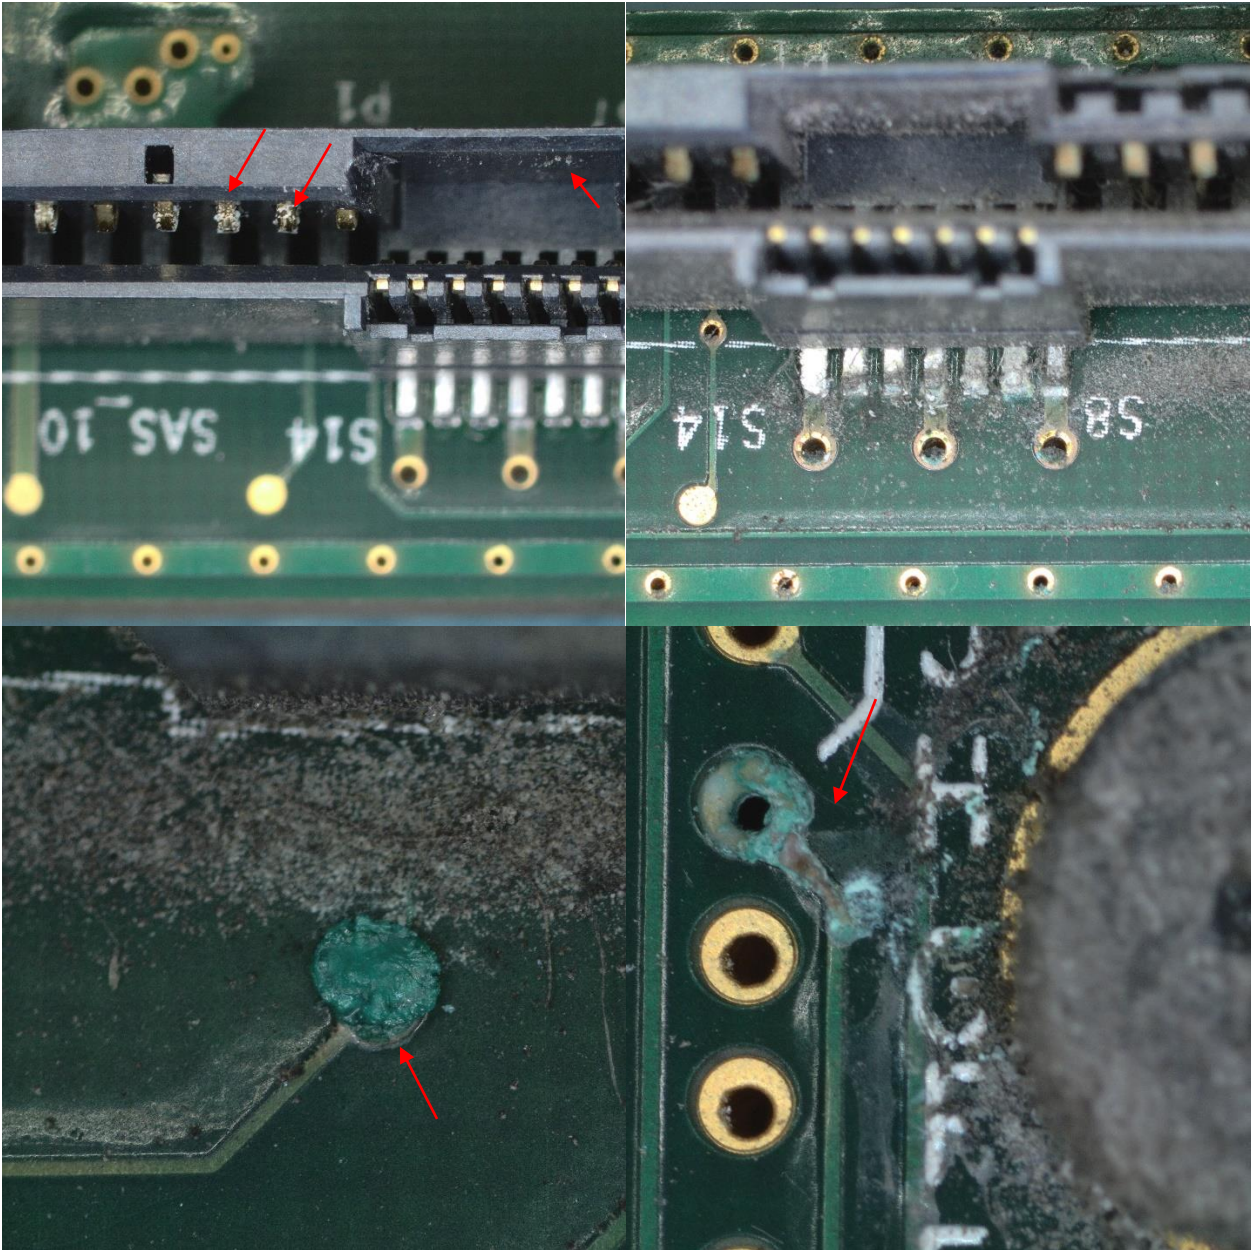
Photo 3. Representative images of the SVC midplane board assembly areas impacted by corrosion.

- Inspection of the SVC-300 midplane assembly revealed extensive corrosion of the midplanes PCBA components, multiple exposed vias, SAS connector terminations and SAS connector pins.

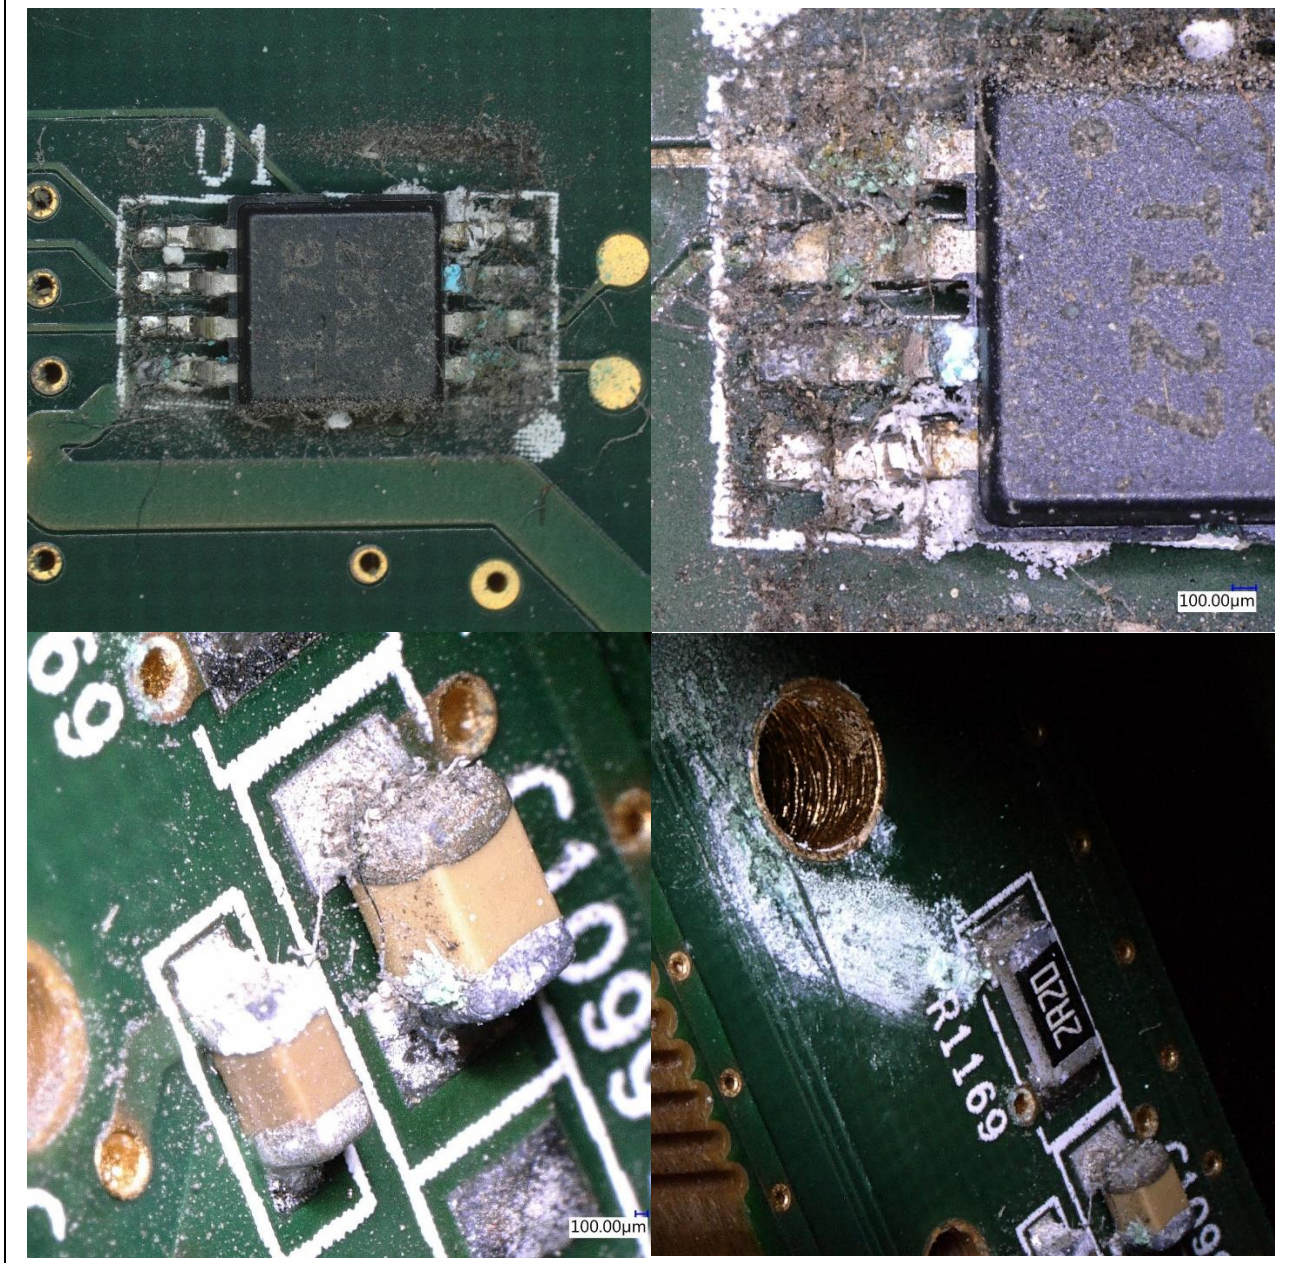
Photo 4. High magnification images of the components impacted by corrosion.

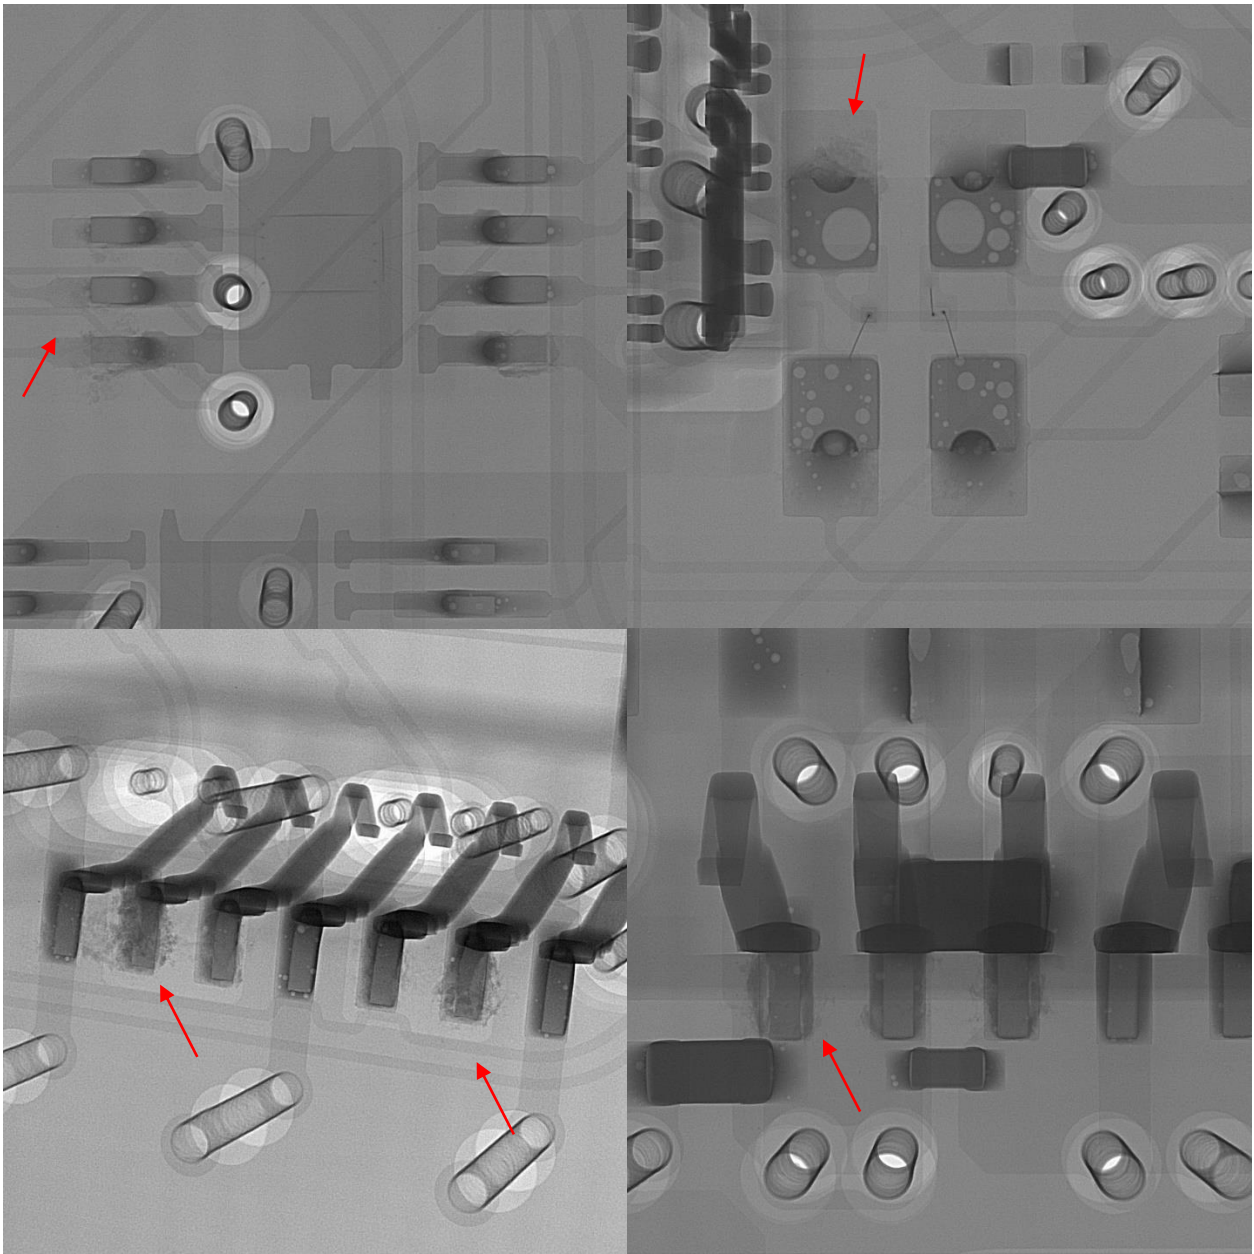
Photo 5. Representative X-ray images of the components impacted by corrosion.

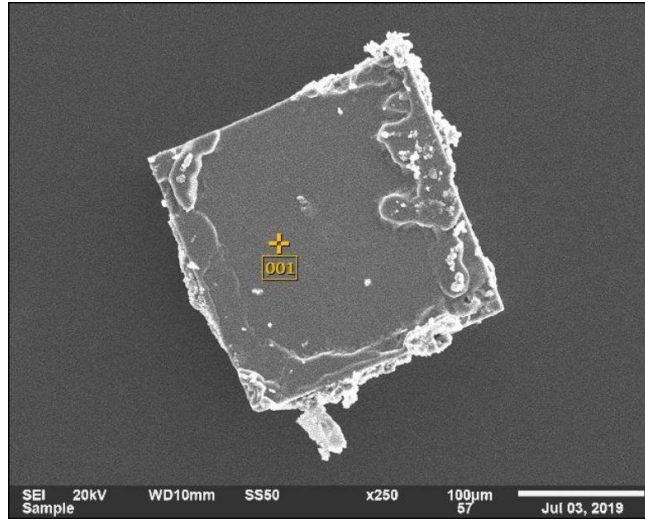
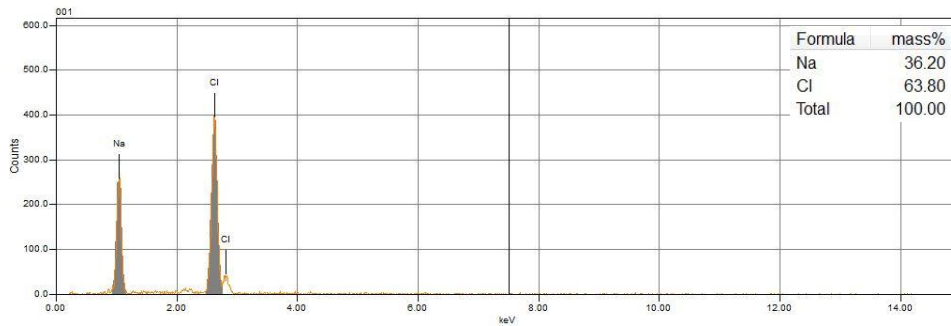
Photo 6. Scanning Electron Microscopy (SEM) & Energy Dispersive X-ray (EDX) analysis of a crystalline debris sample extracted from the midplane surface. The main elements detected were: Sodium (Na) and Chloride (Cl).

- Inspection revealed high accumulation of particulate matter residue accumulated in multiple areas of the PCBA assembly.
- Analysis revealed highly corrosive Sodium Chloride (NaCl) crystals embedded into the assembly PCBA components as well as corrosion byproducts in presents of green residue observed in multiple areas of the midplane PCBA assembly.

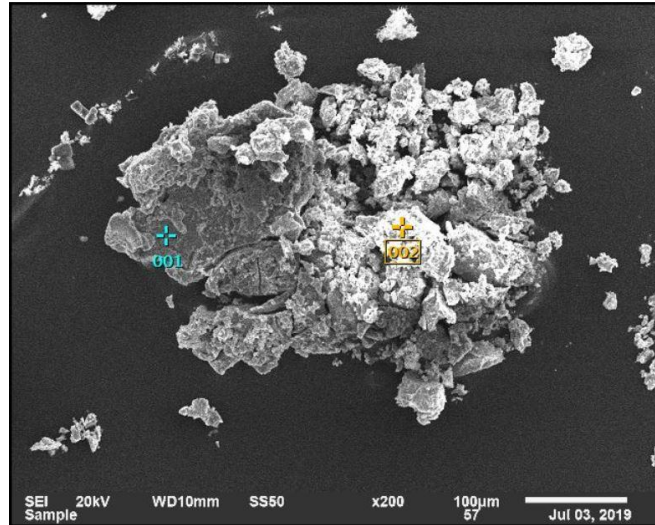
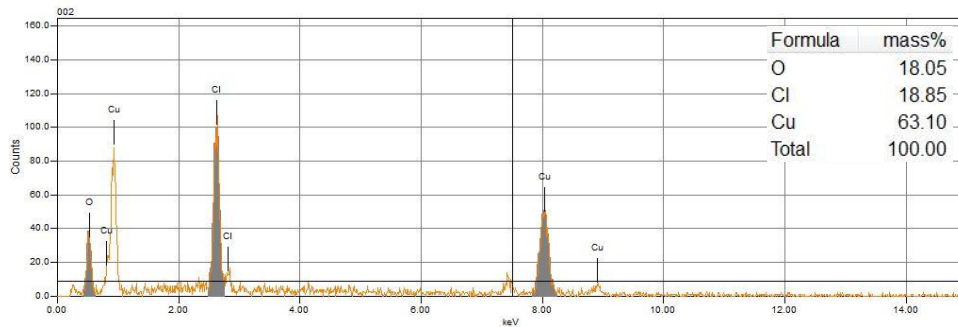
Photo 7. Scanning Electron Microscopy (SEM) & Energy Dispersive X-ray (EDX) analysis of a green debris sample extracted from the midplane surface. The main elements detected were: Copper (Cu), Chloride (Cl) and Oxygen (O).

- Corrosion co-product observed on PCBA surfaces were 'metal salts' (mostly hydrates of Copper (II) Chloride) which does have very good solubility in water, what may have led to situation that in environment with elevated humidity those 'metal salts' creates highly conductive debris, which may have led to electrical short conditions and by that could have contributed to the failure observed at customer site.
