Glaven Valley

Conservation Area Appraisal and Management Plan

Eighth Draft: May 2023

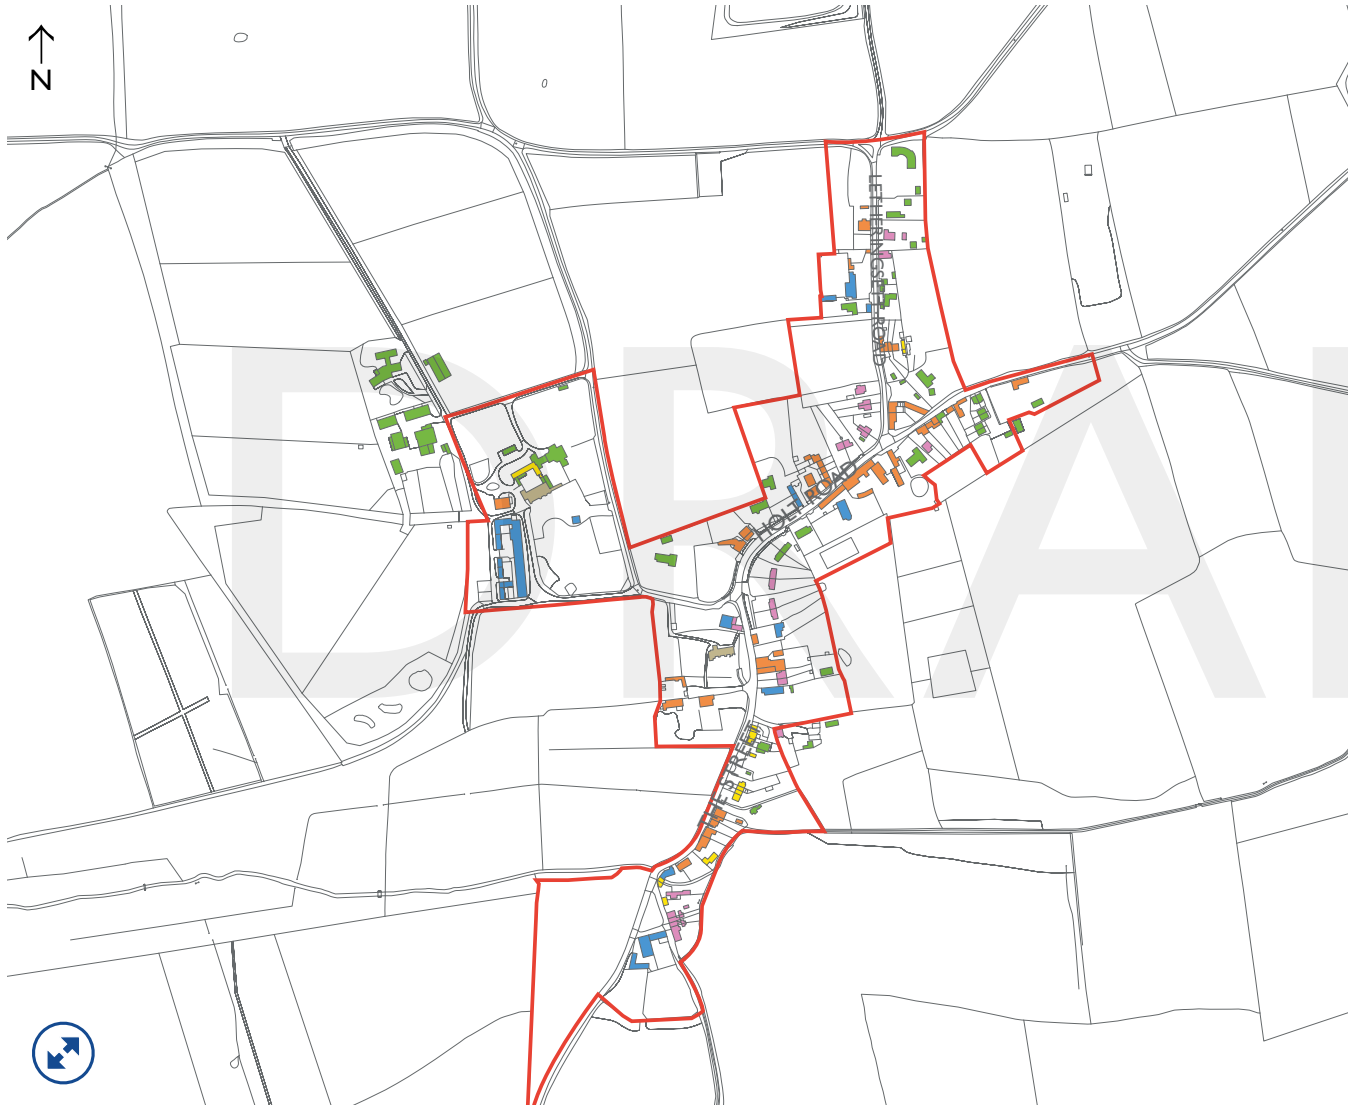
HISTORIC DEVELOPMENT

This plan indicates the age of the existing built fabric of the main buildings and structures in Thornage. It is mostly based on a comparison of historic maps with limited verification through viewing of the existing building from the street. Some buildings may have been constructed in phases but generally only the main phase is shown here. Some buildings may have been partially rebuilt or substantially repaired since they were first built but their footprint was unchanged and so the change is not obvious in map comparisons. Where this is the case, generally the building is coloured for the earliest date that it appears on the map.

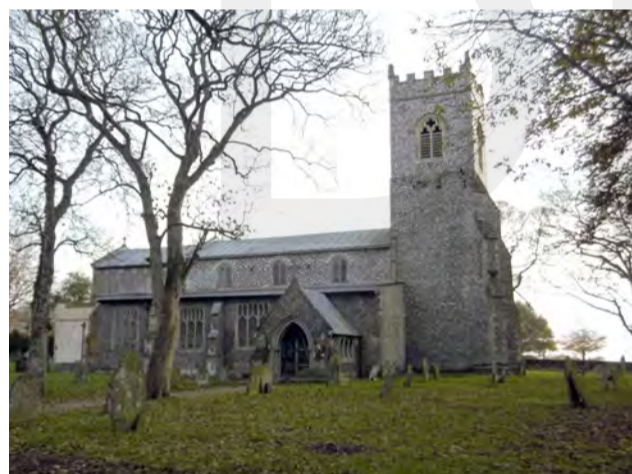
Address / Building Name	The Manor House
Street-by-Street Area	Church Lane/Plumstead Road Area
Status	Grade II*
List Entry Link	https://historicengland.org.uk/listing/the-list/list-entry/1049848
Brief History	Early eighteenth century house built on a sixteenth century core.

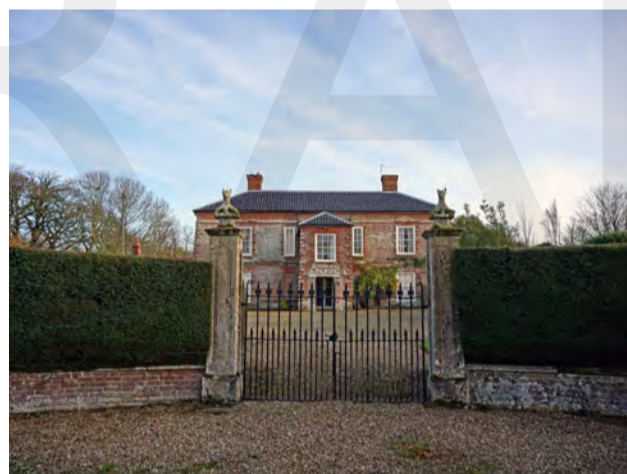
Address / Building Name	Left and Right Gate piers and attached to Splayed Garden wall
Street-by-Street Area	Church Lane/Plumstead Road Area
Status	Grade II
List Entry Link	https://historicengland.org.uk/listing/the-list/list-entry/1373488 and https://historicengland.org.uk/listing/the-list/list-entry/1049849
Brief History	Eighteenth century gate piers at entrance of Manor House.
Brief Description	Square, in rendered brick having recessed semi-circular headed panels to faces; square stone cap with cyma recta of classical leaf moulding, pier surmounted by stone griffin's head erased (the crest of the Newman family who held the manor late seventeenth/early eighteenth century). Low curved brick wall with stone cap attached to right.

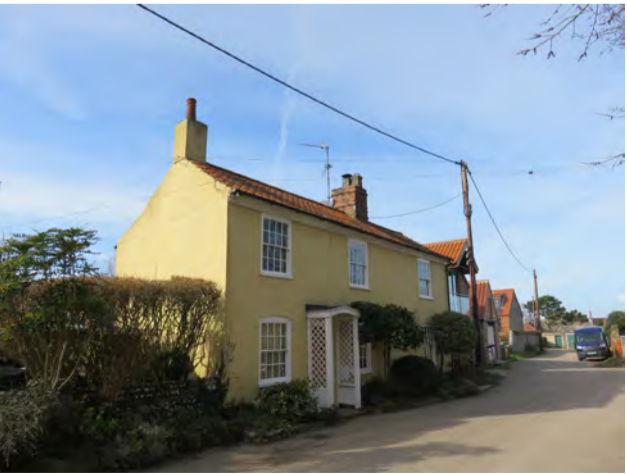
Address / Building Name	Little Cottage
Street-by-Street Assessment	The Fairstead
Status	Locally Listed
List Entry Link	N/A
Brief History	Probably C18th
Brief Description	One and a half storey cottage perpendicular to road. Flint and red brick with brick dressings including a dentil cornice. Red pantile roof with catslide dormer windows and a single replacement chimney.

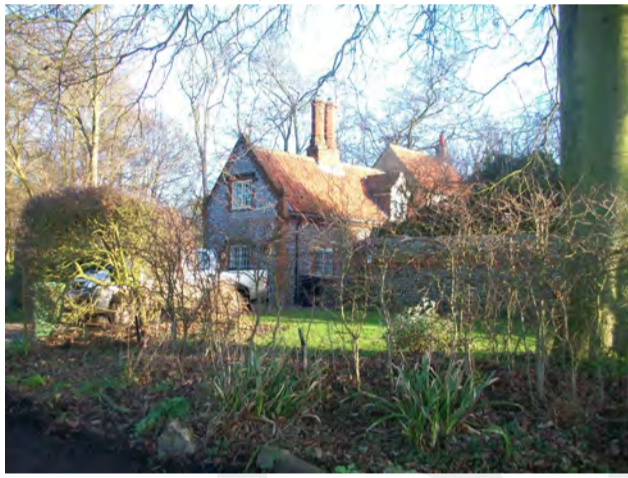
Address / Building Name	The Fairstead and Fairstead Cottage
Street-by-Street Assessment	The Fairstead
Status	Locally Listed
List Entry Link	N/A
Brief History	C18th and C19th
Brief Description	Two storey former barn with inserted casement windows and two heights of pitched roof. Some windows are metal whilst others are replacement timber. Small red brick chimneys to pantile roof.

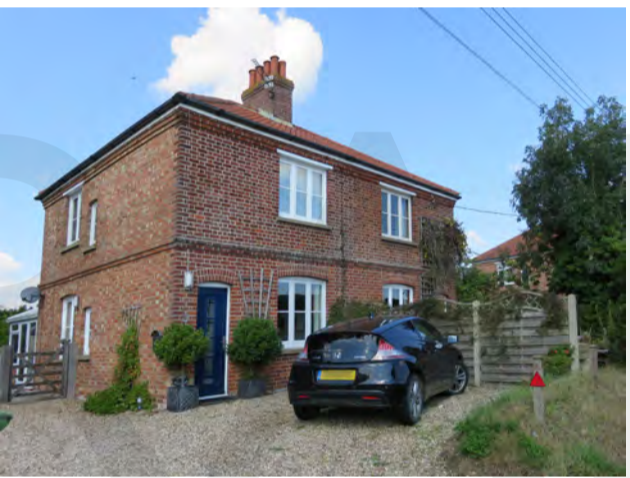
Address / Building Name	5 and 6 Holt Road
Street-by-Street Area	Norwich Road North of The Green
Status	Locally Listed
List Entry Link	N/A
Brief History	1912, a rare example of Parish Council housing and pre-1914 local authority housing. Built in ½ acre plots for £150.
Brief Description	Pair of semi-detached houses. Brick with corrugated tile hipped roof. Two storeys, one bay per-house. Having not benefited from the protection of listing, the windows have been altered to uPVC and doors have been replaced. Single-storey divided wash-house to rear, extended. Included on the local list for group value.

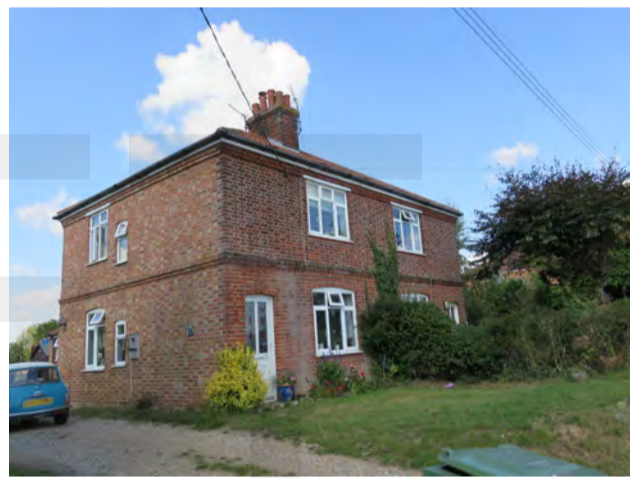
Address / Building Name	7 and 8 Holt Road
Street-by-Street Area	Norwich Road North of The Green
Status	Locally Listed
List Entry Link	N/A
Brief History	1912, a rare example of Parish Council housing and pre-1914 local authority housing. Built in ½ acre plots for £150.
Brief Description	Pair of semi-detached houses. Brick with corrugated tile hipped roof. Two storeys, one bay per-house. Having not benefited from the protection of listing, the windows have been altered to uPVC and doors have been replaced. Single-storey divided wash-house to rear, extended. Included on the local list for group value.

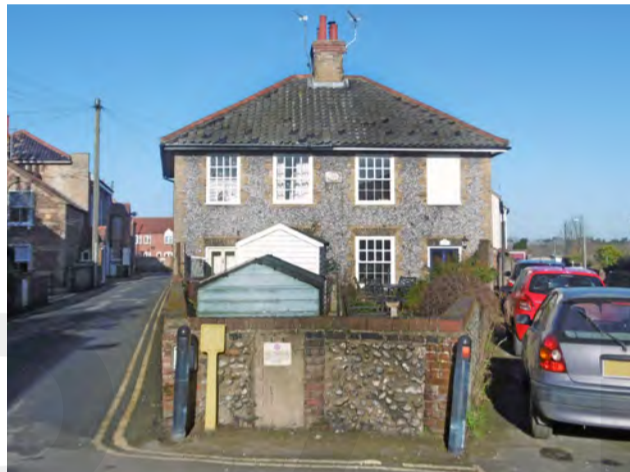
Address / Building Name	28 and 30 Albert Street
Status	Grade II
List Entry Link	https://historicengland.org.uk/listing/the-list/list-entry/1373749
Brief History	Mid C19
Brief Description	Two houses. Two storey. Flint with red brick dressings, red clay pantile roof, brick chimneys, timber sash windows, timber and glazed doors. No. 30 has flint and brick boundary wall. No. 28's front garden has been replaced with parking bay.

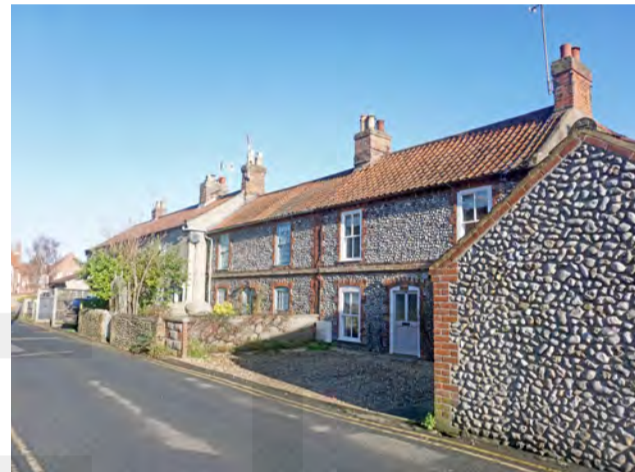
Address / Building Name	Oddfellows Hall
Status	Grade II
List Entry Link	https://historicengland.org.uk/listing/the-list/list-entry/1049336
Brief History	Mid C19
Brief Description	Former chapel, now house. Tall single storey, though now divided internally with a floor level. Flint with gault brick dressings, black glazed pantile roof, modern timber sash windows, modern timber and glazed door with porch over.

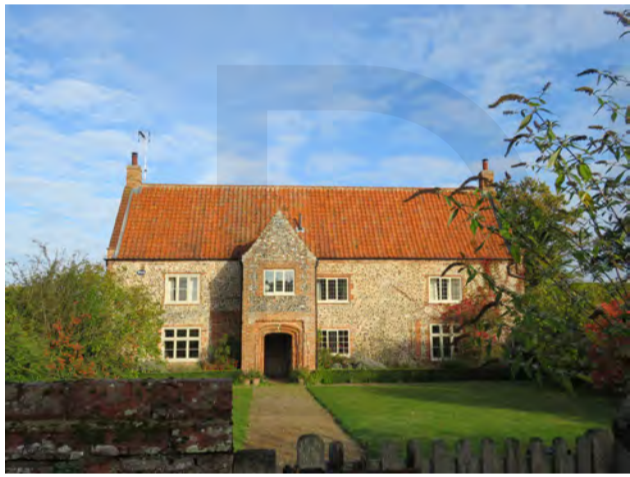
Address / Building Name	5 and 6 Hunworth Road
Street-by-Street Area	Hunworth Road
Status	Grade II
List Entry Link	https://historicengland.org.uk/listing/the-list/list-entry/1049193
Brief History	Mid-C19
Brief Description	Flint and brick cottages with brick dressings, dentil cornice and pantile roof.

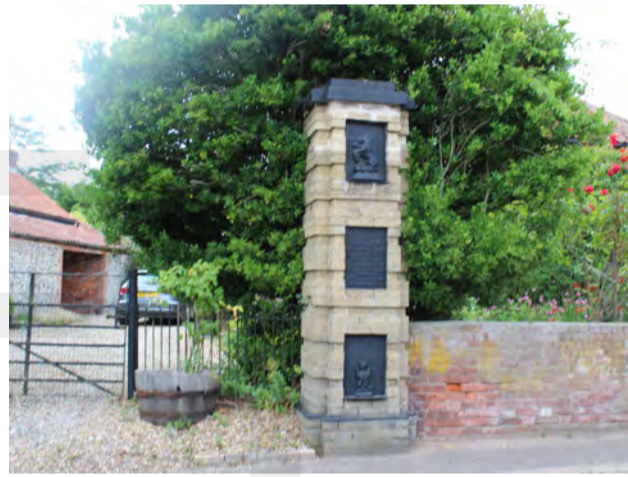
Address / Building Name	Old Foundry House and attached gate pier
Street-by-Street Area	Holt Road
Status	Grade II
List Entry Link	https://historicengland.org.uk/listing/the-list/list-entry/1153054
Brief History	Eighteenth century, with nineteenth century gatepier. There was an iron and brass foundry on the site in the nineteenth century, which would explain the unusual gatepiers.
Brief Description	House. Two storeys. Rendered and colourwashed. Red pantile roof. Sash windows, central panelled door. Gatepier in rusticated gault brick, cast iron double cap, 3 front panels with cast iron plaques showing decorative figurework, cast iron cap to plinth.

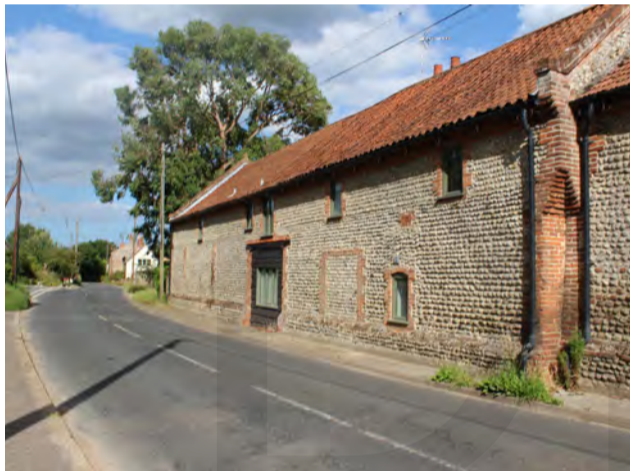
Address / Building Name	Former public house
Street-by-Street Area	Holt Road
Status	Local listing
List Entry Link	N/A
Brief History	Late eighteenth century
Brief Description	Former public house facing sideways to the road. Red brick front elevation with cobble flint gables. Casement windows set in cast iron frames serving as a reminder to the iron and brass foundry.

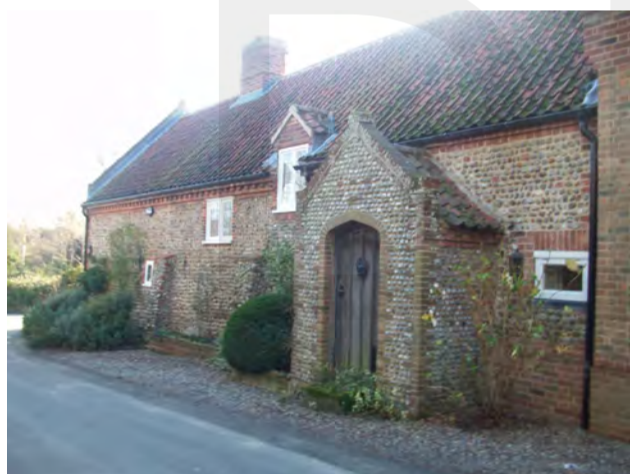
Address / Building Name	8 and 9 Hall Lane
Street-by-Street Assessment	Hall Lane
Status	Locally Listed
List Entry Link	N/A
Brief History	1914

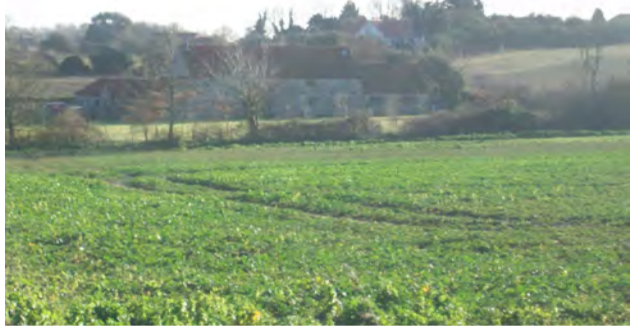
Address / Building Name	Primrose Farm, Chapel Lane
Street-by-Street Assessment	Chapel Lane
Status	Locally Listed
List Entry Link	N/A
Brief History	C18 with mid C19 addition
Brief Description	Four bay range with fifth bay added, probably in the early nineteenth century. It has higher eaves. The large red brick chimney stack is in the centre of the four bay range. The walls are of flint with red brick dressings, including a cornice, flat brick arches at first floor level and segmental arches at first floor level. The painted timber windows appear to be modern replacements. The roof is clay pantiles. Associated with the farmhouse is a one and a half storey barn that runs parallel to the road, now converted. It is flint and brick with brick cornice. The street elevation has eight pattresses. The pantile roof incorporates roof lights. A later extension is also of red brick and flint.

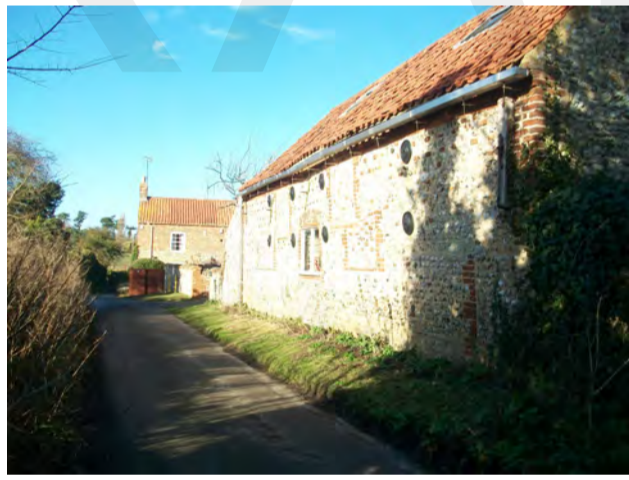
Address / Building Name	Double House
Street-by-Street Assessment	Chapel Lane
Status	Locally Listed
List Entry Link	N/A
Brief History	C18th and early C19th, incorporating earlier fabric
Brief Description	Triple range perpendicular to the road: two ranges of two storeys under roofs of different heights and one single storey range. Three red brick chimneys at each end of the two main ranges and between them; a fourth chimney adorns the single storey range. Clay pantile roofs with solar panels on the single storey range. The south elevation is mostly red brick with some brown brick to the lower storey of the west range. Flat brick arches except one round arch above front elevation windows. Sash windows in the front elevation and east rear range, mostly eight over eight but in different styles West rear range has casement windows. Rear wall predominantly flint and rebuilt in brick. Iron pattresses.

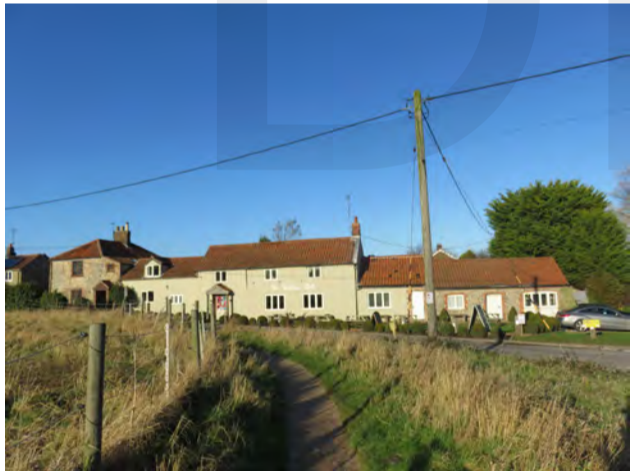
Address / Building Name	Green Farm
Street-by-Street Assessment	Blakeney Road
Status	Locally Listed
List Entry Link	N/A
Brief History	C17th/Early C18th
Brief Description	Eighteenth century farmhouse in poor condition, though seemingly containing original fabric. Two storey house with steeply pitched roof covered with Dutch pantiles and two small chimneys. Attached is a one and a half storey range with attic dormers, a red clay pantile roof and one chimney. Also a mid twentieth century flat roofed extension. Windows are casements. There are no windows in the street gable elevation, which is marked by a later red brick chimney stack insertion as well as other red brick detailing evidencing change. The farmhouse forms the east side of a yard around which are arranged a barn and other outbuildings (see below).
