Glaven Valley

Conservation Area Appraisal and Management Plan

Eighth Draft: May 2023

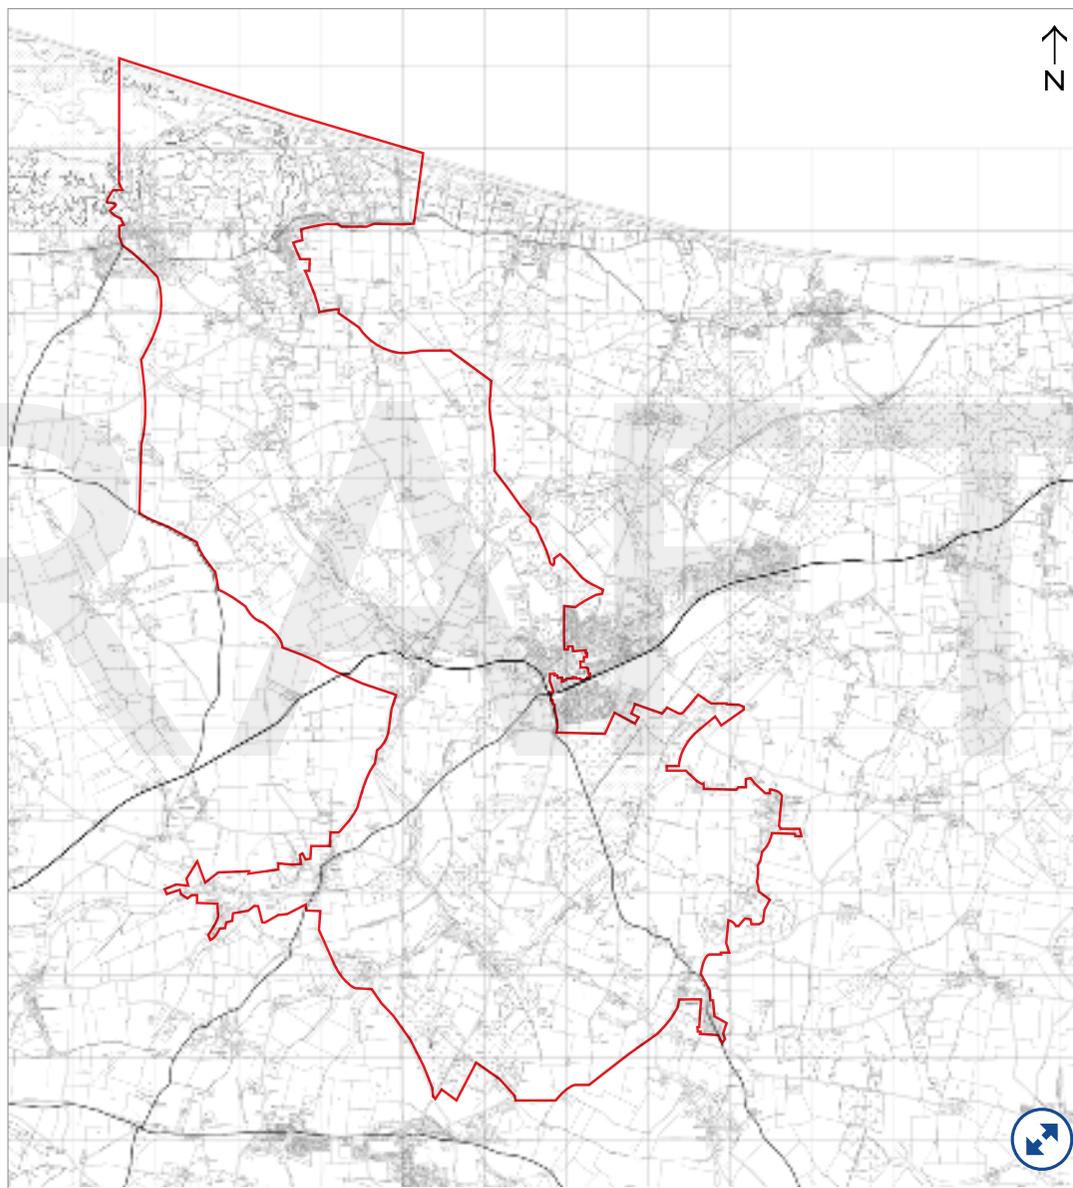
Existing Glaven Valley Conservation Area Boundary Plan © North Norfolk District Council. Reproduced by permission of Ordnance Survey © Crown copyright and database right [2009]. All rights reserved. Ordnance Survey Licence number 100018623. This plan is not to scale.

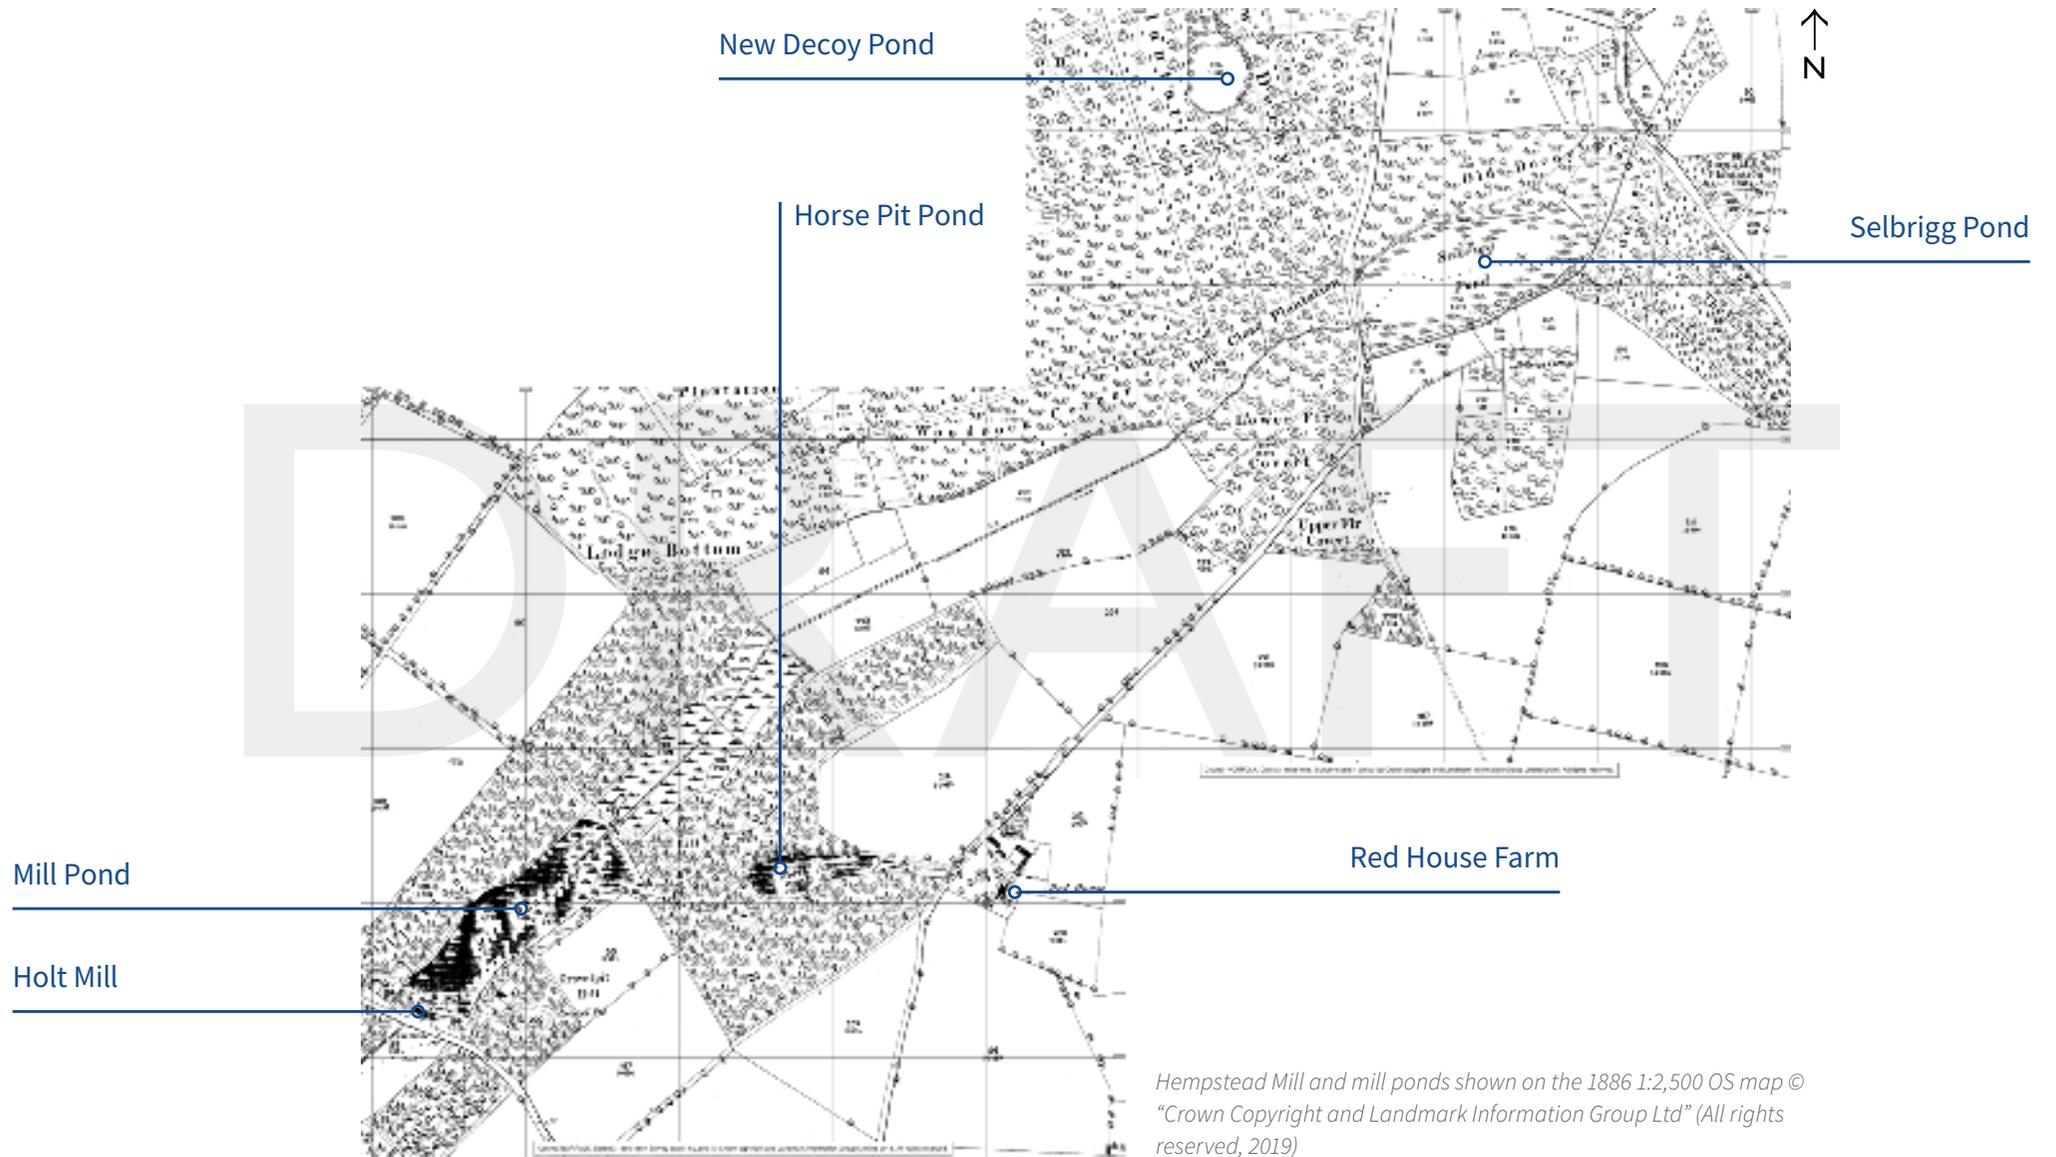
Hempstead Mill and mill ponds shown on the 1886 1:2,500 OS map © "Crown Copyright and Landmark Information Group Ltd" (All rights reserved, 2019)

Milling continued to be a key industry along the river and in the late-eighteenth/early-nineteenth century. The mill buildings at Hempstead (originally called Holt Mill), Thornage and Letheringsett were replaced and further sections of the river were straightened.

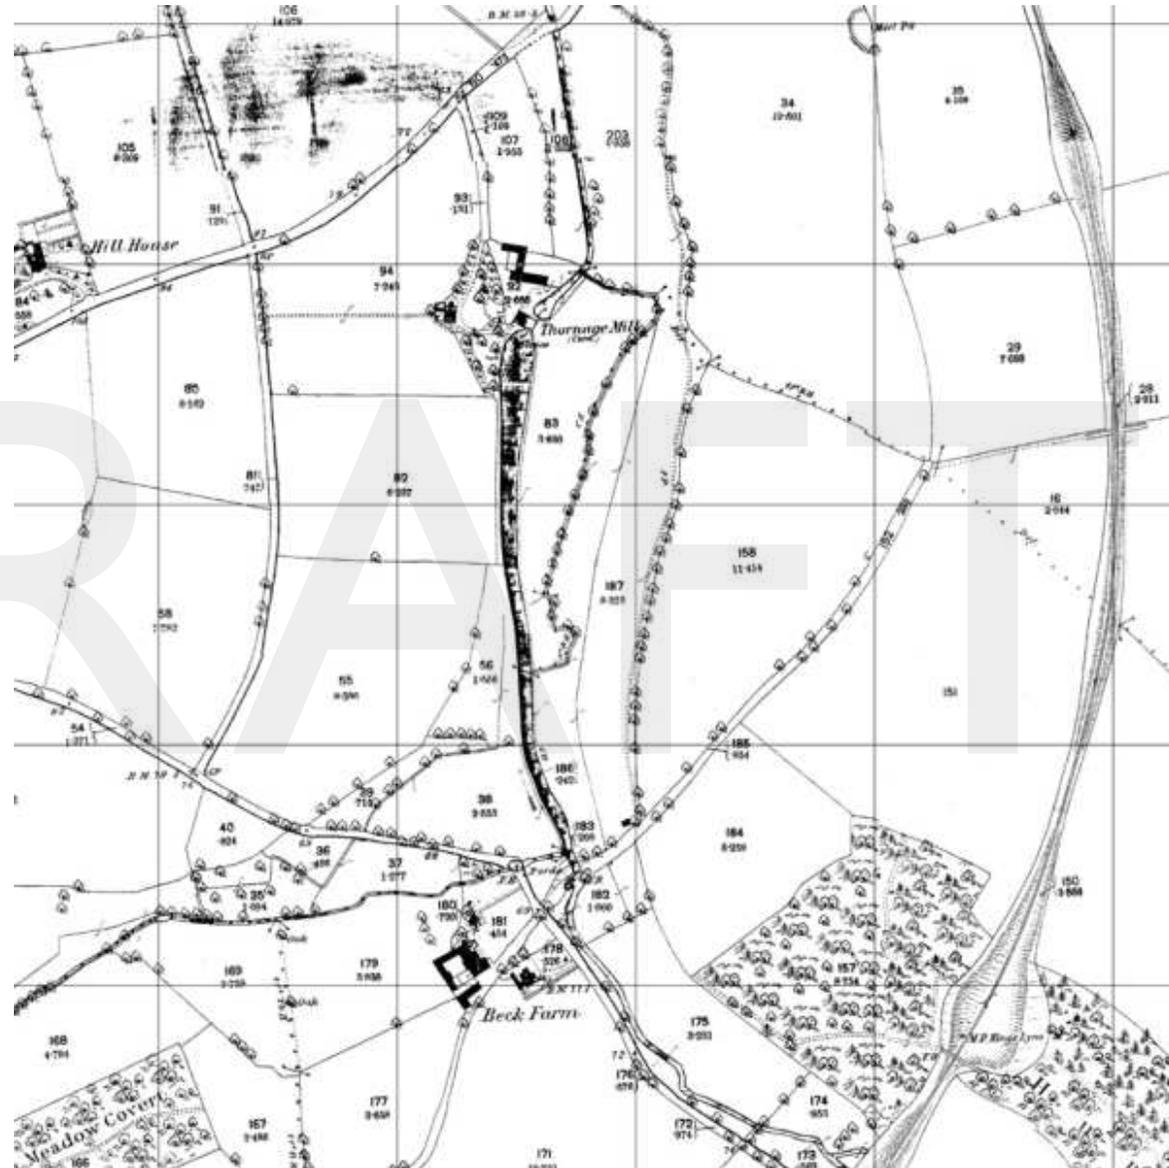
Thornage Mill and mill pond shown on the 1885-86 1:2,500 OS map © "Crown Copyright and Landmark Information Group Ltd" (All rights reserved, 2019)

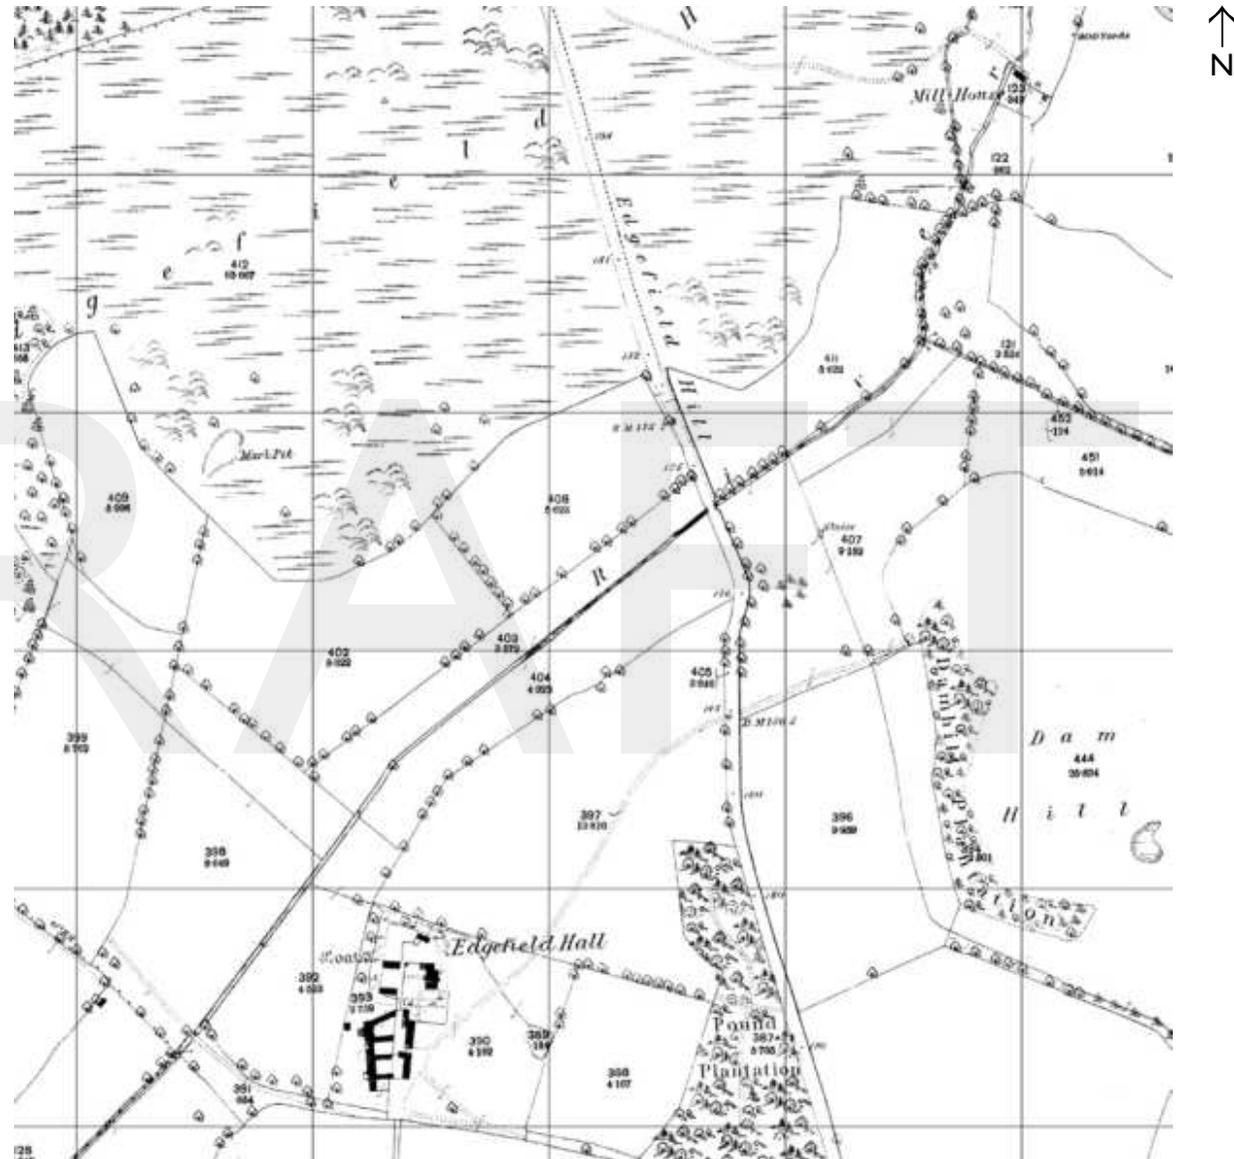
Straightened section of river north of Edgefield Hall and now lost Mill House shown on the 1886-87 1:2,500 OS map © "Crown Copyright and Landmark Information Group Ltd" (All rights reserved, 2019)

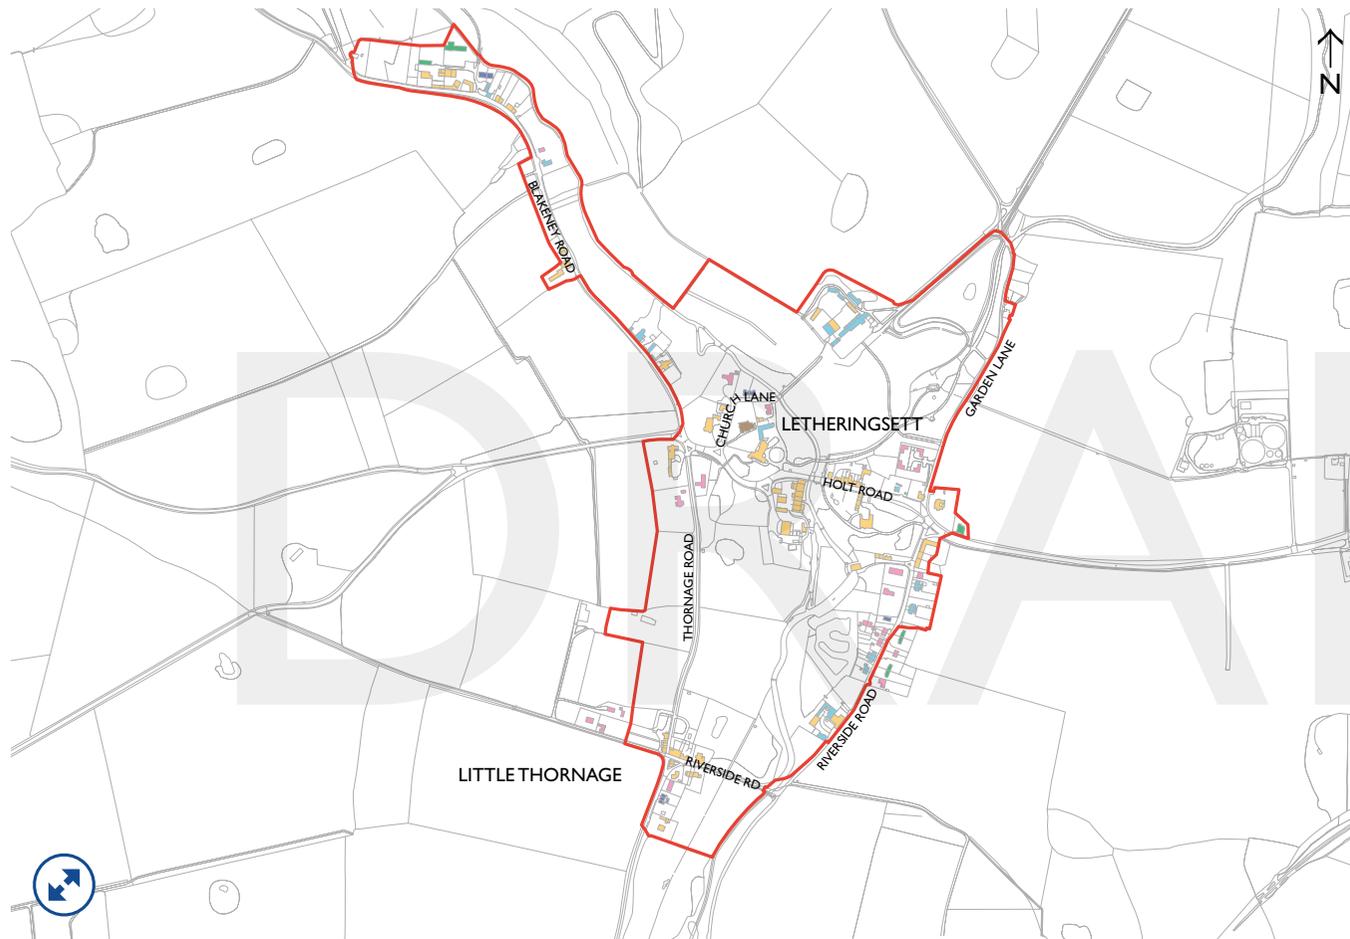
This plan indicates the age of the existing built fabric of the main buildings and structures in Letheringsett and Little Thornage. It is mostly based on a comparison of historic maps with limited verification through viewing of the existing building from the street. Some buildings may have been constructed in phases but generally only the main phase is shown here. Some buildings may have been partially rebuilt or substantially repaired since they were first built but their footprint was unchanged and so the change is not obvious in map comparisons. Where this is the case, generally the building is coloured for the earliest date that it appears on the map.

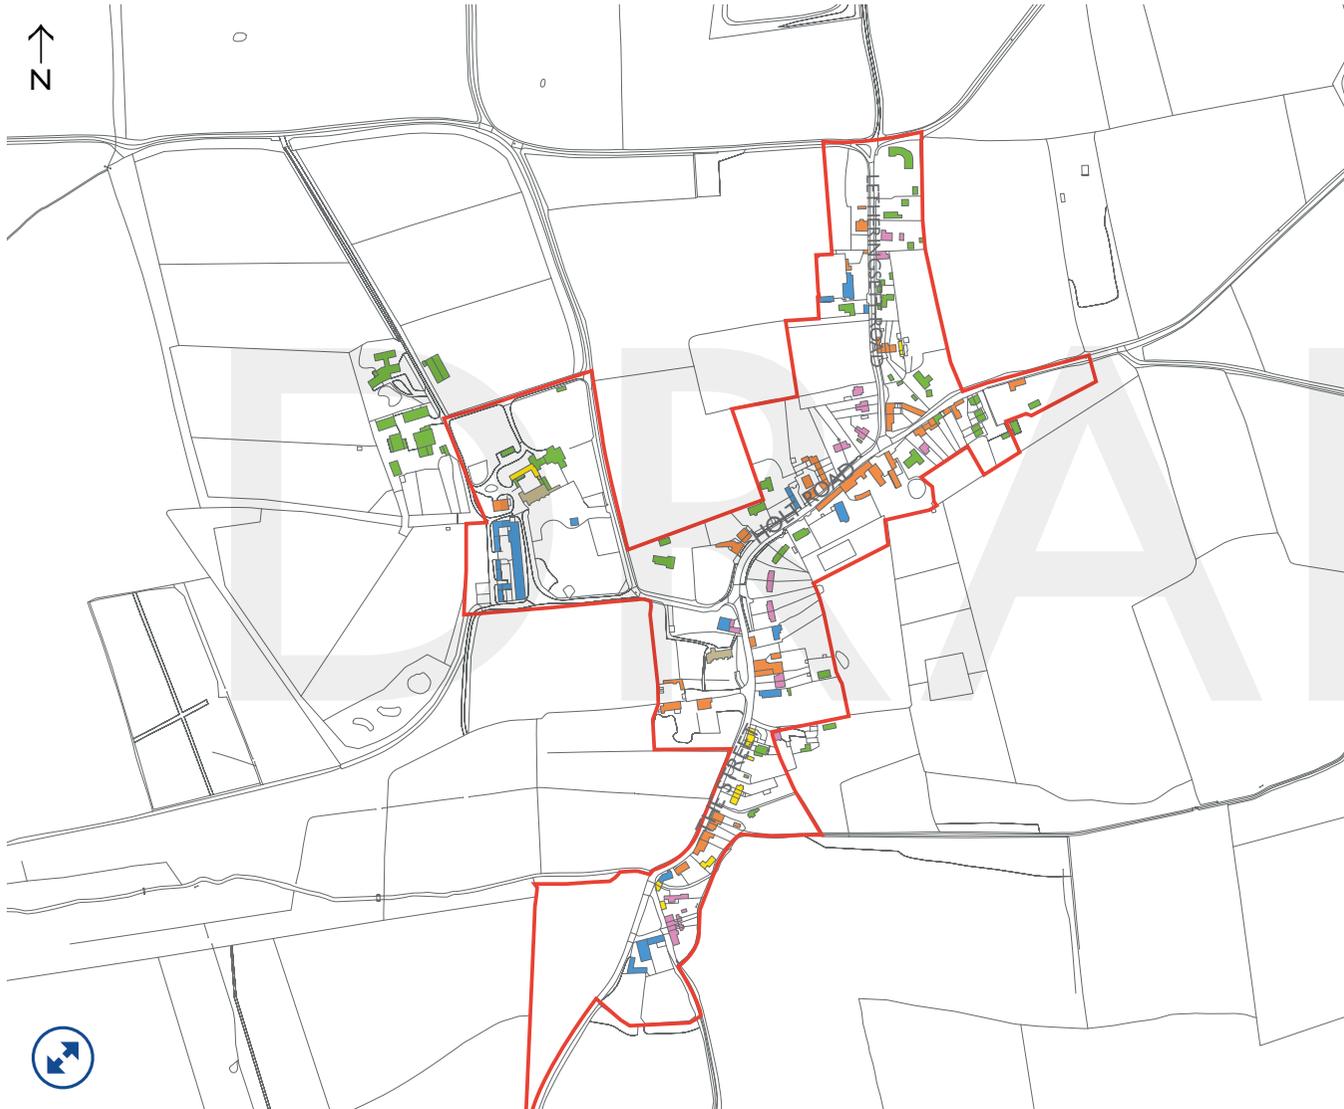
Thornage

This plan indicates the age of the existing built fabric of the main buildings and structures in Thornage. It is mostly based on a comparison of historic maps with limited verification through viewing of the existing building from the street. Some buildings may have been constructed in phases but generally only the main phase is shown here. Some buildings may have been partially rebuilt or substantially repaired since they were first built but their footprint was unchanged and so the change is not obvious in map comparisons. Where this is the case, generally the building is coloured for the earliest date that it appears on the map.

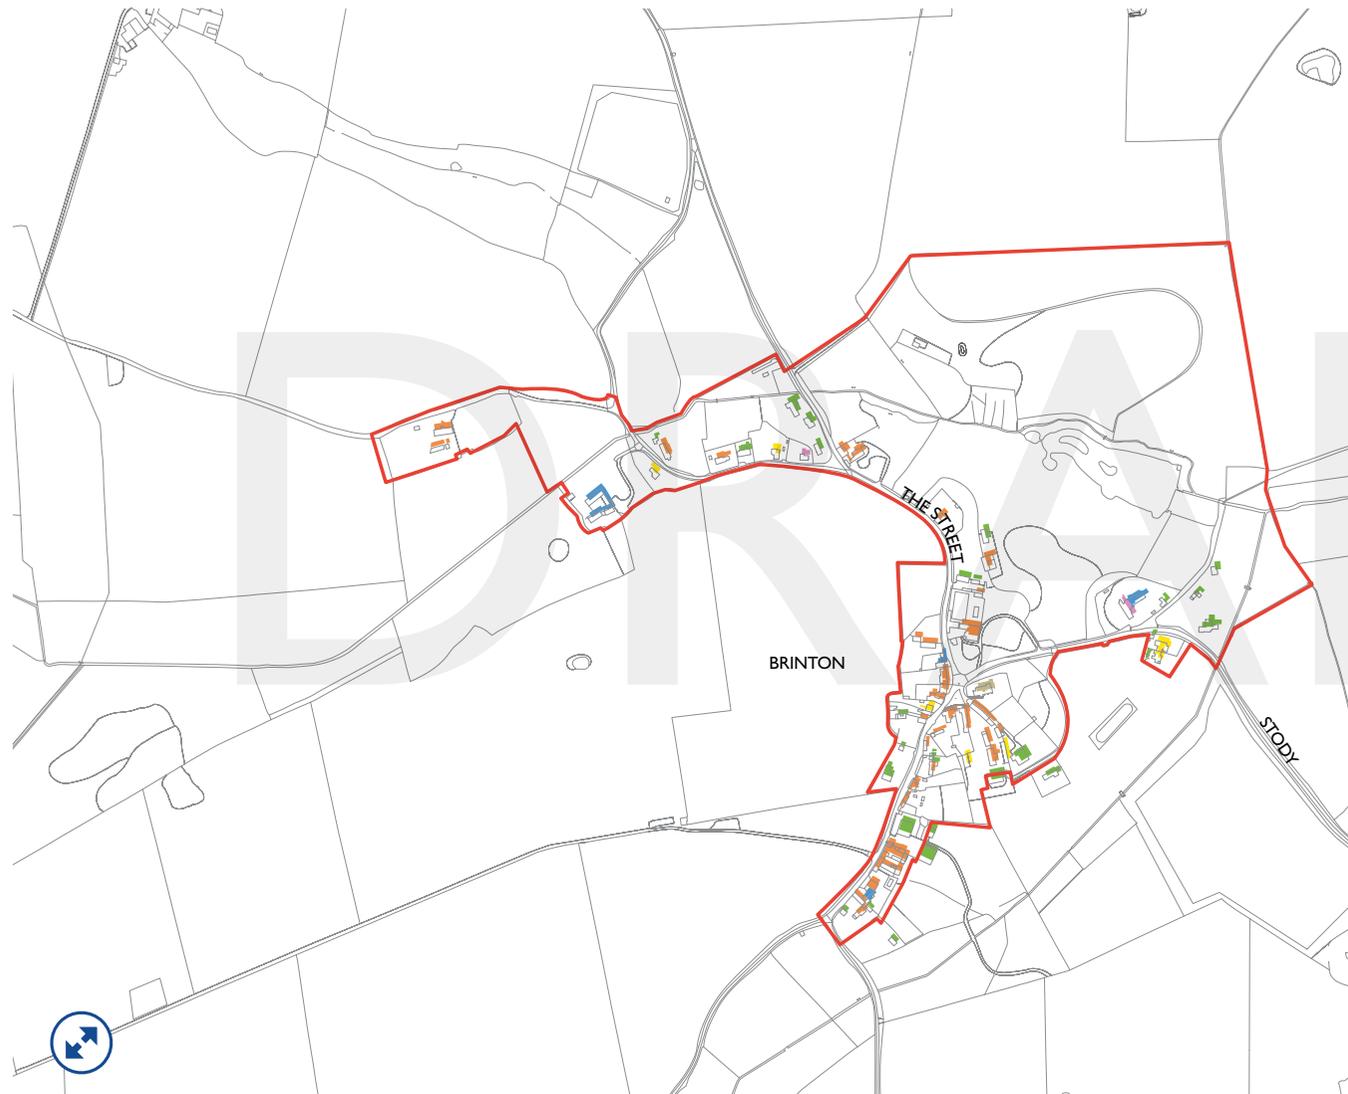
Brinton

This plan indicates the age of the existing built fabric of the main buildings and structures in Brinton. It is mostly based on a comparison of historic maps with limited verification through viewing of the existing building from the street. Some buildings may have been constructed in phases but generally only the main phase is shown here. Some buildings may have been partially rebuilt or substantially repaired since they were first built but their footprint was unchanged and so the change is not obvious in map comparisons. Where this is the case, generally the building is coloured for the earliest date that it appears on the map.

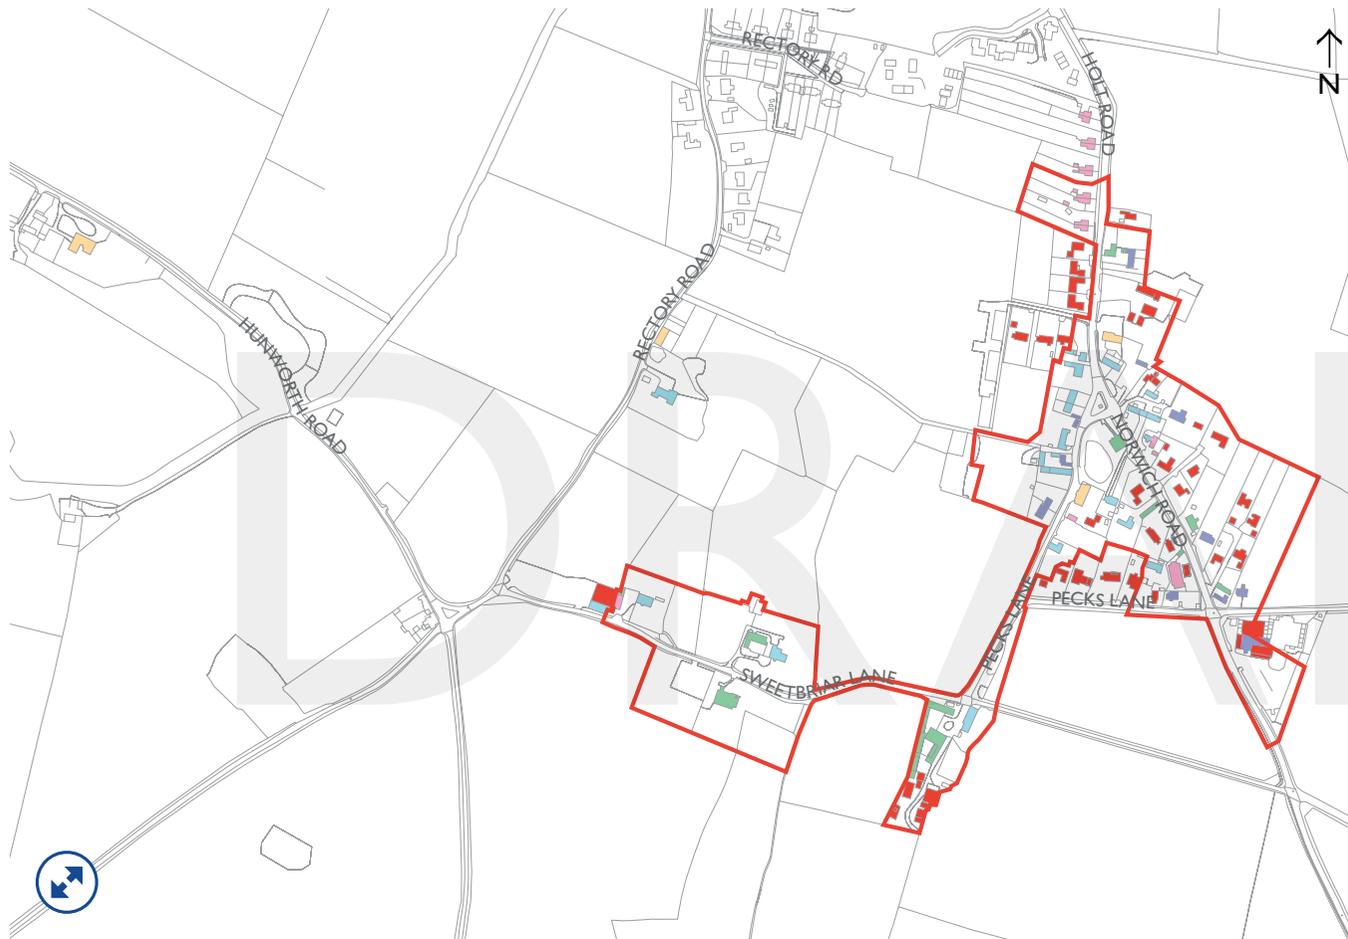
Edgefield

This plan indicates the age of the existing built fabric of the main buildings and structures in Edgefield. It is mostly based on a comparison of historic maps with limited verification through viewing of the existing building from the street. Some buildings may have been constructed in phases but generally only the main phase is shown here. Some buildings may have been partially rebuilt or substantially repaired since they were first built but their footprint was unchanged and so the change is not obvious in map comparisons. Where this is the case, generally the building is coloured for the earliest date that it appears on the map.

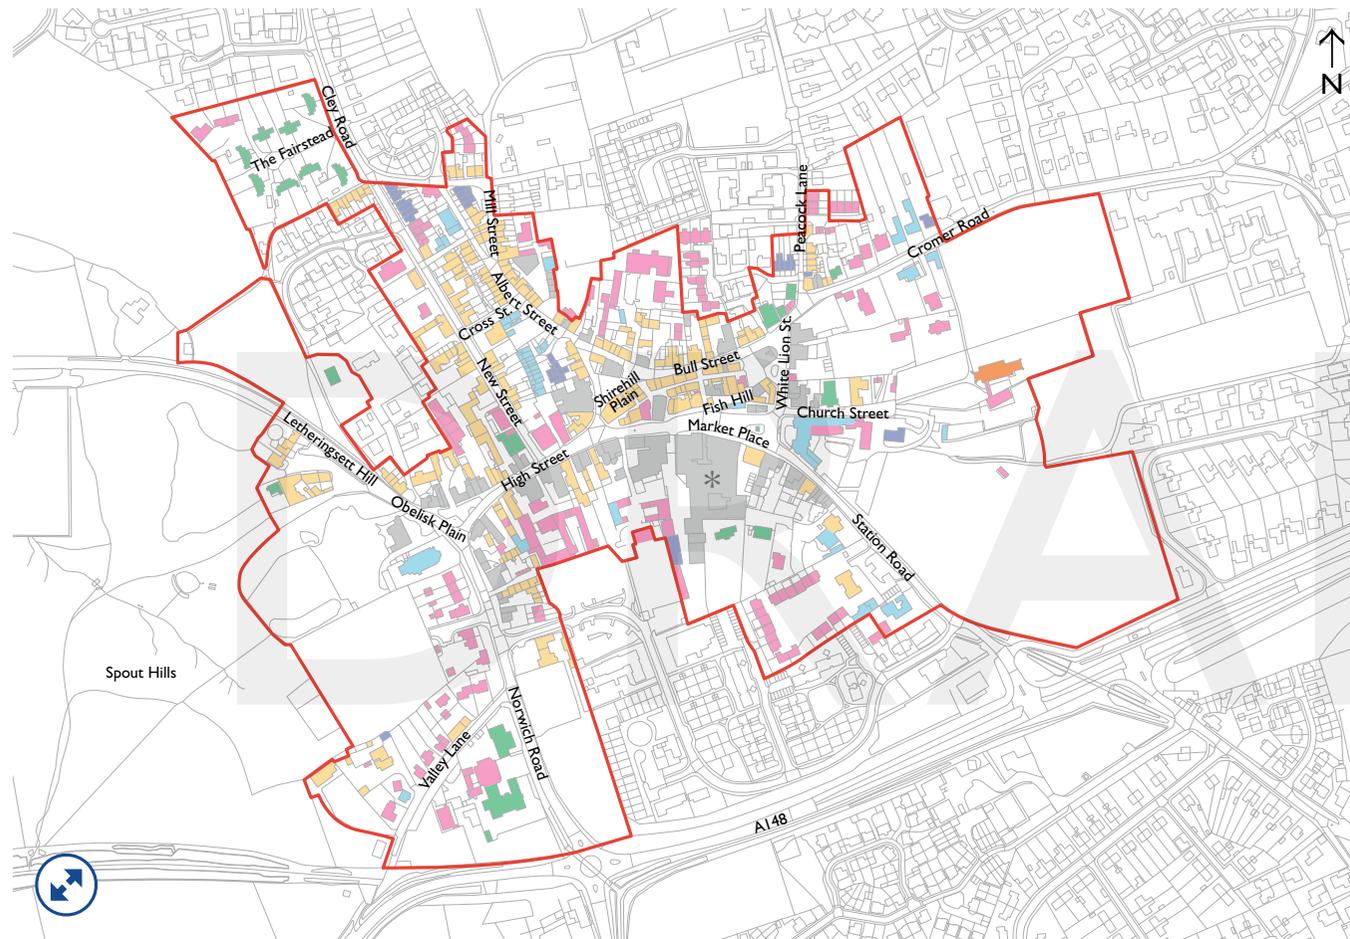
Holt

This plan indicates the age of the existing built fabric of the main buildings and structures in Holt. It is mostly based on a comparison of historic maps with limited verification through viewing of the existing building from the street. Some buildings may have been constructed in phases but generally only the main phase is shown here. Some buildings may have been partially rebuilt or substantially repaired since they were first built but their footprint was unchanged and so the change is not obvious in map comparisons. Where this is the case, generally the building is coloured for the earliest date that it appears on the map.

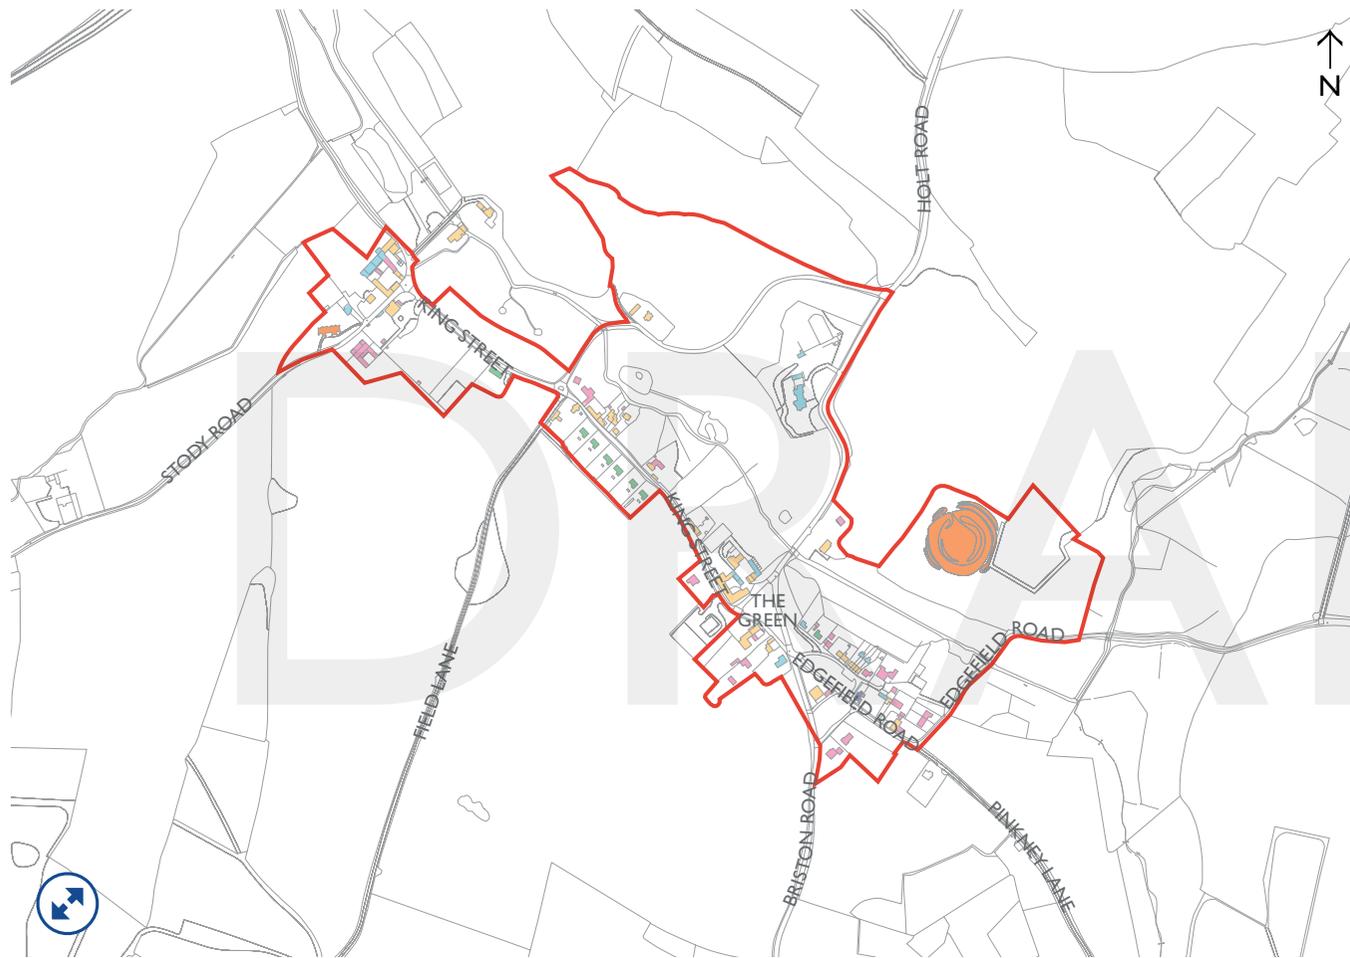
Hunworth

This plan indicates the age of the existing built fabric of the main buildings and structures in Hunworth. It is mostly based on a comparison of historic maps with limited verification through viewing of the existing building from the street. Some buildings may have been constructed in phases but generally only the main phase is shown here. Some buildings may have been partially rebuilt or substantially repaired since they were first built but their footprint was unchanged and so the change is not obvious in map comparisons. Where this is the case, generally the building is coloured for the earliest date that it appears on the map.

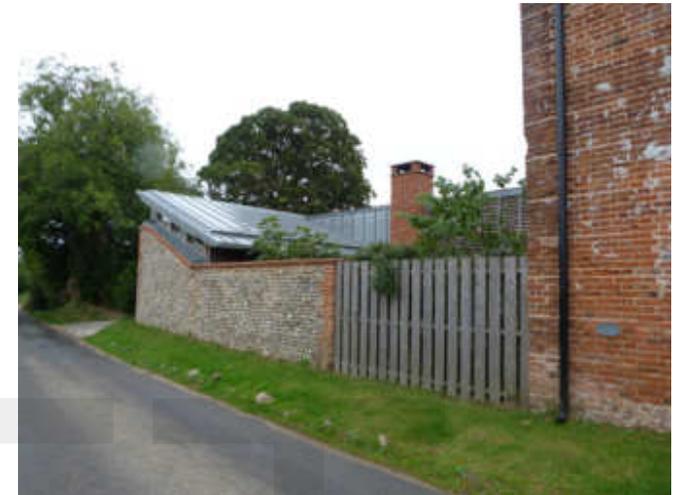
Zinc roof together with more traditional brick and flint to an extension to a barn

Modern buildings usually are of red brick, flint and red clay pantiles. However, there are some examples of modern materials, some which are sensitive examples, such as rolled zinc roofing, timber cladding, and others which are out of character with the Conservation Area, such as uPVC windows and doors.

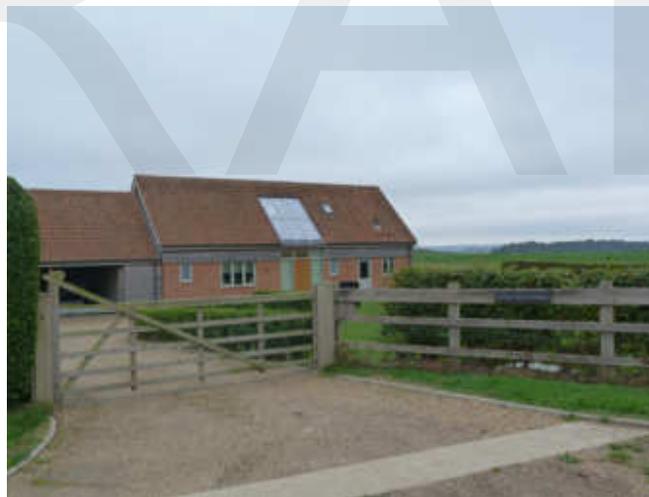
Timber cladding and glazing to a modern house near Holt

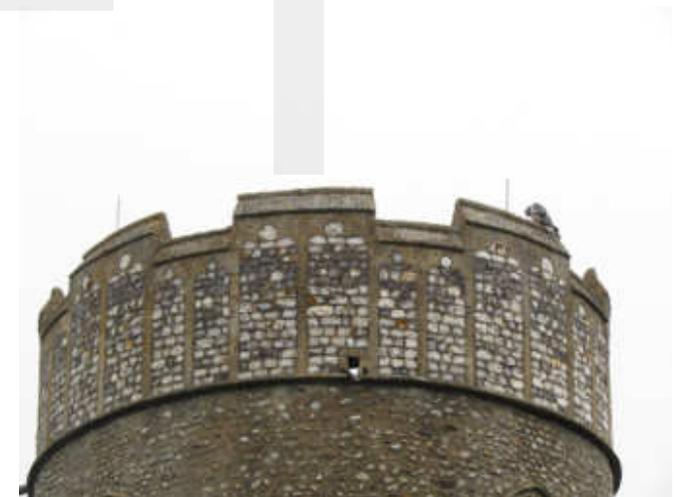
Knapped flint flushwork

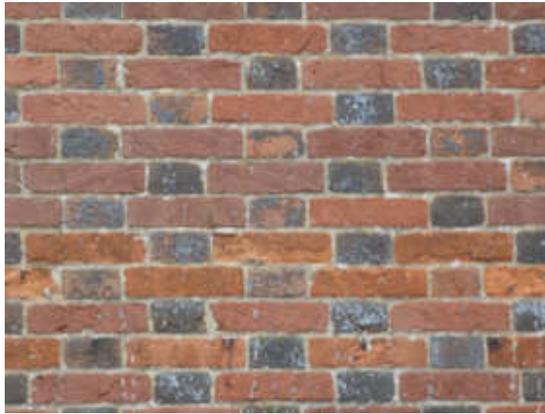
Red brick patterned with darker brickwork

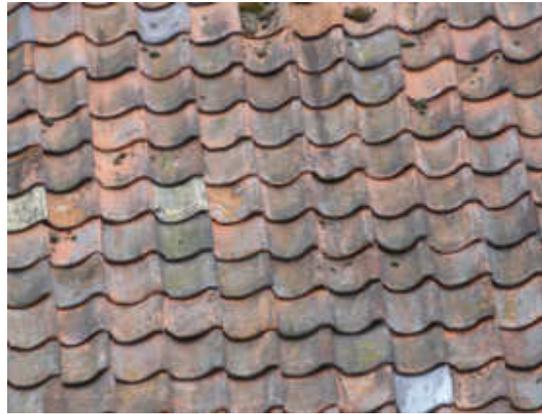
Red clay pantiles

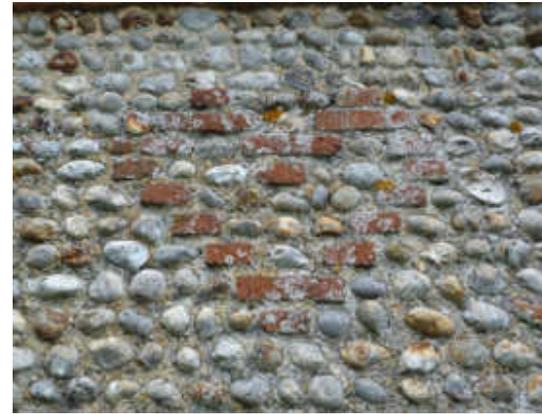
Flint cobbles with red brick heart pattern insert

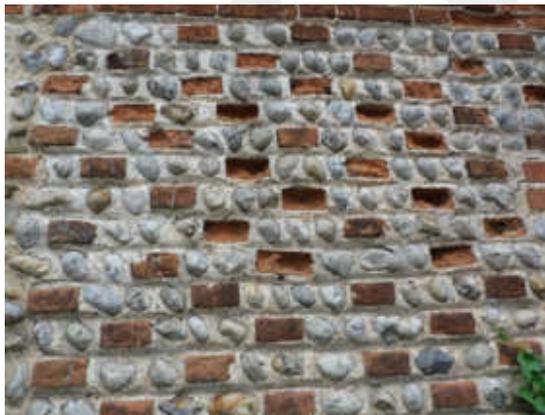
Cobbled flint and red brick patterning, with cement mortar

The rendering of buildings which were traditionally exposed brick or the use of cement mortars is not appropriate as this also traps moisture and reduces the breathability of buildings. Traditional lime mortar should be used for renders or pointing to historic buildings if they are deemed appropriate. The painting of brickwork is not normally good conservation practice, as plastic paints also reduce breathability. Breathable traditional paints are therefore preferable to modern plastic paints.

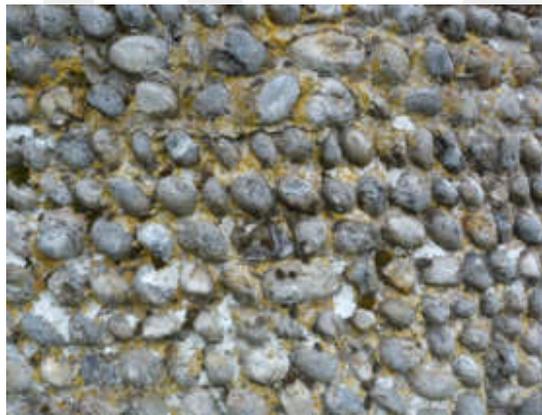
Flint cobbles

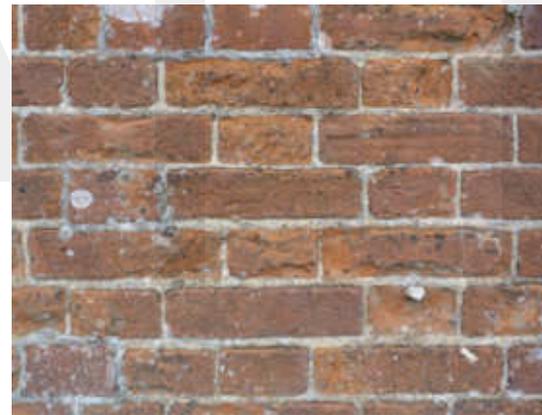
Red brick with lime mortar

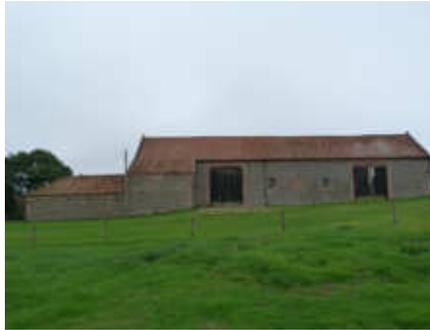
Large threshing barn at Hempstead Hall

All farms have a barn, usually a threshing barn with a larger door (or doors) on one side to accommodate full carts of wheat and a smaller one on the other side through which the empty cart left. Several of these barns are very large, such as the one at Hempstead Hall, and, with their expansive roofs, they are key features within the landscape. Other farm buildings are smaller in scale than the barns but use the same materials of red brick, flint and red clay pantiles. Farm buildings are often surrounded by walls with the buildings within arranged in a group around yards.

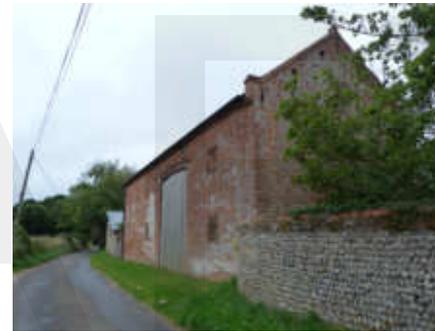
Converted threshing barn near Edgefield Old Rectory

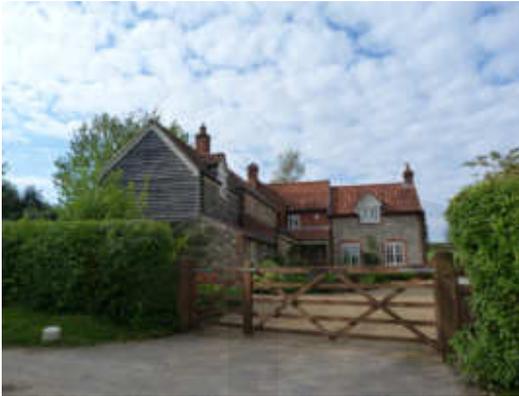
Modern side extension to an historic cottage in Stody

There is a wide variety of modern houses within the Conservation Area. These are typically on the periphery of villages. There is also a mix of single houses, modern extensions to historic houses or housing

estates. Some are good quality, using vernacular materials, detailing and style, such as dormers and casement windows. Others are basic in design using materials not typical of the area, such as buff coloured brick, and lacking character.

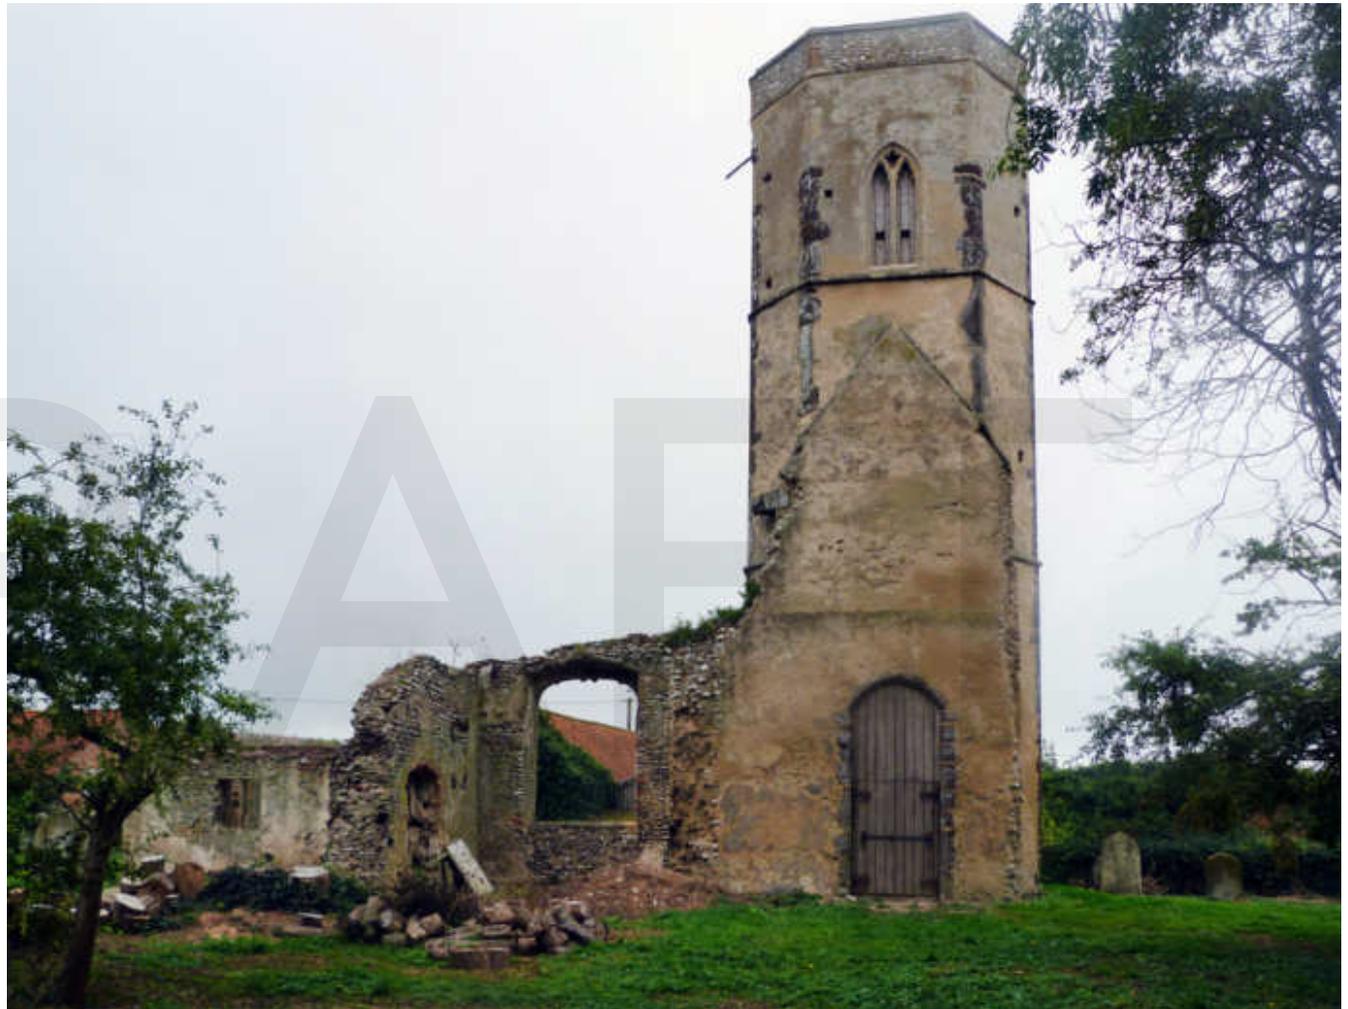
Former Edgefield Church

In addition, there are two ruined churches that lie outside village centres: the former Edgefield Church, and the ruins of St. Margaret's church at Bayfield Hall. St. Peter and Paul at Edgefield dates from the twelfth to fourteenth century but was abandoned when a new church was constructed nearer to the village in 1884. Now the octagonal tower and a few short sections of wall remain. St. Margaret's has origins in eleventh century, with fourteenth century work. It once served the lost village of Bayfield. Flint walls and a bellcote remain now. The church has been in ruins since the eighteenth century. Both churches are flint, with stone dressings and feature Gothic detailing.

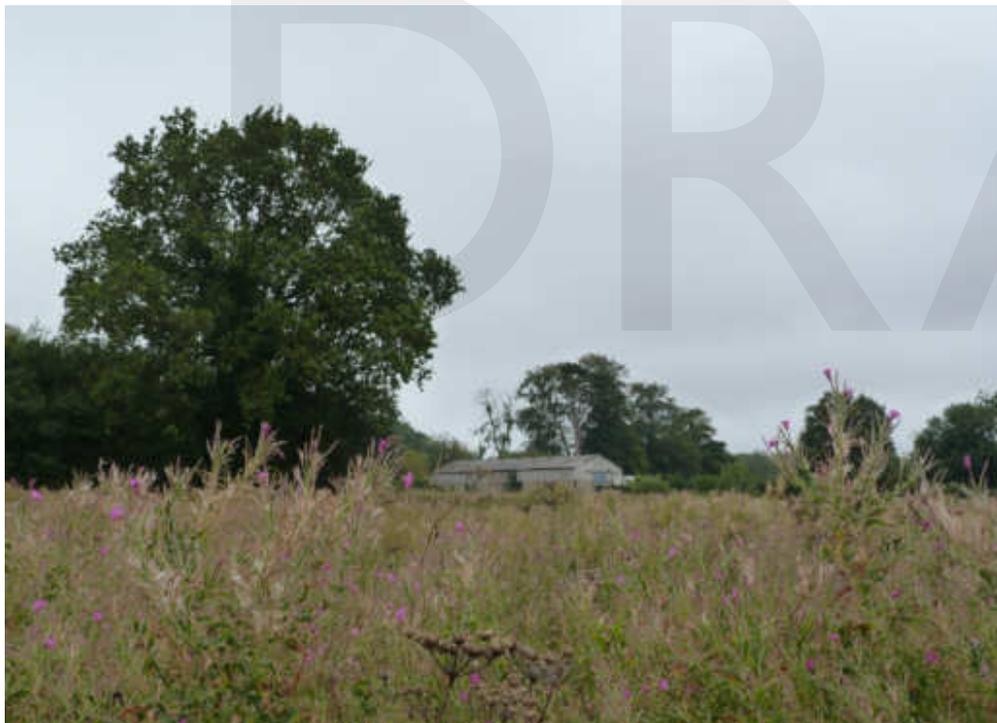
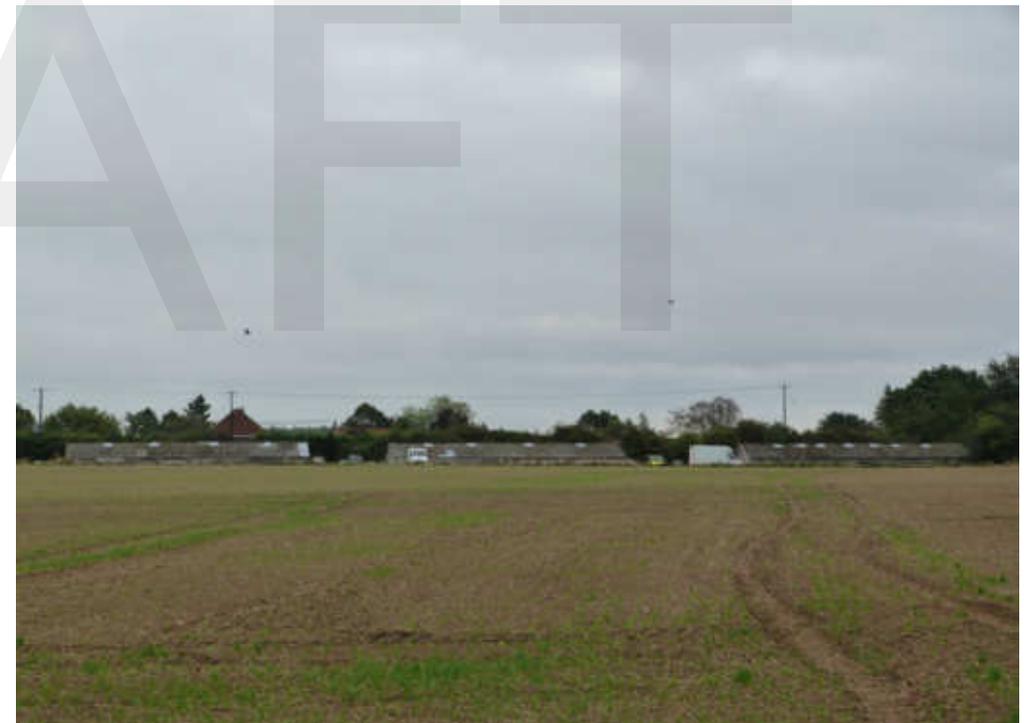
Example of a modern barn on the edge of a village

Modern agricultural barns are often large scale and tend to sit on the peripheries of villages or farm complexes where they are very visible in the landscape. Their materials are usually concrete blocks with corrugated metal sheeting for the upper walls and roofs. These are very incongruous materials when compared with the typical materiality of the Conservation Area, which includes red brick and flint. These barns are therefore often in contrast to the smaller scale historic farm buildings which they sit next to. For agricultural buildings, permitted development

allows that if a farm is more than five hectares the owner has the right to erect, extend or alter a building. These barns are essential for the continued agricultural use of the land. However, there could be opportunities to soften their appearance, such as with weatherboarding. New barns could be located where they are less visually intrusive and could use materials that are more in character with the Conservation Area.
