Glaven Valley

Conservation Area Appraisal and Management Plan

Eighth Draft: May 2023

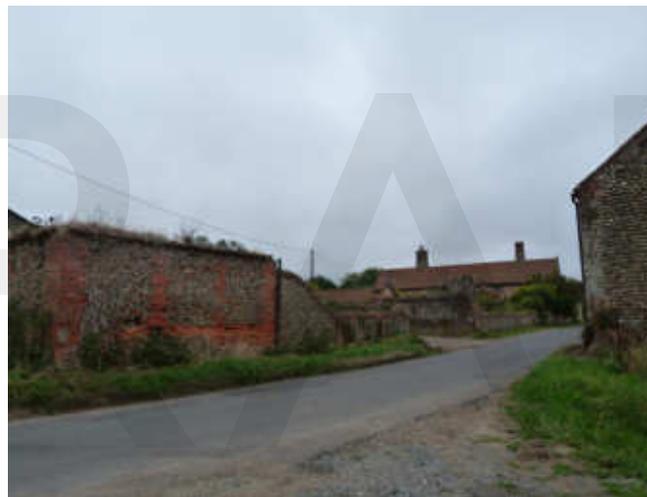
Vacant buildings and derelict structures at Green Farm

There are few examples of structures in poor condition within the Glaven Valley Conservation Area. However, some examples of vacant farm buildings which are in deteriorating condition highlights the difficulties and cost in the upkeep of this type of building, where often large modern barns are now required as opposed to smaller historic ones. These farm sites are often remote from settlements meaning a new use not related to farming is challenging to implement. Hempstead (Holt) Mill is also another prime example of a vacant building at risk of decay if not brought back into a viable use. In this case it includes the threat of decay or loss of the historic milling machinery. Vacancy is a particular threat to historic buildings as it means maintenance issues tend not to be spotted or addressed quickly, leading to irreversible damage or loss which is costly to repair and is a permanent diminishing of our heritage.

There is an opportunity to bring these buildings back into use. The examples of the converted mills at Thornage, Glandford and Hunworth show that residential conversion can be successful. In the case of Thornage it included the incorporation of the milling machinery into the living spaces, ensuring this

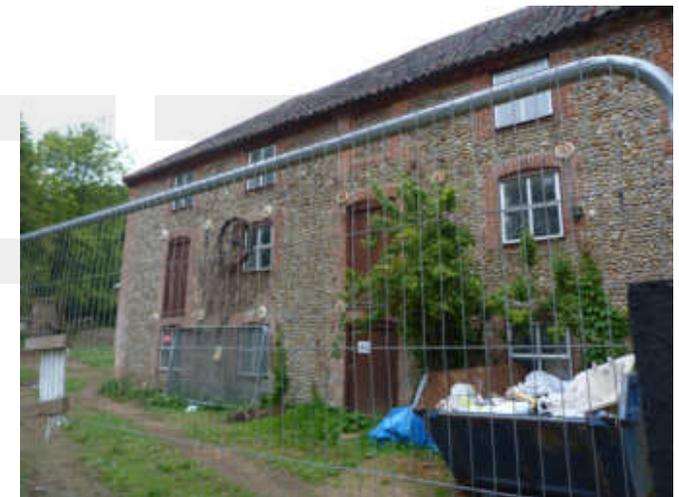
Hempstead Mill, which is vacant though there appears to be building work on the site. The building also has modern uPVC and timber windows that are out of character with the historic building and Conservation Area

The replacement of historic or traditional doors and windows with inappropriate alternatives, such as those in uPVC, is a significant threat to individual historic buildings and to the Conservation Area as a whole. Changes to traditional fenestration causes the loss of historic fabric, can alter the appearance and aesthetic value of a building and can also affect the historic fabric of the remainder of the building by changing its breathability. It is preferable to repair damaged windows and to undertake regular maintenance to ensure their enduring longevity. Well executed like-for-like replacement windows (i.e. same size and proportions of elements constructed using the same materials and finishes as the existing) maintain the aesthetic, though not the evidential value, of the historic windows. It can also be possible with some windows to incorporate slimline double-glazing to traditional style timber windows without affecting the appearance substantially. Visible trickle vents also disrupt the appearance of both timber and uPVC windows. uPVC windows should not be used in historic buildings in a Conservation Area and are undesirable on modern buildings within the Conservation Area. uPVC conservatories are also likely to be inappropriate, particularly where they are visible from the public highway.

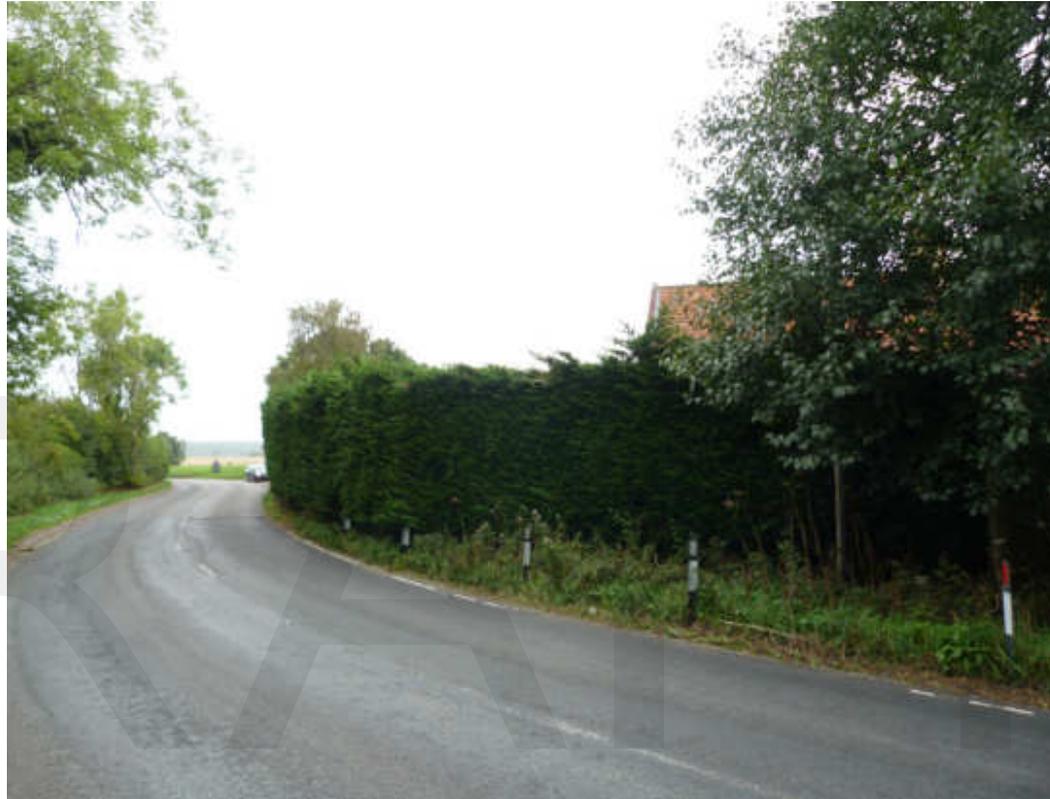
Coniferous hedging is out of keeping with the traditional rural character of the Conservation Area

The Glaven Valley's rural character is one of the things that make it so special. With a gradual growth in houses on the edges of settlements, the desire of owners to alter their properties and the conversion of once functional agricultural buildings into residential use, there is a risk of suburbanisation or over restoration of buildings and public realm or surfacing treatments. Elements such as hard surfacing, for example kerbs, bricks or concrete as opposed to gravel, formal gates, loss of grass verges, coniferous hedging, high or hard fences and larger parking areas could erode the informal, rural feel of the area. External lighting and light pollution at night is also a threat, as part of the night time character of the area is one of darkness, with the ability to see the stars **on clear nights**. Excessive signage should be avoided and traditional signage, such as timber finger posts as opposed to modern metal road signs, should be encouraged. Road markings are generally quite minimal and this should remain the case.

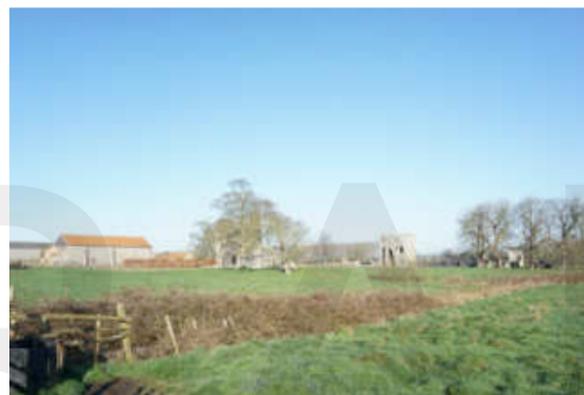
Address / Building Name	Baconsthorpe Castle moated site with fortified house, gatehouse, courtyards and formal gardens
Parish	Baconsthorpe
Status	Scheduled Monument
List Entry Link	https://historicengland.org.uk/listing/the-list/list-entry/1013093
Brief History	House built in the mid-late C15, altered in the early C17 and many of the buildings were demolished in mid-C17.
Brief Description	Moated site with the remains of a fine fortified house built by the Heydon family. The site includes a mere and associated earthworks, an outer gatehouse, courtyards and earthwork remains of formal gardens.

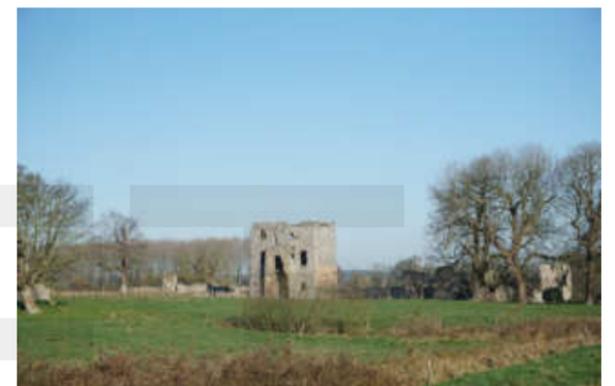
Address / Building Name	Remains of Baconsthorpe Castle
Parish	Baconsthorpe
Status	Grade I
List Entry Link	https://historicengland.org.uk/listing/the-list/list-entry/1049845
Brief History	House built in the mid-late C15, altered in C16 before demolition in mid-C17
Brief Description	Ruins of castle of flint with brick. Square court with three storey roofless gatehouse and roofless remains of two storey east range.

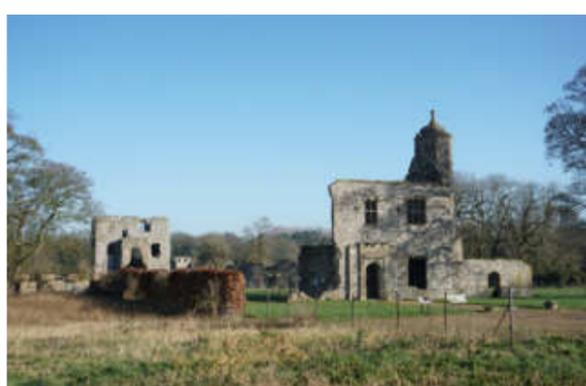
Address / Building Name	Remains of Baconsthorpe Hall 80m South of Baconsthorpe Castle
Parish	Baconsthorpe
Status	Grade II
List Entry Link	https://historicengland.org.uk/listing/the-list/list-entry/1049846
Brief History	Built in C16 as outer gatehouse to the Castle, converted to a house in late C16 or early C17, altered C19.
Brief Description	Roofless remains of outer gatehouse of galletted flint. Two or the three original bays survive; turret to right gable, partly octagonal with a stone cupola.

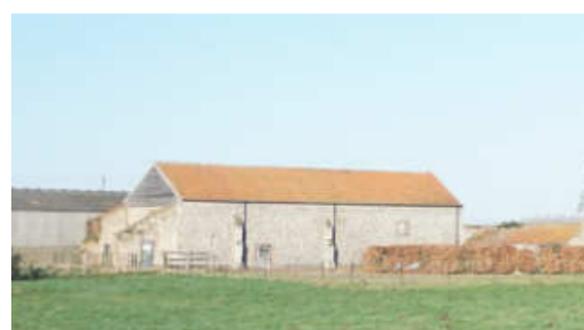
Address / Building Name	Barn at Hall Farm circa 35m west of Baconsthorpe Hall
Parish	Baconsthorpe
Status	Grade II
List Entry Link	https://historicengland.org.uk/listing/the-list/list-entry/1373486?section=official-list-entry
Brief History	C16 with lateral alterations
Brief Description	Stone dressed flint barn of six steads. Pantile roof.

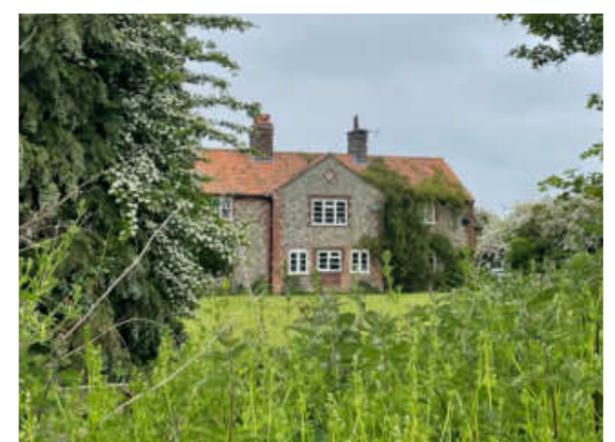
Address / Building Name	Breck Farmhouse and barn
Parish	Baconsthorpe
Status	Proposed Local Listing
List Entry Link	N/A
Brief History	Buildings are indicated on Faden's 1797 map of Norfolk and the buildings included for local listing appear on the 1882 OS map.
Brief Description	Flint and brick, single range farmhouse with central gable, two chimneystacks and a pantile roof. The barn has a large pantile roof and was part of a larger complex of historic farm buildings that has since been partially rebuilt.

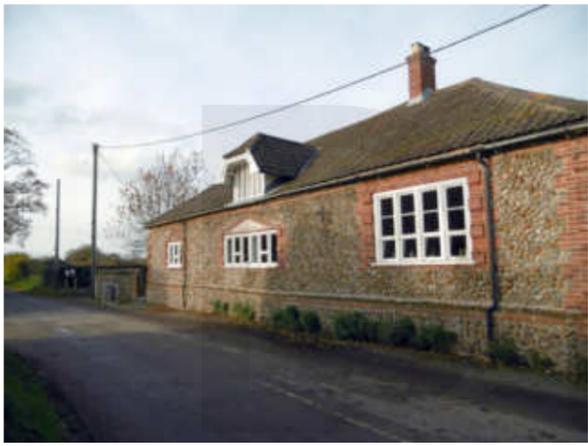
Address / Building Name	The Old School
Street-by-Street Area	Church Lane/Plumstead Road
Status	Grade II
List Entry Link	https://historicengland.org.uk/listing/the-list/list-entry/1049850
Brief History	Former school, now village hall, dated 1816.
Brief Description	Pebble flint with brick dressings; hipped roof, corrugated tiles to front, black glazed pantiles to sides, pantiles to rear. Three bays with outshuts to rear. South front with chamfered brick cap to flint plinth, dentil cornice, axial stack to right. Inscription '1816 National School' within third pediment.

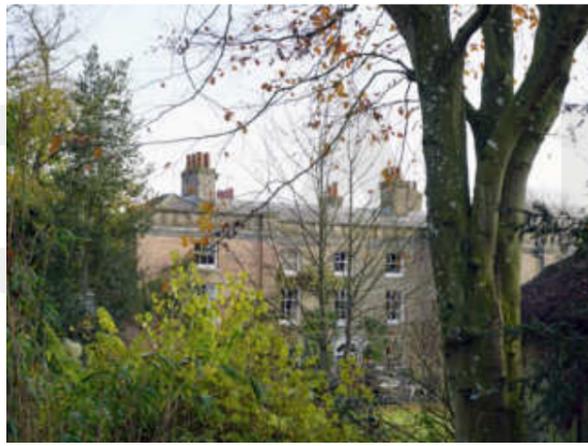
Address / Building Name	The Rectory
Street-by-Street Area	Church Lane/Plumstead Road Area
Status	Proposed Locally Listed
List Entry Link	N/A
Brief History	Late-18th or early-19th century
Brief Description	Three storeys in red and gault brick, with a stone parapet and a slate roof. Timber sash windows, a Classical architrave frames the painted timber panelled front door. Proposed for local listing for its link with the church, its elegant appearance and as one of the larger, grander buildings in the Conservation Area.

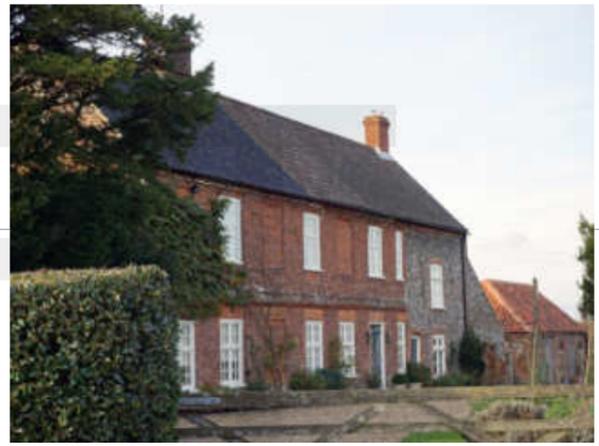
Address / Building Name	Manor House Farmhouse
Street-by-Street Area	Church Lane/Plumstead Road Area
Status	Grade II
List Entry Link	https://historicengland.org.uk/listing/the-list/list-entry/1373487
Brief History	Eighteenth century façade on earlier core dated 1635.
Brief Description	Brick, black glazed pantiles and pantiles. Two phases now under a continuous roof. Two storeys plus attic. Nineteenth century door and windows.

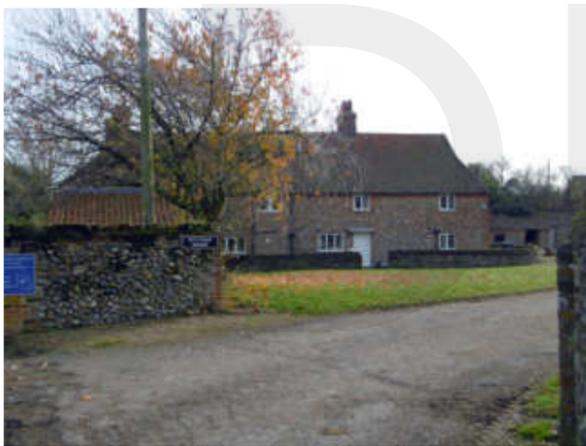
Address / Building Name	Pitt Farm and barns to the rear
Street-by-Street Area	The Street
Status	Proposed Locally Listed
List Entry Link	N/A
Brief History	Sixteenth to seventeenth century house, with large flint and timber barns. Anecdotally has a connection with Anne Boleyn.

Brief Description Red brick house with steep dutch gable hipped roof. Small casement windows. Window to rear looks to be sixteenth century. Proposed for local listing because of its considerable age, the impressive size of historic barns to the rear of the house, and the potential historic connection to Anne Boleyn. It is unusual that a building of this age is not nationally listed.

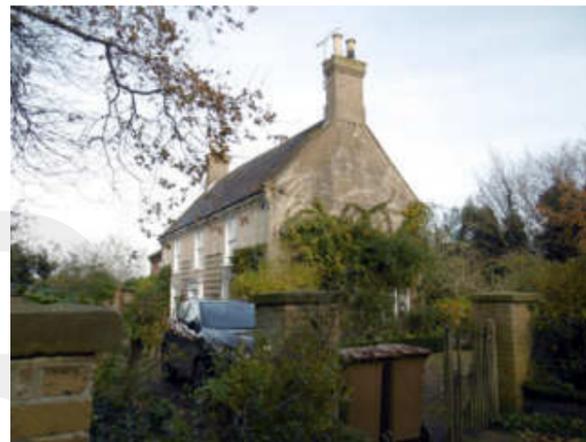
Brief History Eighteenth century house at right angles to the street.

Brief Description Rendered, black glazed pantiles, unglazed to right. Three bays, two storeys. Gable parapets on shaped kneelers, end internal stacks in gault brick each with projecting base and oversailing cap having two yellow chimney pots with hexagonal cups.

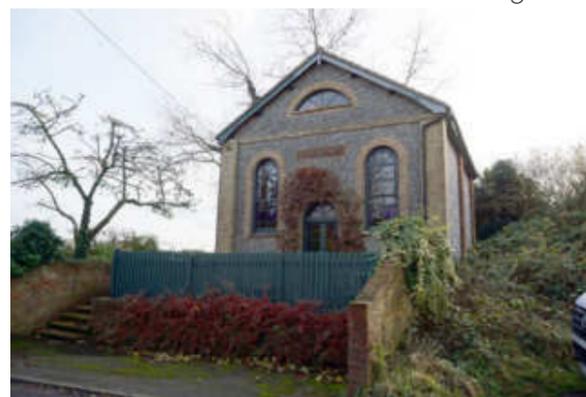
Brief Description Former Wesleyan Chapel now converted to residential. Pebble flint with gault brick dressings. Arched windows and door to north end are distinctive. Name and date plaque on north elevation. Proposed for local listing for its distinctive design, its demonstration of the popularity of Methodism in the area and as a former communal building.

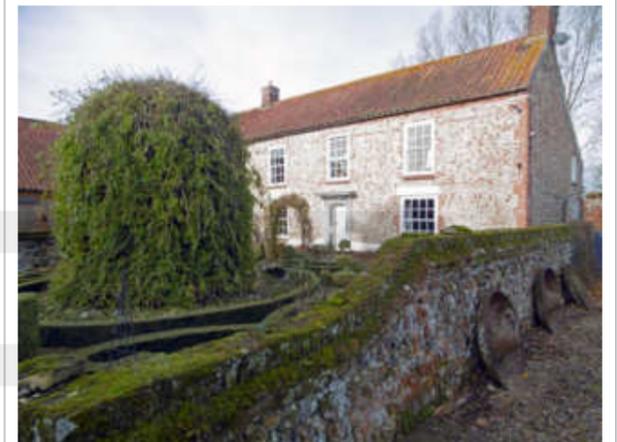
Brief History Pre-eighteenth century.

Brief Description Red brick house with red brick dressings and pantile roof. Proposed for local listing because of its elegant symmetrical façade, good quality doors and windows, and as one of the larger and better quality farmhouses within the village.

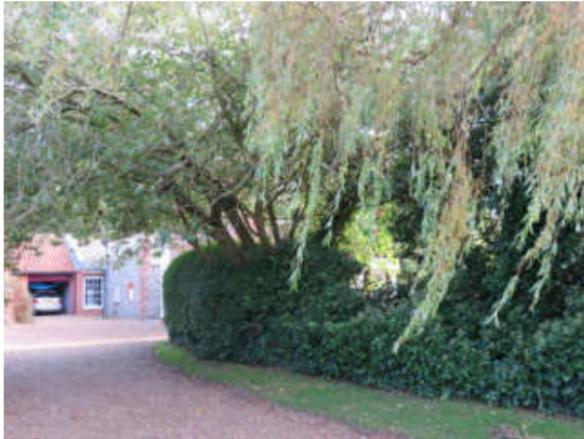
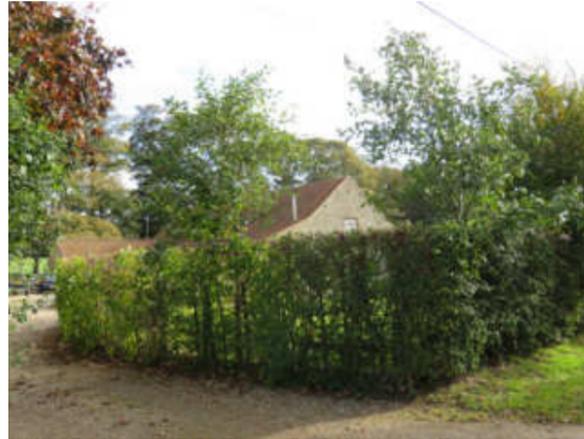
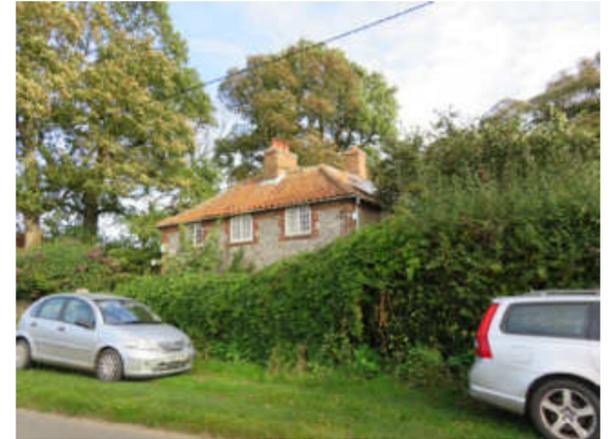
Address / Building Name	Swan Lodge, Holt Road, Cley NR25 7EA
Parish	Cley-next-the-Sea
Status	Proposed Local Listing
List Entry Link	N/A
Brief History	Pre-1886
Brief Description	Red brick lodge house with slate roof. Glimpsed views

Address / Building Name	Swan Lodge Barn
Parish	Cley-next-the-Sea
Status	Proposed Local Listing
List Entry Link	N/A
Brief History	Pre-1886
Brief Description	Large, converted flint barn with red brick dressings and catslide roof of red clay pantiles. Visible

Address / Building Name	Swan Cottage
Parish	Cley-next-the-Sea
Status	Proposed Local Listing
List Entry Link	N/A
Brief History	Pre-1886
Brief Description	Cottage of cobble flints with red brick dressings and iron windows. Very visible

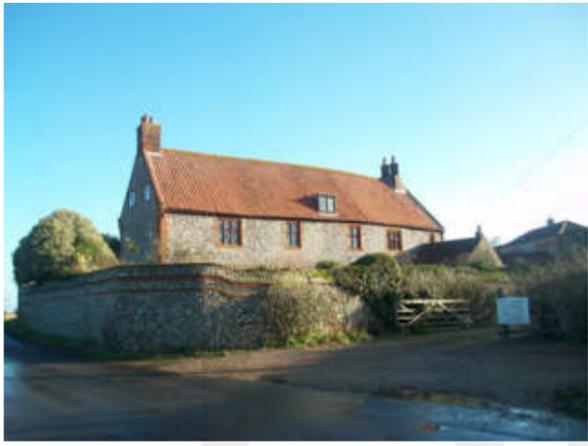
Address / Building Name	The Old Hall
Street-by-Street Assessment	Coast Road
Status	Listed Building Grade II
List Entry Link	https://www.historicengland.org.uk/listing/the-list/list-entry/1373491
Brief History	C16th C17th with stair turret and window alterations of mid-C20th
Brief Description	Flint with brick dressings and pantiles. Seven bay structure over two storeys plus attic. Probably standing on site of medieval manor house.

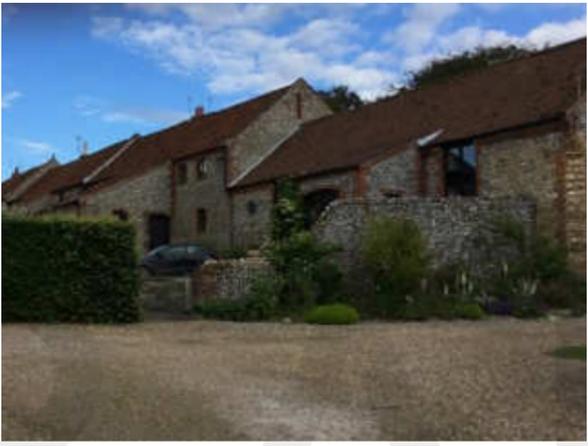
Address / Building Name	Barns 40m SE of Old Hall
Street-by-Street Assessment	Coast Road
Status	Listed Building Grade II
List Entry Link	https://historicengland.org.uk/listing/the-list/list-entry/1373492
Brief History	Early C18th with later alterations including the rebuilding of the oversailing eaves cornice.
Brief Description	Four flint and brick barns under 3 roofs.

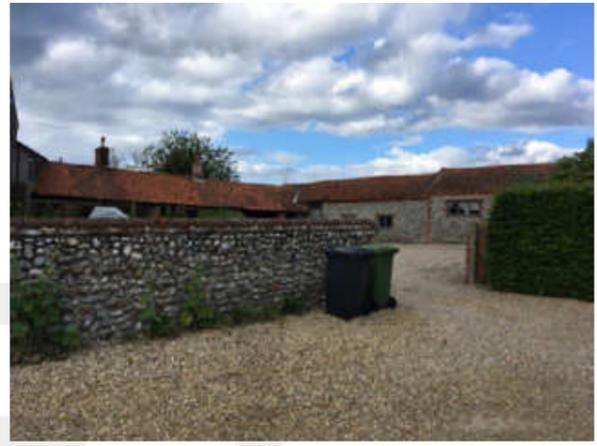
Address / Building Name	Ranges of Attached Farm Buildings at Old Hall
Street-by-Street Assessment	Coast Road
Status	Listed Building Grade II
List Entry Link	https://historicengland.org.uk/listing/the-list/list-entry/1172463
Brief History	C18th
Brief Description	Lofted, four bay cowshed with attached two storeyed, single bay dwelling. The cowshed is also attached to the Old Hall by a single storey range to the north.

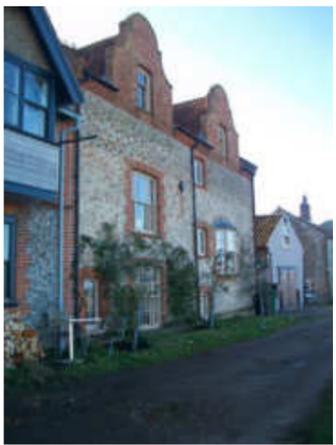
Address / Building Name	Umgeni
Street-by-Street Assessment	Coast Road
Status	Locally Listed
List Entry Link	N/A
Brief History	C19th
Brief Description	Two and half storey brick and flint house with prominent Dutch gables overlooking marshes. Variety of window styles including one oriel and one with round headed arch.

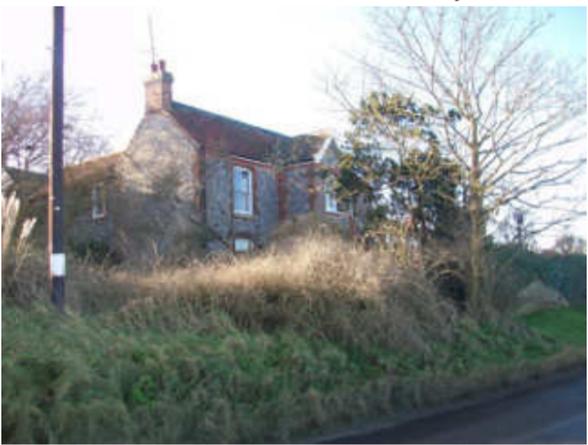
Address / Building Name	Rushmere
Street-by-Street Assessment	Coast Road
Status	Locally Listed
List Entry Link	N/A
Brief History	C19th
Brief Description	Two storey, three bay, late-nineteenth century flint cottage with brick dressings. Central bay projects with third gable. Clay pantile roof with bargeboards to front gable and red brick chimney over each end gable. Two over two painted timber sash windows appear original. Brick and flint porch extension to west of central bay.

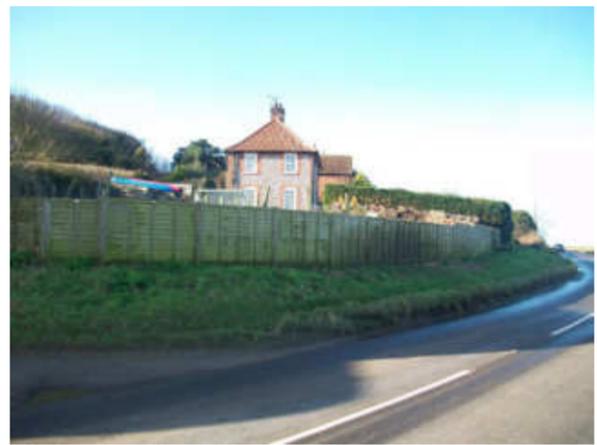
Address / Building Name	Watchers Cottage
Street-by-Street Assessment	Coast Road
Status	Locally Listed
List Entry Link	N/A
Brief History	Late C20th
Brief Description	Square two-storey two-bay cottage with hipped roof and central red brick chimney stack. Prominent location on small rise. Six over six painted timber sash windows. Plaque NNT – 1986.

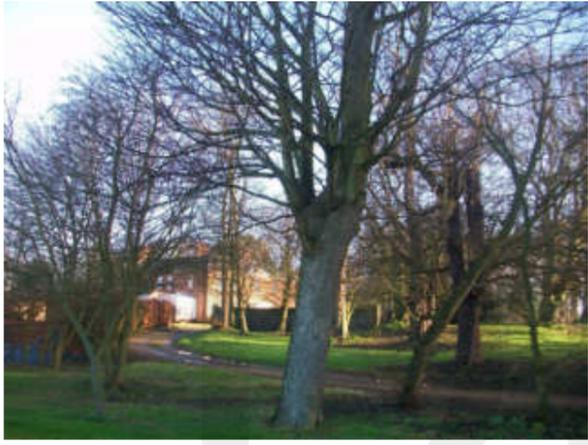
Address / Building Name	Cley Hall
Street-by-Street Assessment	The Fairstead
Status	Listed Building Grade II
List Entry Link	https://www.historicengland.org.uk/listing/the-list/list-entry/1373453
Brief History	c.1770
Brief Description	Red brick façade of five bays, double depth plus rear wings to left and right. Symmetrical south front of two storeys with central pediment, wide eaves and modillions.

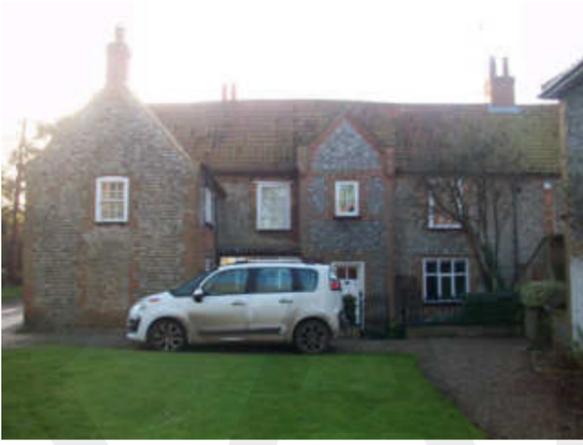
Address / Building Name	Fairstead House
Street-by-Street Assessment	The Fairstead
Status	Listed Building Grade II
List Entry Link	https://www.historicengland.org.uk/listing/the-list/list-entry/1049854
Brief History	C18th and later
Brief Description	House, formerly five cottages. Coursed flint with mosaic brick dressings and pantile roof. Irregular plan of long range with six uneven bays.

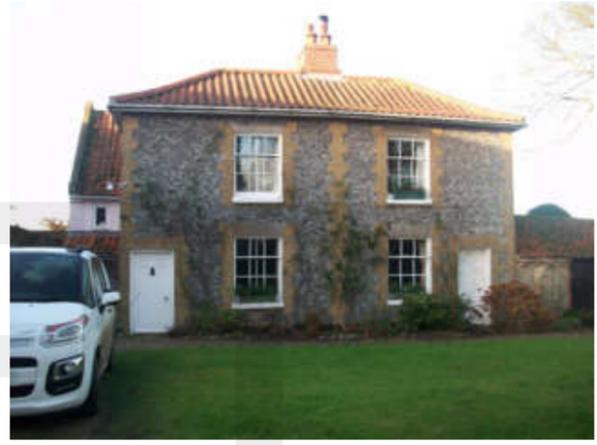
Address / Building Name	The Cottage
Street-by-Street Assessment	The Fairstead
Status	Listed Building Grade II
List Entry Link	https://www.historicengland.org.uk/listing/the-list/list-entry/1305114
Brief History	Early C19th front C17th/ C18th rear range
Brief Description	Pebble flint with gault brick dressings and pantiles to hipped roof. Two bays of double depth, two storey façade.

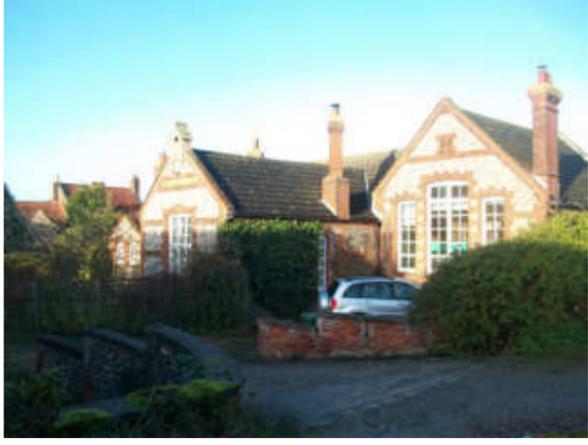
Address / Building Name	The Old School
Street-by-Street Assessment	The Fairstead
Status	Locally Listed
List Entry Link	N/A
Brief History	1860 with 1896 Infants extension
Brief Description	Former school, large-scale, single storey structure with tall windows, original tall red brick chimneys and a bell turret. Flint with red brick dressings and small cornice.

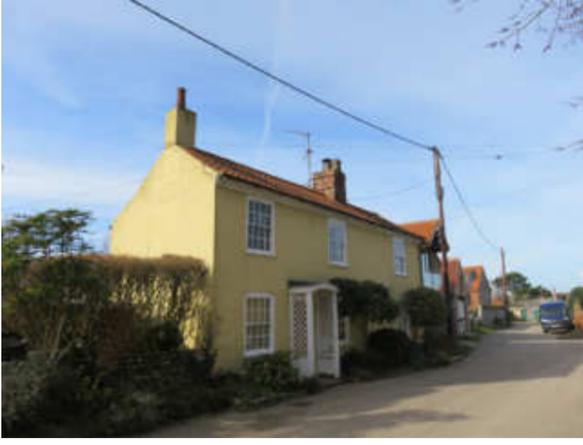
Address / Building Name	Holly Cottage
Street-by-Street Assessment	The Fairstead
Status	Locally Listed
List Entry Link	N/A
Brief History	Early C19th
Brief Description	Painted brick two storey cottage with historic sash windows and red pantile roof. Simple timber porch with trellis. One red brick chimney and one rendered chimney.

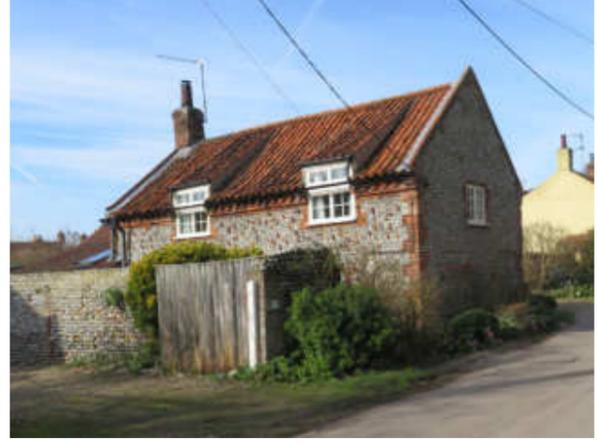
Address / Building Name	Little Cottage
Street-by-Street Assessment	The Fairstead
Status	Locally Listed
List Entry Link	N/A
Brief History	Probably C18th
Brief Description	One and a half storey cottage perpendicular to road. Flint and red brick with brick dressings including a dentil cornice. Red pantile roof with catslide dormer windows and a single replacement chimney.

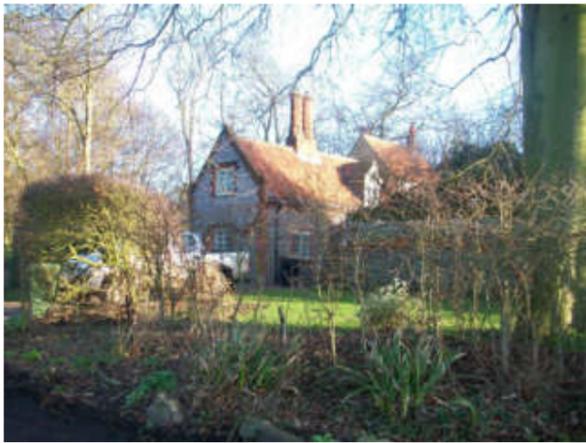
Address / Building Name	The Lodge
Street-by-Street Assessment	The Fairstead
Status	Locally Listed
List Entry Link	N/A
Brief History	Early C19th with 1950 and 2011 extensions
Brief Description	Nineteenth century flint and brick cottage, serving as entrance lodge to Cley Hall. Octagonal red brick chimneys and tall dormer windows to pantile roof. Cast iron windows.

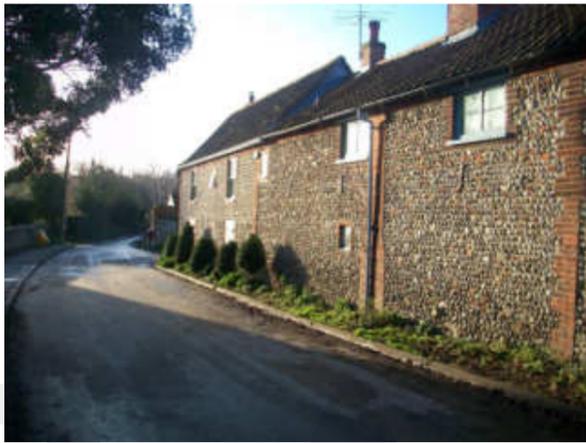
Address / Building Name	The Fairstead and Fairstead Cottage
Street-by-Street Assessment	The Fairstead
Status	Locally Listed
List Entry Link	N/A
Brief History	C18th and C19th
Brief Description	Two storey former barn with inserted casement windows and two heights of pitched roof. Some windows are metal whilst others are replacement timber. Small red brick chimneys to pantile roof.

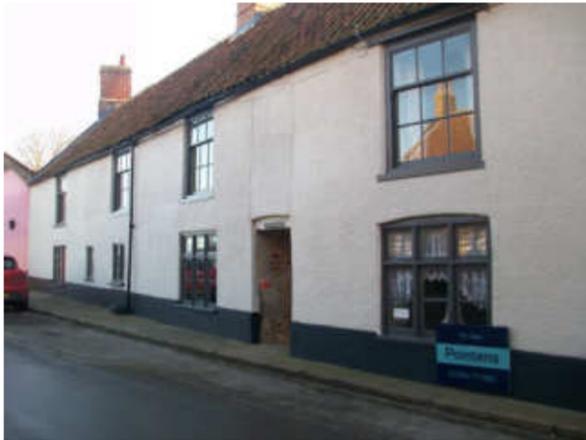
Address / Building Name	The Long House
Street-by-Street Assessment	High Street (East Side)
Status	Listed Building Grade II
List Entry Link	https://www.historicengland.org.uk/listing/the-list/list-entry/1172597
Brief History	Late C15th
Brief Description	House now two dwellings. Rendered and colour-washed. Four bays of one and a half storeys, with passage to rear between bays three and four.

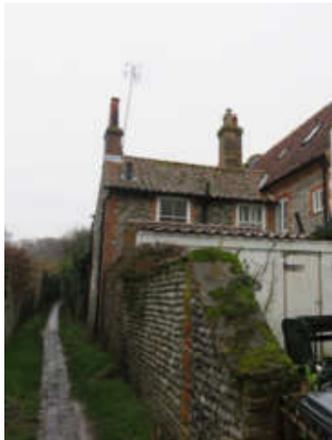
Address / Building Name	London House
Street-by-Street Assessment	High Street (East Side)
Status	Listed Building Grade II
List Entry Link	https://www.historicengland.org.uk/listing/the-list/list-entry/1049858
Brief History	c.1700 C19th wing to east.
Brief Description	Brick and flint with pantile roof, one bay double depth structure, of two storeys plus attic.

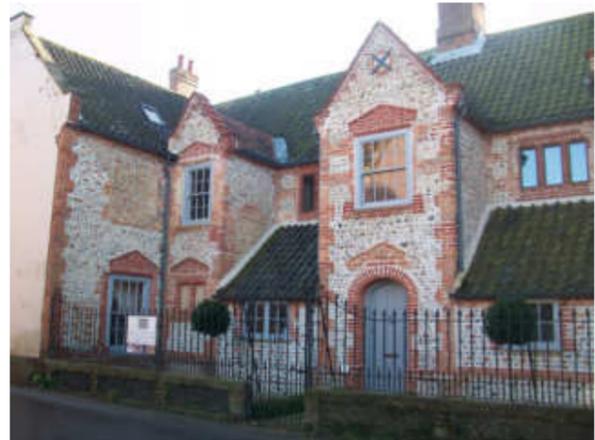
Address / Building Name	The Manor House
Street-by-Street Assessment	High Street (East Side)
Status	Listed Building Grade II
List Entry Link	https://www.historicengland.org.uk/listing/the-list/list-entry/1305073
Brief History	C17th with later additions
Brief Description	Formerly rendered and colour-washed, now exposed flint, with roof of black unglazed pantiles. L-plan: wing to road is six bays, two storeys with attic.

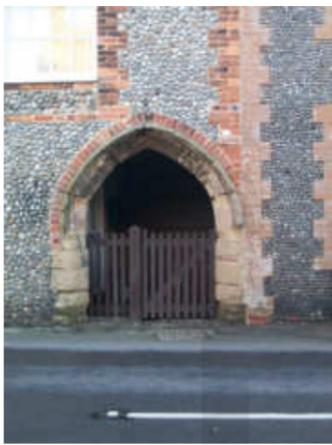
Address / Building Name	Medieval arch at Maison du Quay
Street-by-Street Assessment	High Street (East Side)
Status	Listed Building Grade II
List Entry Link	https://www.historicengland.org.uk/listing/the-list/list-entry/1049857
Brief History	C15th
Brief Description	Stone arch of former doorway, heavily weathered. Set into right hand façade of Maison du Quai

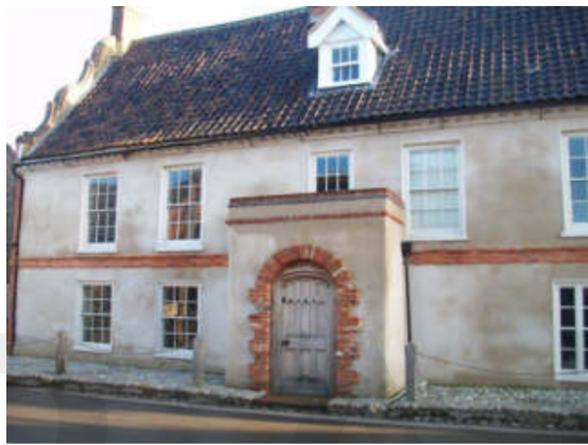
Address / Building Name	Sunbeams
Street-by-Street Assessment	High Street (East Side)
Status	Listed Building Grade II
List Entry Link	https://www.historicengland.org.uk/listing/the-list/list-entry/1049856
Brief History	Early C18th
Brief Description	House, previously inn (Fishmongers Arms), closed 1958. Rendered with black glazed pantile roof. Five irregular bays with two bay addition to right. Two storeys.

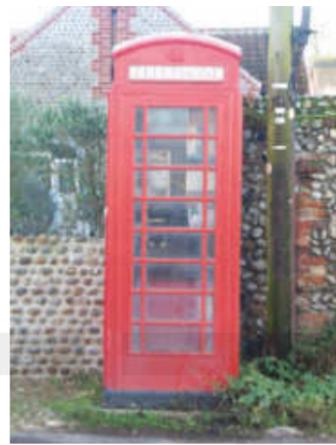
Address / Building Name	K6 Telephone Kiosk
Street-by-Street Assessment	High Street (East Side)
Status	Listed Building Grade II
List Entry Link	https://www.historicengland.org.uk/listing/the-list/list-entry/1373505
Brief History	1935
Brief Description	Square iron kiosk with domed roof, to designs by Sir Giles Gilbert Scott

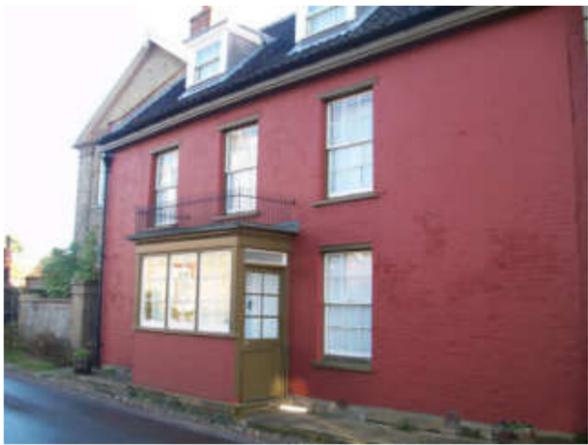
Address / Building Name	Rocket House
Street-by-Street Assessment	High Street (East Side)
Status	Listed Building Grade II
List Entry Link	https://www.historicengland.org.uk/listing/the-list/list-entry/1172519
Brief History	Mid-C18th on earlier core
Brief Description	Brick colour-washed pink with black glazed pantile roof. Three bays, two storeys plus attic. Central door enclosed by C19th porch

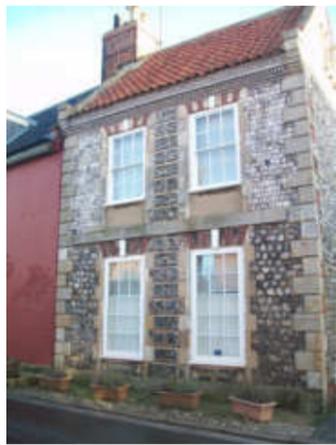
Address / Building Name	Whalebone House
Street-by-Street Assessment	High Street (East Side)
Status	Listed Building Grade II
List Entry Link	https://www.historicengland.org.uk/listing/the-list/list-entry/1049855
Brief History	C18th façade with alterations
Brief Description	House, formerly shop. Flint with stone dressings, pantile roof and gable parapet. Two storeys and two bays.

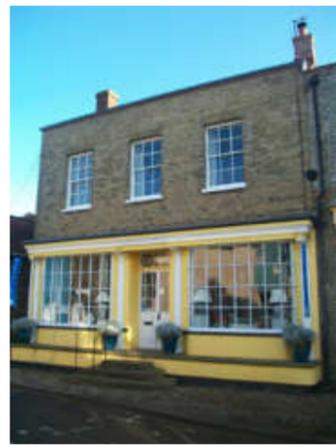
Address / Building Name	Starr House
Street-by-Street Assessment	High Street (East Side)
Status	Listed Building Grade II
List Entry Link	https://www.historicengland.org.uk/listing/the-list/list-entry/1172486
Brief History	House c.1700 Shop c.1800
Brief Description	At right angles to High Street, shop façade to street. Gault brick, three bays, two storeys. Raised platform reached by stone steps. Ground floor façade punctuated by square fluted pilasters.

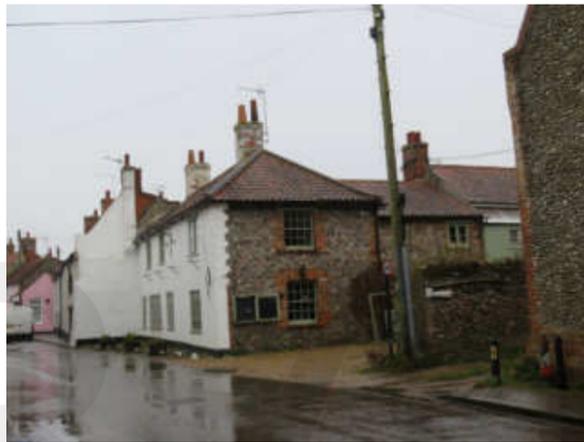
Address / Building Name	The Harnser
Street-by-Street Assessment	High Street (East Side)
Status	Locally Listed
List Entry Link	N/A
Brief History	C18th
Brief Description	Prominent corner location. Formerly King's Head public house. Flint with red brick dressings including dentil cornice and rendered façade to street. Sash and casement windows, mostly replacements. Two red brick chimneys to hipped Dutch pantile roof.

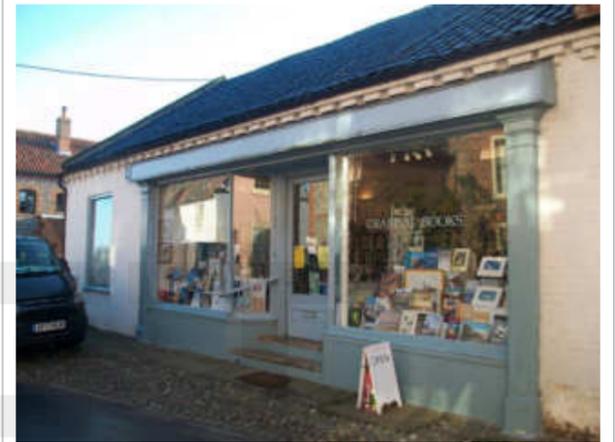
Address / Building Name	The Crab Pot
Street-by-Street Assessment	High Street (East Side)
Status	Locally Listed
List Entry Link	N/A
Brief History	C19th
Brief Description	Single storey book shop with late nineteenth or early twentieth century shop front. Painted brick walls with brick cornice and Dutch pantile roof.

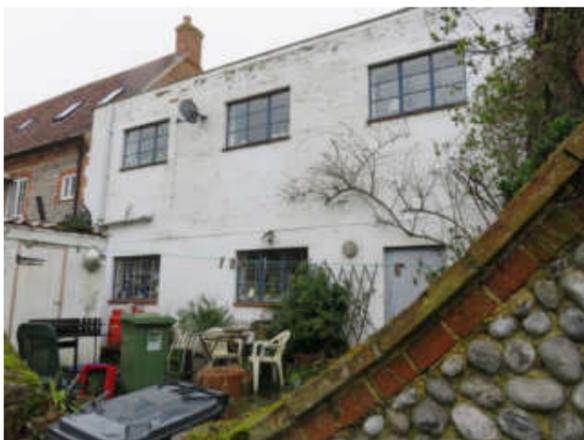
Address / Building Name	Warehouse behind Crabpot Books
Street-by-Street Assessment	High Street (East Side)
Status	Locally Listed
List Entry Link	N/A
Brief History	Early-mid C20th
Brief Description	Converted painted brick warehouse with flat roof and Crittall windows.

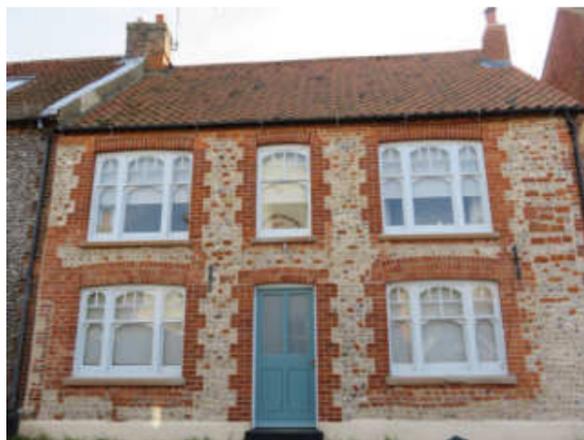
Address / Building Name	Worthington House
Street-by-Street Assessment	High Street (East Side)
Status	Locally Listed
List Entry Link	N/A
Brief History	Late C19th/early C20th
Brief Description	Slightly off-centre symmetrical façade of flint and brick with brick dressings and late nineteenth/early twentieth century sash windows. Red clay pantile roof with small rebuilt chimneys.

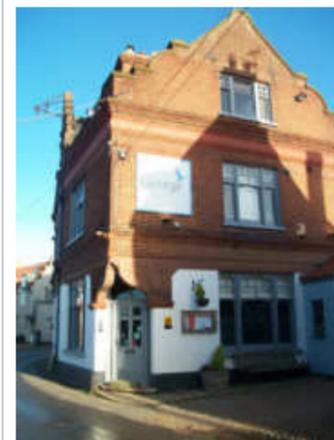
Address / Building Name	The George
Street-by-Street Assessment	High Street (East Side)
Status	Locally Listed
List Entry Link	N/A
Brief History	C18th with late C19th frontage
Brief Description	Public house in prominent location on High Street. Building incorporates C18th fabric but has a late C18th façade. Brick built with terracotta detailing and Dutch gable. Modern single storey additions not included in the listing.

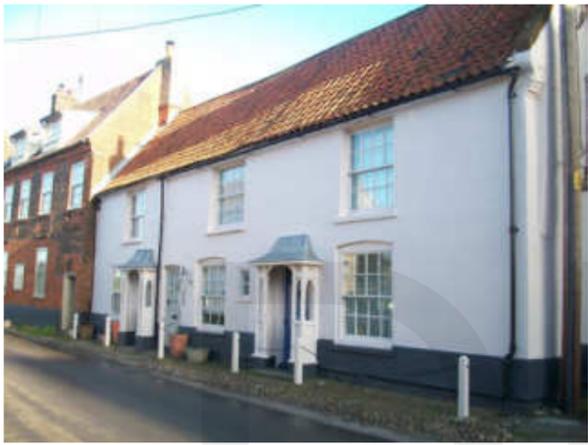
Address / Building Name	Bank Cottages
Street-by-Street Assessment	High Street (East Side)
Status	Locally Listed
List Entry Link	N/A
Brief History	Late C18th/Early C19th
Brief Description	Set of two storey cottages with pantile roof, rendered. Decorative porches to doors.

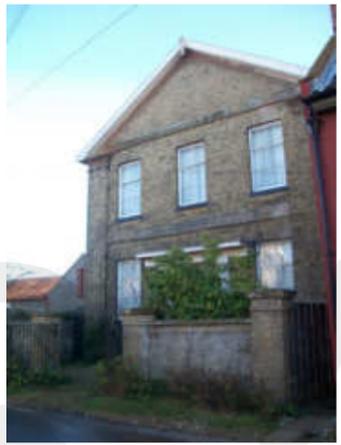
Address / Building Name	The Old Chapel
Street-by-Street Assessment	High Street (East Side)
Status	Locally Listed
List Entry Link	N/A
Brief History	Early C19th
Brief Description	Two storey, gault brick former chapel with gable designed to appear as a pediment supported on brick pilasters. Timber sash windows and decorative doorcase with engaged columns.

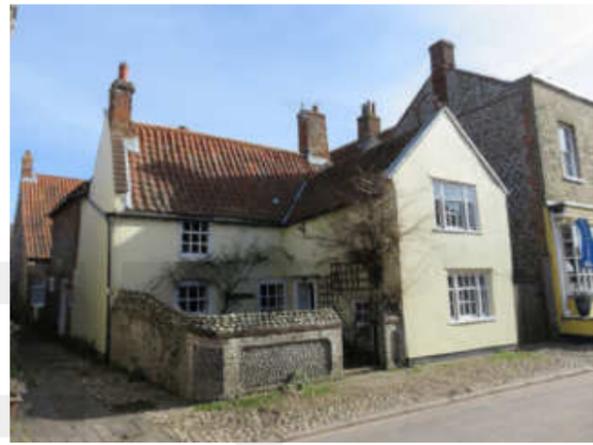
Address / Building Name	Hambleton
Street-by-Street Assessment	High Street (East Side)
Status	Locally Listed
List Entry Link	N/A
Brief History	Late C17th/ C18th with later range
Brief Description	Small scale, two storey L-shaped cottage with rendered walls, red pantile roof and red brick chimneys. Early nineteenth century sash windows to north range and early nineteenth century doorcase. Late nineteenth or early twentieth century sash windows to west range.

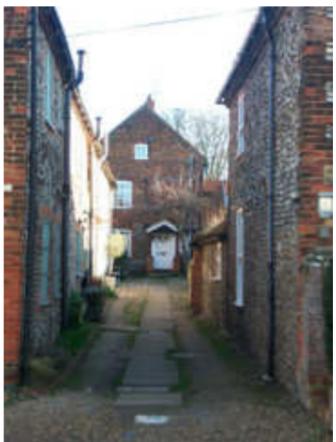
Address / Building Name	Wrights Yard Cottage
Street-by-Street Assessment	High Street (East Side)
Status	Locally Listed
List Entry Link	N/A
Brief History	Likely mid-C19th
Brief Description	Two storey cottage with attic, built of red brick with gabled front elevation. The cottage is set at the end of Wrights Yard off the High Street.

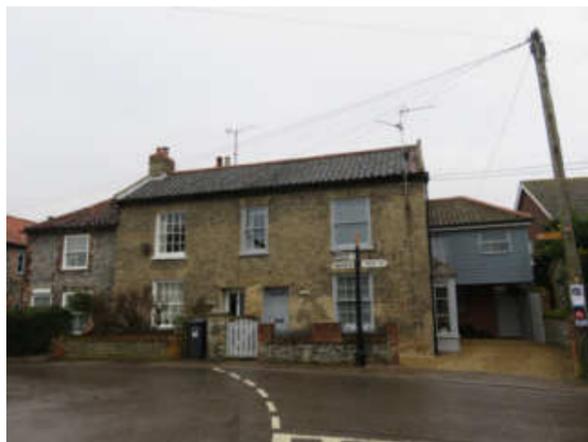
Address / Building Name	Carlton House, The Anchorage
Street-by-Street Assessment	High Street (East Side)
Status	Locally Listed
List Entry Link	N/A
Brief History	Early C19th
Brief Description	Two storey pair of gault brick cottages with early nineteenth century sash windows and black glazed pantile roof. Prominent location at the junction with New Road. Modern additions are well proportioned and contrasting materials but are excluded from listing. Fine example of nineteenth century ironwork decoration to front garden wall of Carlton House.

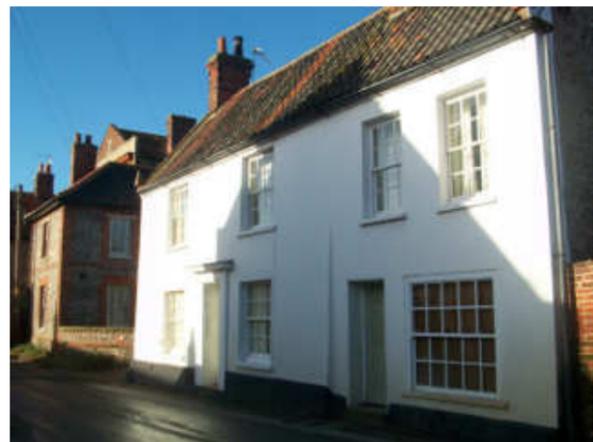
Address / Building Name	The White House
Street-by-Street Assessment	High Street (West Side)
Status	Listed Building Grade II
List Entry Link	https://www.historicengland.org.uk/listing/the-list/list-entry/1373512
Brief History	C18th
Brief Description	House, rendered with black glazed pantile roof. Four bays and two storeys. Gabled parapets with pyramidal stone finials at bases.

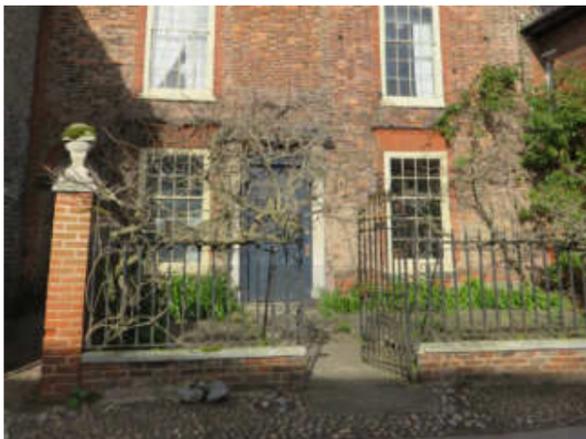
Address / Building Name	Gate Railings in front of Customs House
Street-by-Street Assessment	High Street (West Side)
Status	Listed Building Grade II
List Entry Link	https://www.historicengland.org.uk/listing/the-list/list-entry/1049820
Brief History	C18th
Brief Description	Wrought iron railings and gate to High Street front of Customs House. Square brick biers each surmounted by stone ball.

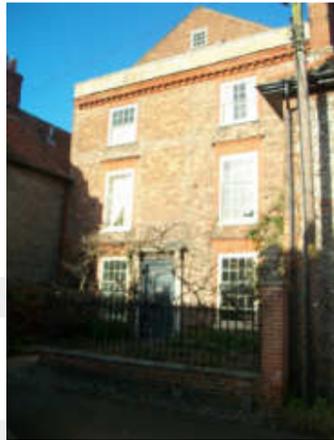
Address / Building Name	The Custom House
Street-by-Street Assessment	High Street (West Side)
Status	Listed Building Grade II
List Entry Link	https://www.historicengland.org.uk/listing/the-list/list-entry/1049861
Brief History	c.1700
Brief Description	House set back from street. Pinkish brick with red brick dressings and roof hidden behind parapet. Three bay double depth structure over three storeys plus attic. Asymmetrical façade to street.

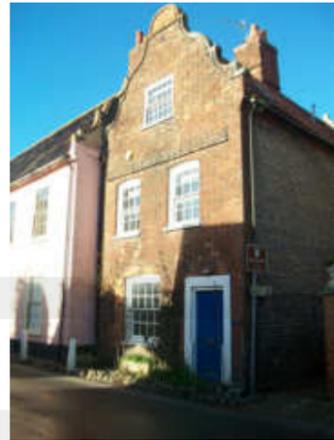
Address / Building Name	Mill Leet
Street-by-Street Assessment	High Street (West Side)
Status	Listed Building Grade II
List Entry Link	https://www.historicengland.org.uk/listing/the-list/list-entry/1049860
Brief History	c.1700
Brief Description	Brick with some coloured headers and pantile roof. Shaped gable to road. Double depth plan over two storeys.

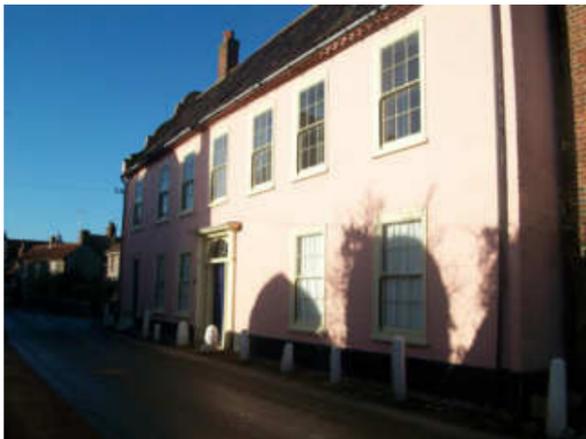
Address / Building Name	The Gables
Street-by-Street Assessment	High Street (West Side)
Status	Listed Building Grade II
List Entry Link	https://www.historicengland.org.uk/listing/the-list/list-entry/1172622
Brief History	Warehouse C17th adopted as house C18th
Brief Description	Brick façade colour-washed pink, with black glazed pantile roof. Seven irregular bays of two storeys and attic, passage and two storied extension to rear.

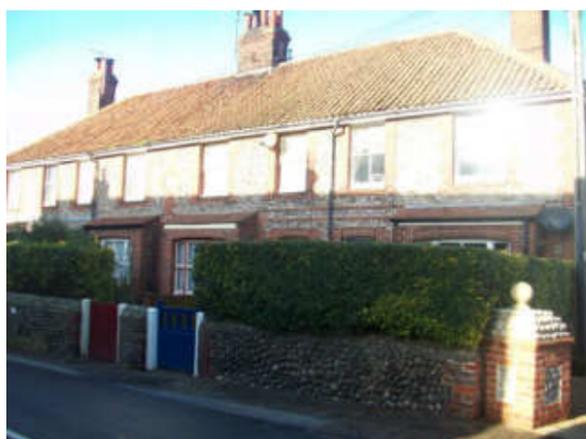
Address / Building Name	Bank Cottages Bank House
Street-by-Street Assessment	High Street (West Side)
Status	Listed Building Grade II
List Entry Link	https://www.historicengland.org.uk/listing/the-list/list-entry/1172533
Brief History	Late C18th façade to older core
Brief Description	Terrace of three cottages. Formerly rendered and colour-washed, now exposed brick and flint with pantile roof and raised gable parapet. Double range of three bays and two storeys.

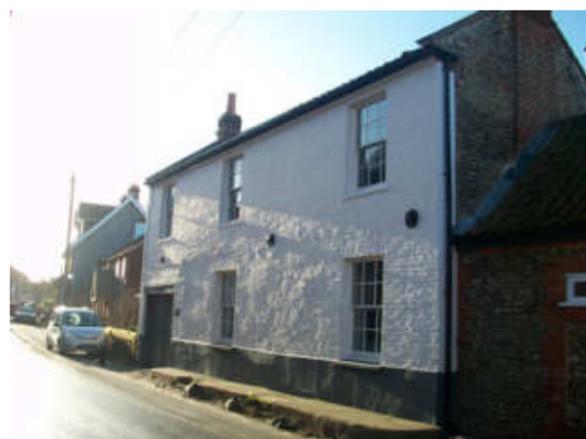
Address / Building Name	Flanders
Street-by-Street Assessment	High Street (West Side)
Status	Listed Building Grade II
List Entry Link	https://www.historicengland.org.uk/listing/the-list/list-entry/1049859
Brief History	c.1780s
Brief Description	House, formerly shop. Front façade colour-washed brick with pantile roof, three bays and two storeys. Central door under semi-circular fanlight with glazing bars.

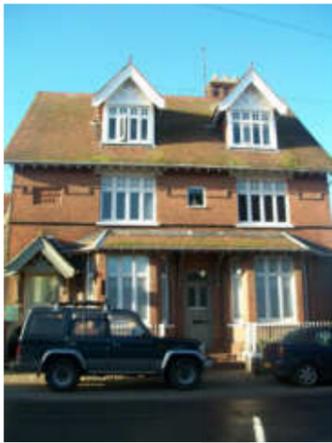
Address / Building Name	Old Town Hall
Street-by-Street Assessment	High Street (West Side)
Status	Locally Listed
List Entry Link	N/A
Brief History	1896
Brief Description	Two storey brick built house with bay windows to ground floor and gabled dormers in roof. Date stone on principal façade.

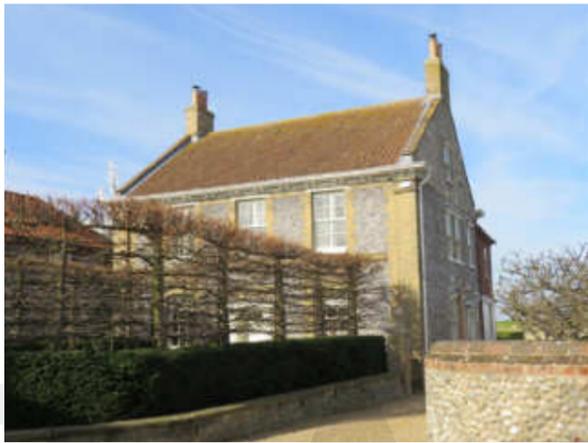
Address / Building Name	Zetland House
Street-by-Street Assessment	High Street (West Side)
Status	Locally Listed
List Entry Link	N/A
Brief History	Mid C19th
Brief Description	Two and half storey brick and flint house with classical detailing in gault brick. Pantile roof and gault brick chimneys. Timber sash windows and doorcase. Elaborate gutter.

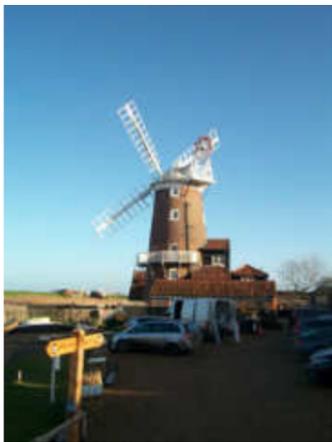
Address / Building Name	Cley Mill
Street-by-Street Assessment	The Quay
Status	Listed Building Grade II*
List Entry Link	https://www.historicengland.org.uk/listing/the-list/list-entry/1049823
Brief History	C18th
Brief Description	Windmill used as holiday accommodation. Brick Tower, white painted wooden cap, sails and fantail. Five storeys with part balcony to 2nd floor.
