Glaven Valley

Conservation Area Appraisal and Management Plan

Eighth Draft: May 2023

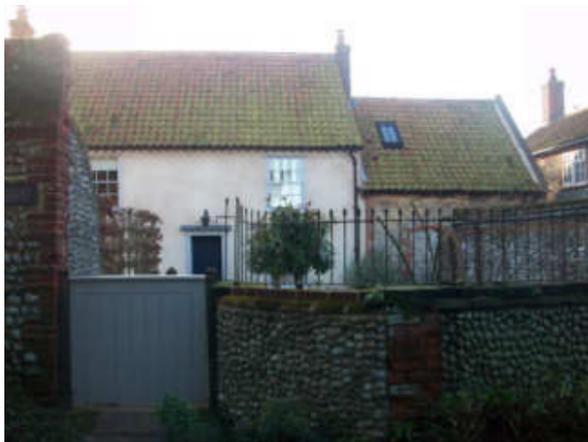
Address / Building Name	The Pyghtle
Street-by-Street Assessment	Town Yard
Status	Listed Building Grade II
List Entry Link	https://www.historicengland.org.uk/listing/the-list/list-entry/1049824
Brief History	c.1800 with older core
Brief Description	Rendered flint with dentil cornice and pantile roof. Three bays of two storeys with one and half storey extension to right in coursed flint

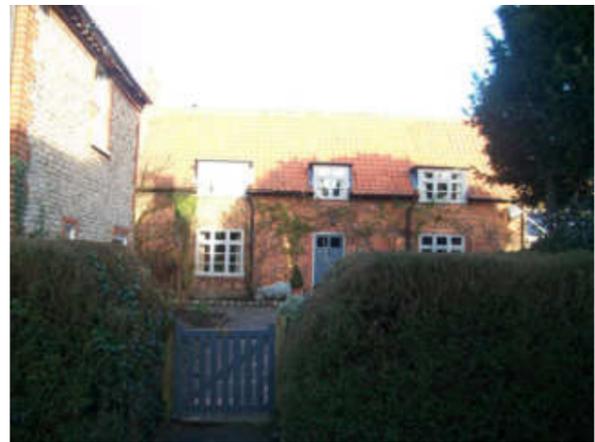
Address / Building Name	Salt Marsh Cottage and outbuilding to rear
Street-by-Street Assessment	Town Yard
Status	Locally Listed
List Entry Link	N/A
Brief History	C19th
Brief Description	One and a half storey red brick cottage with dormers in red pantile roof.

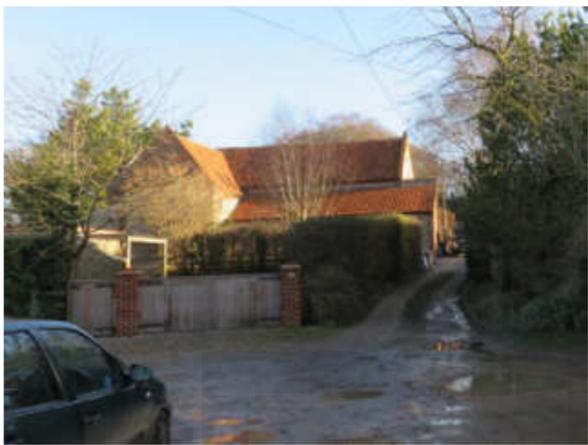
Address / Building Name	Barn at Green Farm
Street-by-Street Assessment	Holt Road (North)
Status	Listed Building Grade II
List Entry Link	https://www.historicengland.org.uk/listing/the-list/list-entry/1049821
Brief History	1715
Brief Description	Coursed flint with brick dressings. Extended porch to second bay of west front.

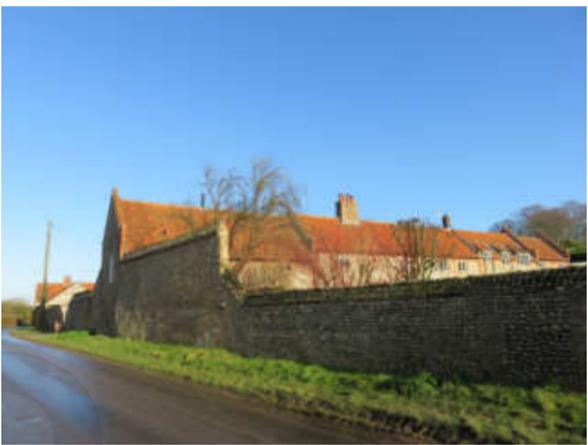
Address / Building Name	Green Farm House
Street-by-Street Assessment	Holt Road (North)
Status	Listed Building Grade II
List Entry Link	https://www.historicengland.org.uk/listing/the-list/list-entry/1373473
Brief History	C17th
Brief Description	Coursed flint with evenly spaced bricks to some cornices. Three bays, two storeys with attached former dairy to left.

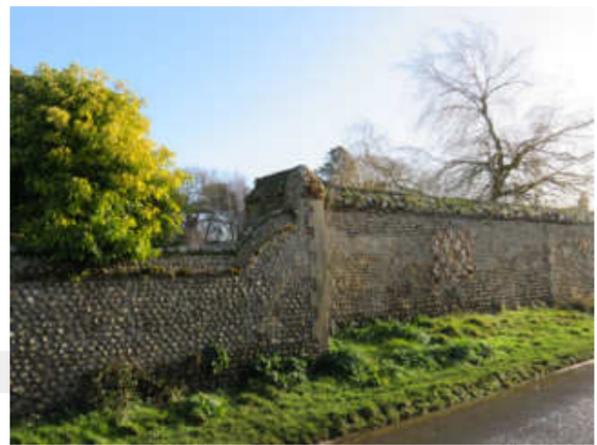
Address / Building Name	Garden Walls at Green Farm House
Street-by-Street Assessment	Holt Road (North)
Status	Listed Building Grade II
List Entry Link	https://www.historicengland.org.uk/listing/the-list/list-entry/1373474
Brief History	1676
Brief Description	Coursed flint under flint coping with brick ridge and dogs tooth brick cornice

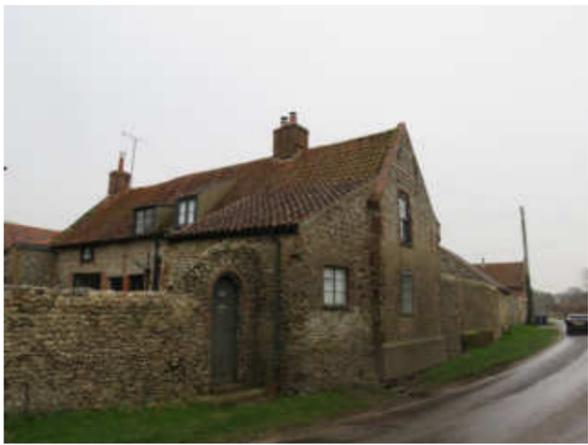
Address / Building Name	Lime Kiln Cottage
Street-by-Street Assessment	Holt Road (North)
Status	Locally Listed
List Entry Link	N/A
Brief History	C17th-C19th
Brief Description	Historically part of Green Farm complex. Flint and brick cottage with red clay pantile roof with dormers and red brick chimneys of different designs. Mix of casement and sash windows.

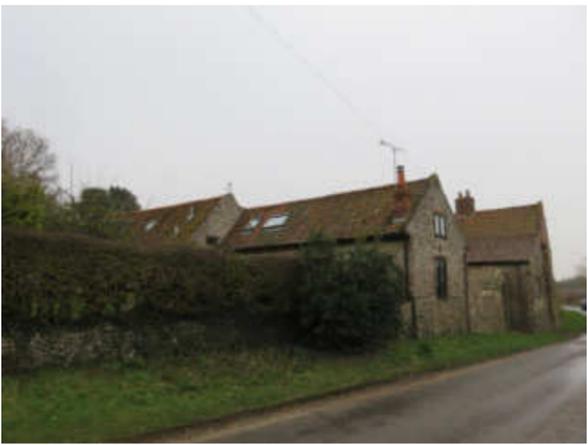
Address / Building Name	Lime Kiln Barn
Street-by-Street Assessment	Holt Road (North)
Status	Locally Listed
List Entry Link	N/A
Brief History	C17th-C19th
Brief Description	Historically part of Green Farm complex. Flint and brick converted barn/outbuildings with red pantile roofs. Modern timber casement windows and rooflights.

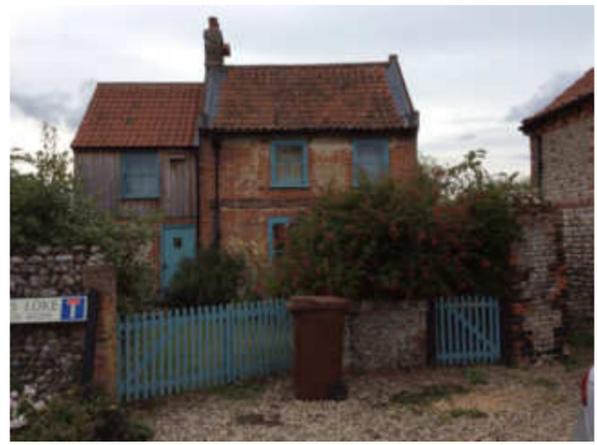
Address / Building Name	Loke Cottage
Street-by-Street Assessment	Holt Road (North)
Status	Locally Listed
List Entry Link	N/A
Brief History	C18th
Brief Description	Red brick cottage with plat band detail set in a defined garden and forming the focal point of Dawes Loke. Red clay pantile roof with red brick chimney. Nineteenth century sash windows. Modern brick and timber weatherboarding extension not included in listing.

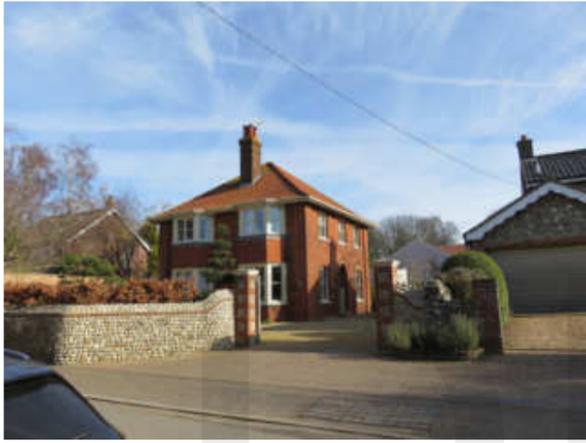
Address / Building Name	Ingleside
Street-by-Street Assessment	Holt Road (North)
Status	Locally Listed
List Entry Link	N/A
Brief History	Early C20th
Brief Description	A rare local example of an early twentieth century Arts and Crafts house. Red brick with corner pilasters and moulded brick arch to entrance. Two full height canted bays. Timber sash windows.

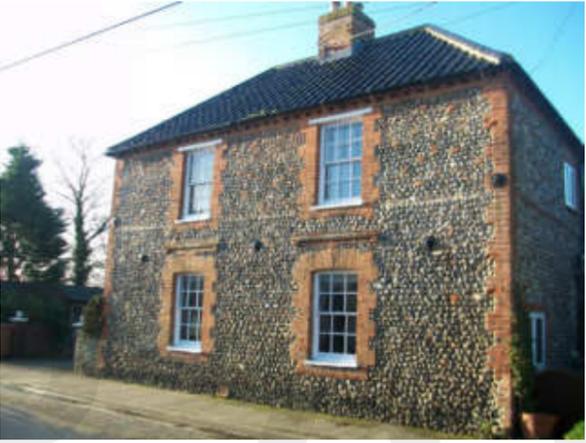
Address / Building Name	Hunters
Street-by-Street Assessment	Holt Road (North)
Status	Locally Listed
List Entry Link	N/A
Brief History	C18th
Brief Description	Detached two storey square brick and flint cottage with dentil cornice. Hipped Dutch pantile roof with central red brick chimney. Sash windows to street façade, casements elsewhere. Originally two cottages. Prominent as the first building on this side of the road.

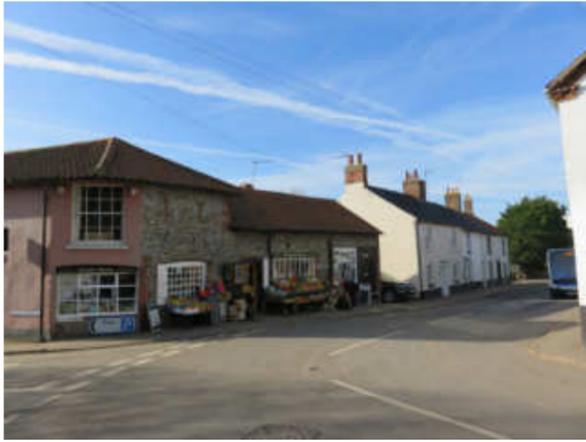
Address / Building Name	Picnic Fayre
Street-by-Street Assessment	Holt Road (North)
Status	Locally Listed
List Entry Link	N/A
Brief History	Probably Early C19th with mid C19th extension
Brief Description	Two (early nineteenth century) and one storey (mid nineteenth century) brick and flint building. Former forge, now shop. Long window with mullions is typical of a forge.

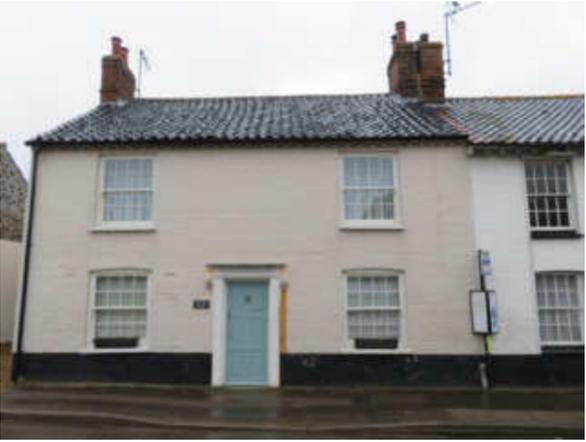
Address / Building Name	Northcote, New Road
Street-by-Street Assessment	Holt Road (North)
Status	Locally Listed
List Entry Link	N/A
Brief History	Late C18th
Brief Description	Painted brick two storey townhouse with dentil cornice, symmetrically arranged sash windows and central doorcase. Dutch pantile roof with pair of red brick chimneys.

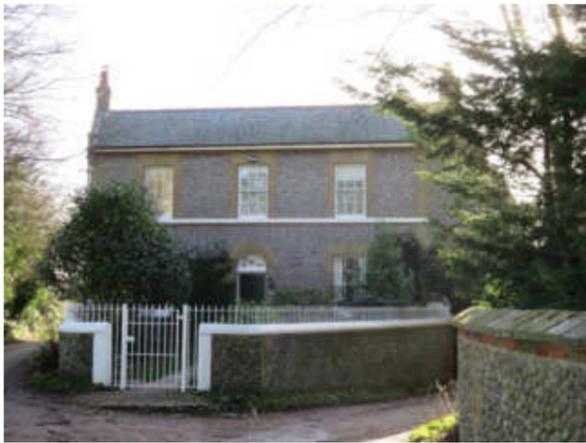
Address / Building Name	The Knoll with attached garden walls
Street-by-Street Assessment	Church Lane
Status	Listed Building Grade II
List Entry Link	https://www.historicengland.org.uk/listing/the-list/list-entry/1049852
Brief History	c.1800
Brief Description	Pebble flint with gault brick dressings, slate roof, and raised gable parapets. Three bays over two storeys, with rear wing to right. Stone plaque inscribed Randall Buildings.

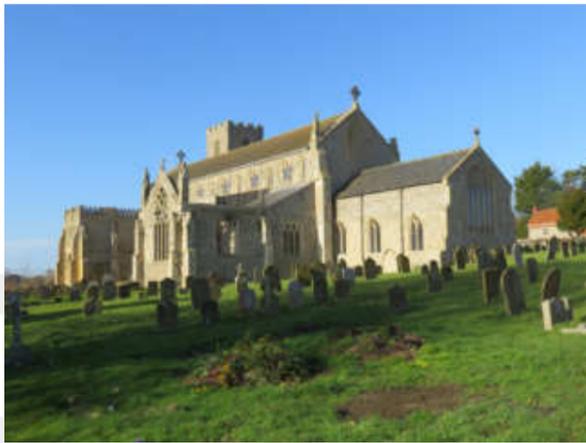
Address / Building Name	Church of St Margaret
Street-by-Street Assessment	Church Lane
Status	Listed Building Grade I
List Entry Link	https://www.historicengland.org.uk/listing/the-list/list-entry/1172407
Brief History	C14th and C15th
Brief Description	Parish church, flint with stone dressings and grey tiles. NW tower, nave, north and south aisles, ruined north and south transepts, chancel, and porches to N, W and S.

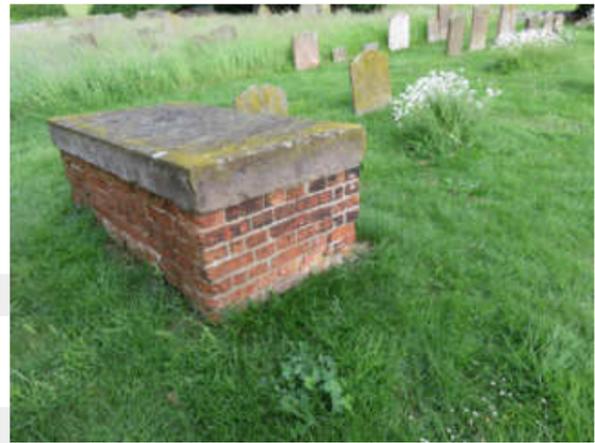
Address / Building Name	Memorial to James Greeve
Street-by-Street Assessment	Church Lane
Status	Listed Building Grade II
List Entry Link	https://www.historicengland.org.uk/listing/the-list/list-entry/1049853
Brief History	1689, additions 1722, 1728 and 1743
Brief Description	Altar tomb memorial. Brick walls, sandstone slab with inscription to James Greeve and family. Greeve assisted the famous admiral, Sir Cloudsley Shovell.

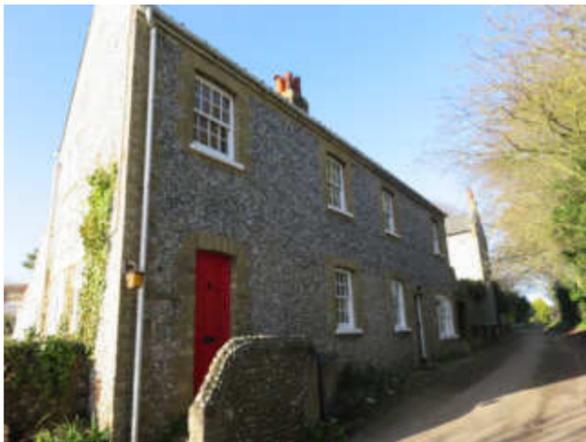
Address / Building Name	Knoll Cottages
Street-by-Street Assessment	Church Lane
Status	Locally Listed
List Entry Link	N/A
Brief History	Early C19th
Brief Description	Two storey brick and flint cottages with buff brick detailing. Forms a group with the Knoll.

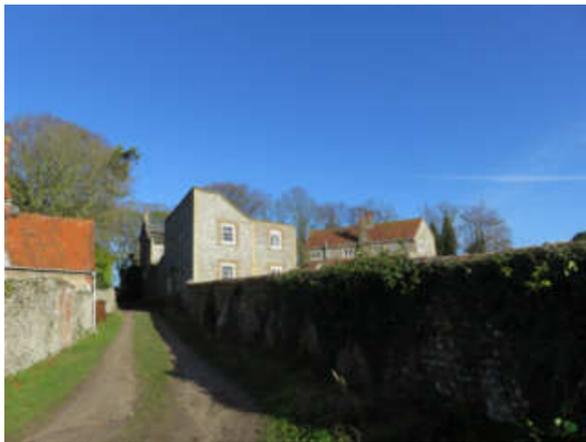
Address / Building Name	Church Knoll
Street-by-Street Assessment	Church Lane
Status	Locally Listed
List Entry Link	N/A
Brief History	Early C19th
Brief Description	Flat roofed two storey structure of gault brick and flint. Forms a group with The Knoll.

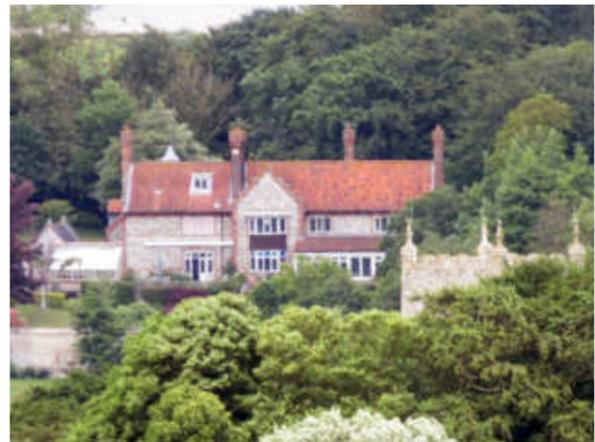
Address / Building Name	The Green
Street-by-Street Assessment	Church Lane
Status	Locally Listed
List Entry Link	N/A
Brief History	Late C19th
Brief Description	Large two storey house with attic lit by dormers. Flint with red brick dressings and prominent central gable to front and rear elevations. Tall red brick chimneys enliven the red pantile roof. Timber, leaded casement windows. Rear extension excluded from listing.

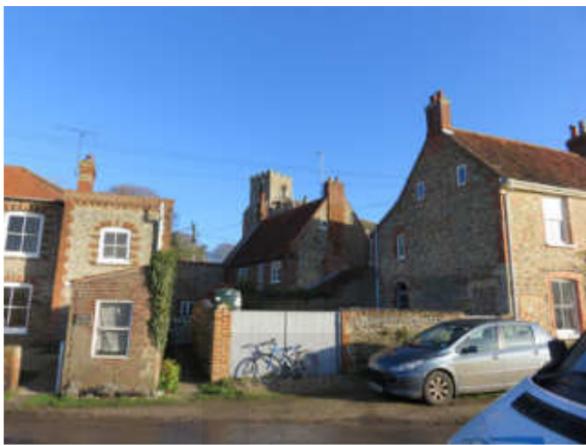
Address / Building Name	Well Cottage
Street-by-Street Assessment	Cley Green
Status	Listed Building Grade II
List Entry Link	https://www.historicengland.org.uk/listing/the-list/list-entry/1172448
Brief History	Early C18th C20th extension
Brief Description	Two bay, two storey façade with attic. Brick with pantiles. C20th single storey forward extension.

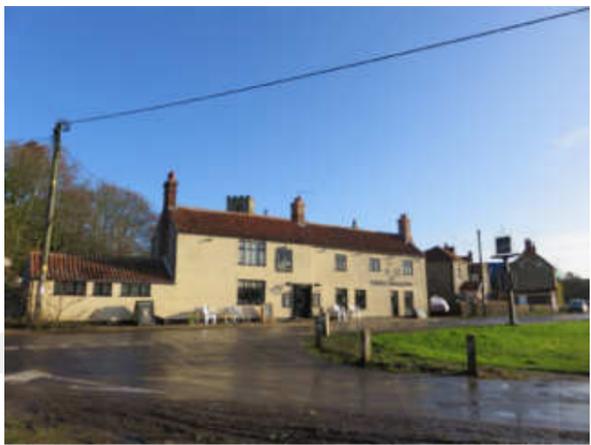
Address / Building Name	Three Swallows Inn
Street-by-Street Assessment	Cley Green
Status	Locally Listed
List Entry Link	N/A
Brief History	Late C17th/Early C18th
Brief Description	Two storey pub, brick and flint with front façade rendered.

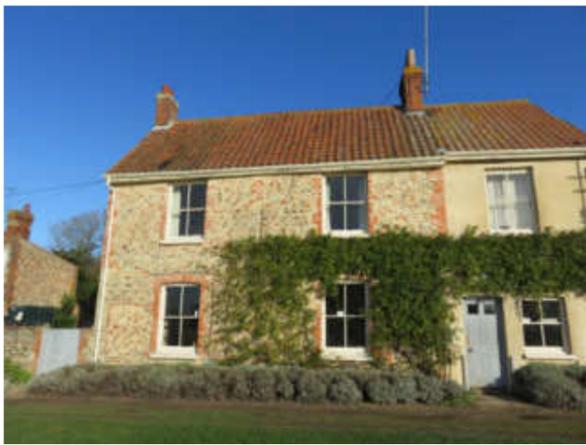
Address / Building Name	Glaven House
Street-by-Street Assessment	Cley Green
Status	Locally Listed
List Entry Link	N/A
Brief History	C18th
Brief Description	Flint and red brick cottage with rendered historic extension. Nineteenth century sash windows. Red pantile roof with two red brick chimneys,

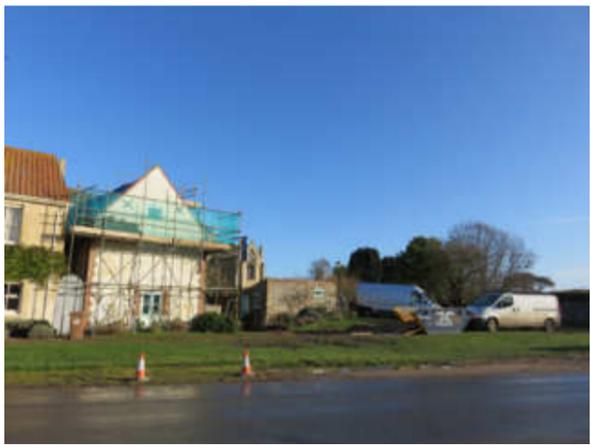
Address / Building Name	Newgate Cottage
Street-by-Street Assessment	Cley Green
Status	Locally Listed
List Entry Link	N/A
Brief History	C18th
Brief Description	Two storey flint cottage, painted white, perpendicular to road.

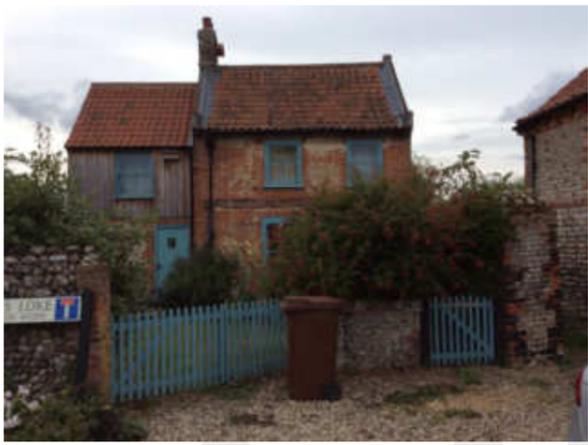
Address / Building Name	Newgate Farm House
Street-by-Street Assessment	Holt Road (West)
Status	Listed Building Grade II
List Entry Link	https://www.historicengland.org.uk/listing/the-list/list-entry/1049822
Brief History	1685 C19th extension
Brief Description	Coursed flint with brick dressings. Front is rendered and colour-washed. Single range of four bays and two storeys.

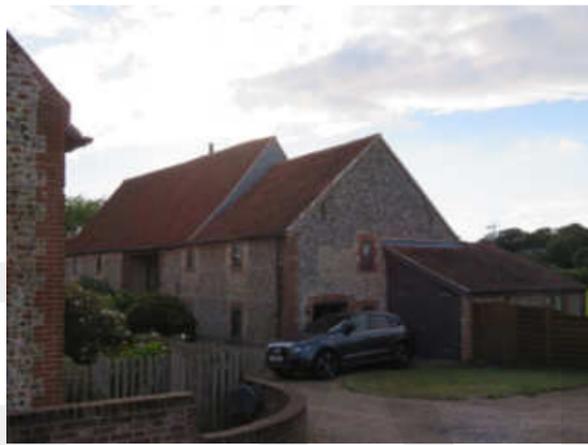
Address / Building Name	Barn at Newgate Farm
Street-by-Street Assessment	Holt Road (West)
Status	Listed Building Grade II
List Entry Link	https://www.historicengland.org.uk/listing/the-list/list-entry/1373475
Brief History	C18th
Brief Description	Coursed flint with some brick, brick dressings and asbestos roof. Five bays, with roof over end bays to the right rebuilt to a lower height.

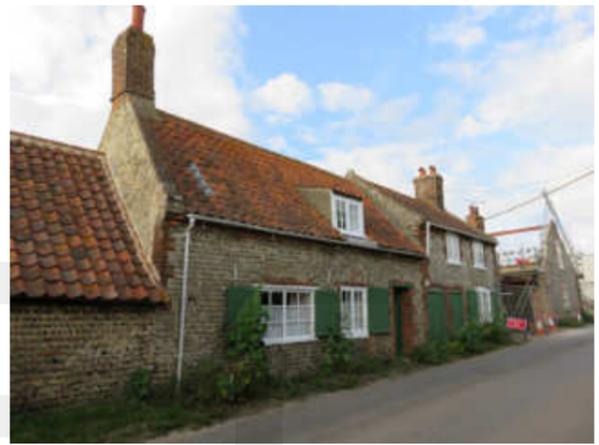
Address / Building Name	Green Shutters
Street-by-Street Assessment	Holt Road (West)
Status	Locally Listed
List Entry Link	N/A
Brief History	C18th
Brief Description	Cottage of two parts set on the road. East end is two storey; west end is one storey with attic. Flint with red brick dressings and a variety of historic casement windows including one dormer. Prominent green shutters to windows give the cottage its name.

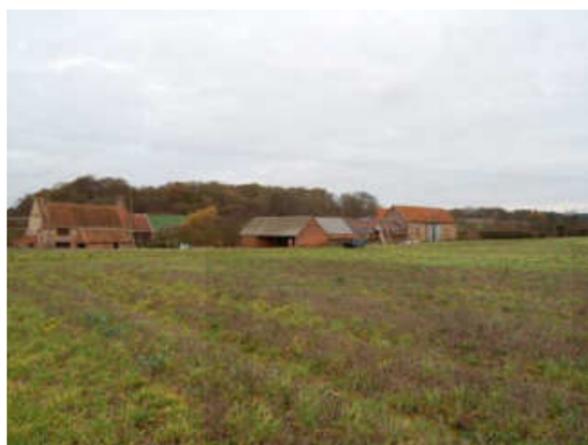
Address / Building Name	Lowes Farmhouse
Parish	Edgefield
Status	Grade II
List Entry Link	https://historicengland.org.uk/listing/the-list/list-entry/1049207
Brief History	1637
Brief Description	Farmhouse of flint with brick dressings, 4 bays, 2 storeys with attic

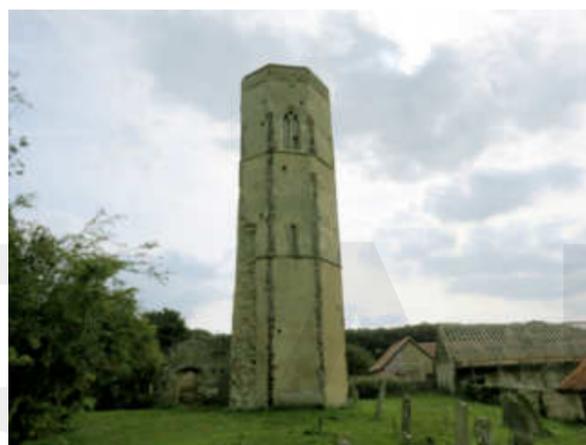
Address / Building Name	Remains of former parish church of St Peter and St Paul
Parish	Edgefield
Status	Grade II*
List Entry Link	https://historicengland.org.uk/listing/the-list/list-entry/1049203
Brief History	C13
Brief Description	Ruins of former medieval parish church in the form of a tower, south porch and connecting west wall only.

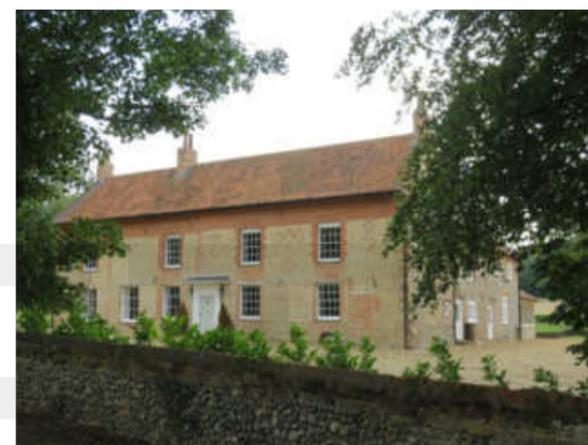
Address / Building Name	The Mount
Parish	Edgefield
Status	Grade II
List Entry Link	https://historicengland.org.uk/listing/the-list/list-entry/1049208
Brief History	C17
Brief Description	Two storey house of flint and brick with pantile roof. Single range of 4 bays, two wings to rear. 2 storeys, attic and cellar.

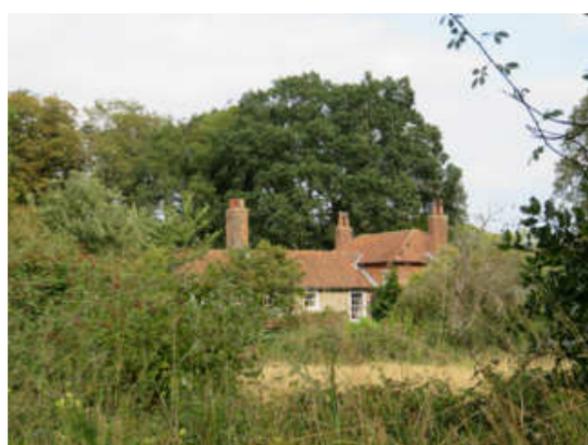
Address / Building Name	Old Parsonage House
Parish	Edgefield
Status	Grade II
List Entry Link	https://historicengland.org.uk/listing/the-list/list-entry/1373805
Brief History	C17
Brief Description	House, formerly Rectory. C17 with cross wing of c1830. Flint with brick dressings; colour washed to front, pantile roof, hipped to right. Lobby entrance with central axial stack.

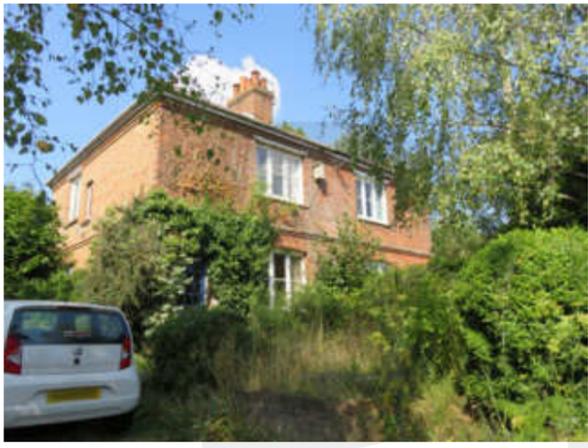
Address / Building Name	1 and 2 Holt Road
Street-by-Street Area	Norwich Road North of The Green
Status	Grade II
List Entry Link	https://historicengland.org.uk/listing/the-list/list-entry/1304649
Brief History	1912, a rare example of Parish Council housing and pre-1914 local authority housing. Built in ½ acre plots for £150.
Brief Description	Pair of semi-detached houses. Brick with corrugated tile hipped roof. Two storeys, one bay per house. Timber casement windows. Single-storey divided wash-house to rear, extended.

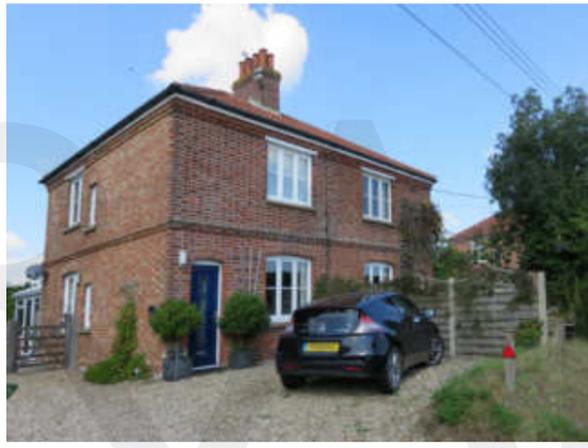
Address / Building Name	3 and 4 Holt Road
Street-by-Street Area	Norwich Road North of The Green
Status	Grade II
List Entry Link	https://historicengland.org.uk/listing/the-list/list-entry/1049209
Brief History	1912, a rare example of Parish Council housing and pre-1914 local authority housing. Built in ½ acre plots for £150.
Brief Description	Pair of semi-detached houses. Brick with corrugated tile hipped roof. Two storeys, one bay per house. Timber casement windows. Single-storey divided wash-house to rear, extended.

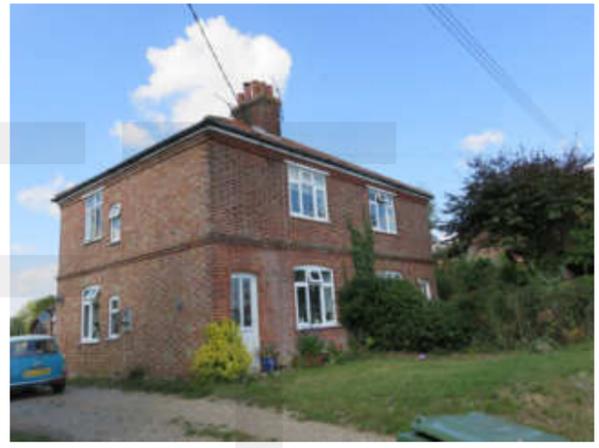
Address / Building Name	5 and 6 Holt Road
Street-by-Street Area	Norwich Road North of The Green
Status	Locally Listed
List Entry Link	N/A
Brief History	1912, a rare example of Parish Council housing and pre-1914 local authority housing. Built in ½ acre plots for £150.
Brief Description	Pair of semi-detached houses. Brick with corrugated tile hipped roof. Two storeys, one bay per-house. Having not benefited from the protection of listing, the windows have been altered to uPVC and doors have been replaced. Single-storey divided wash-house to rear, extended. Included on the local list for group value.

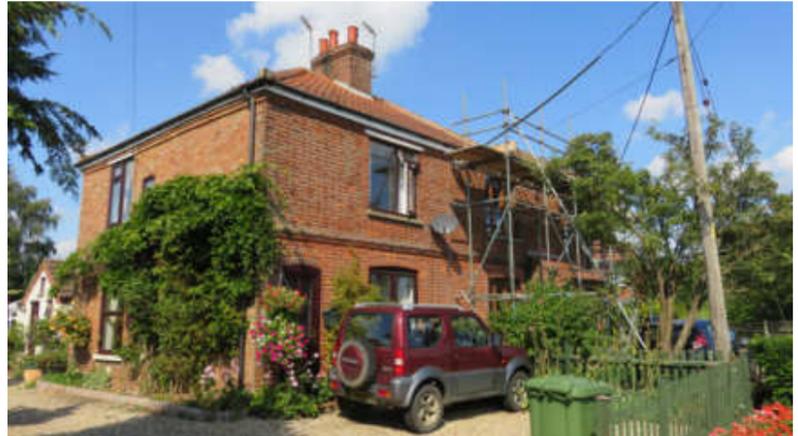
Address / Building Name	7 and 8 Holt Road
Street-by-Street Area	Norwich Road North of The Green
Status	Locally Listed
List Entry Link	N/A
Brief History	1912, a rare example of Parish Council housing and pre-1914 local authority housing. Built in ½ acre plots for £150.
Brief Description	Pair of semi-detached houses. Brick with corrugated tile hipped roof. Two storeys, one bay per-house. Having not benefited from the protection of listing, the windows have been altered to uPVC and doors have been replaced. Single-storey divided wash-house to rear, extended. Included on the local list for group value.

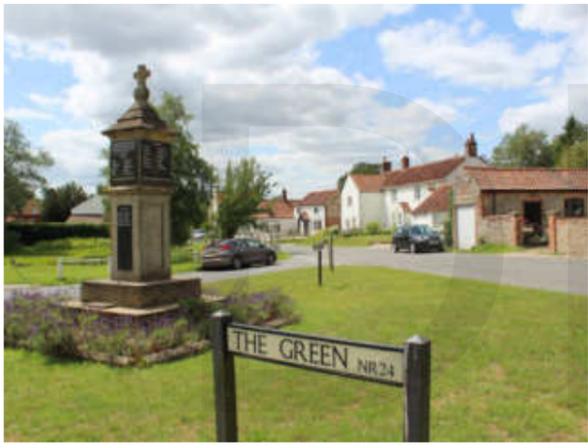
Address / Building Name	Edgefield War Memorial
Street-by-Street Area	The Green
Status	Grade II
List Entry Link	https://historicengland.org.uk/listing/the-list/list-entry/1455235
Brief History	1920 as a memorial to five local servicemen who died, seven wounded and a further 28 who served in WWI, plus names of those who died during WWII.. Polished black plaques added in 2004 to replace inscriptions.
Brief Description	Concrete pillar on two-stepped square concrete base, supporting a four-sided head made of stone and bearing polished block inscription panels. Head surmounted by Latin cross on a ball.

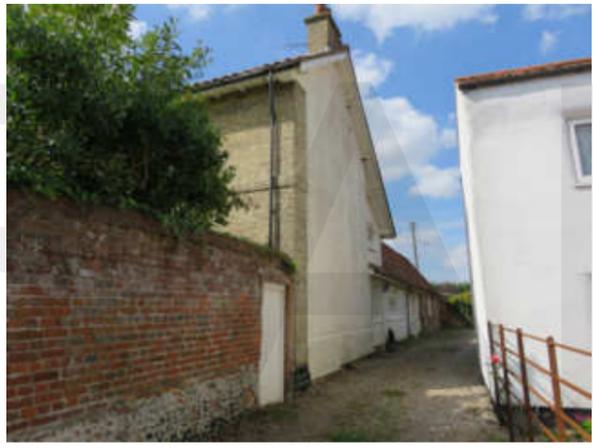
Address / Building Name	The Lodge
Street-by-Street Area	The Green
Status	Locally listed
List Entry Link	N/A
Brief History	House in the Regency style from the early nineteenth century.
Brief Description	Regency style house with recessed brick arches in gaunt brick. North of the Village Green within a walled boundary.

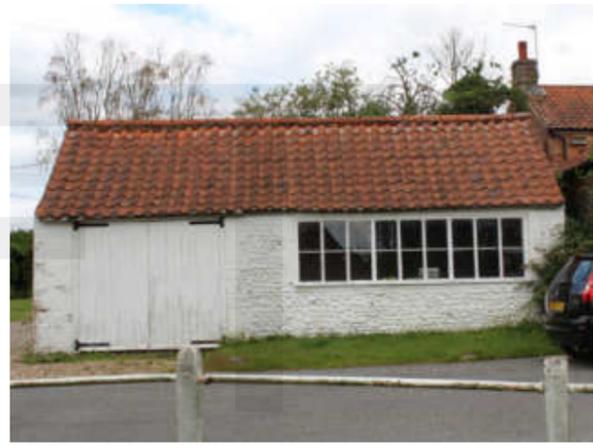
Address / Building Name	The Old Smithy
Street-by-Street Area	The Green
Status	Locally listed
List Entry Link	N/A
Brief History	House is first seen on the 1815 Enclosure award but may be earlier.
Brief Description	Old smithy building located north of the Village Green. Single storey building with a rectangular plan form and long window on front elevation. Constructed of bricks, cobble flints and red clay pantiles.

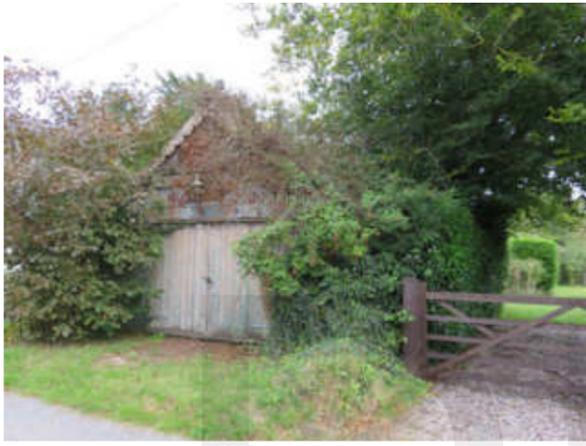
Address / Building Name	Former Baptist Chapel
Street-by-Street Area	Pecks Lane (North-South)
Status	Locally Listed
List Entry Link	N/A
Brief History	The Baptist Chapel appears on the first OS Map of Edgefield from 1886 as a General Baptist Chapel.
Brief Description	A former Baptist Chapel constructed of corrugated metal sheeting, now a private garage. Structure retains fretted bargeboard and light fixture above doorway.

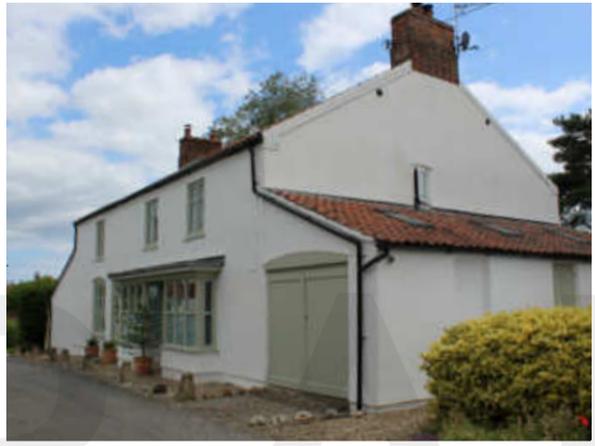
Address / Building Name	The Old Post Office
Street-by-Street Area	Pecks Lane (North-South)
Status	Locally Listed
List Entry Link	N/A
Brief History	The Old Post Office was formerly a house and was converted into a Post Office in the late nineteenth century. It was converted back into a house during the twentieth century.
Brief Description	Detached four bay building of two storeys located south of the Village Green on Pecks Lane.

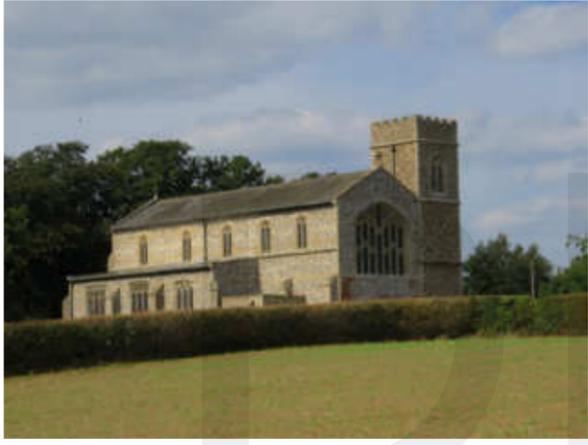
Address / Building Name	Church of St. Peter and St. Paul
Street-by-Street Area	Sweetbriar Lane
Status	Grade II*
List Entry Link	https://historicengland.org.uk/listing/the-list/list-entry/1049204
Brief History	1883-84 by J.D. Sedding, incorporating much fabric and fittings of earlier medieval church dismantled to north-west.
Brief Description	Church. Flint with stone dressings, slate and lead roofs. Large nave compared to proportionately small, square tower. Traceried windows.

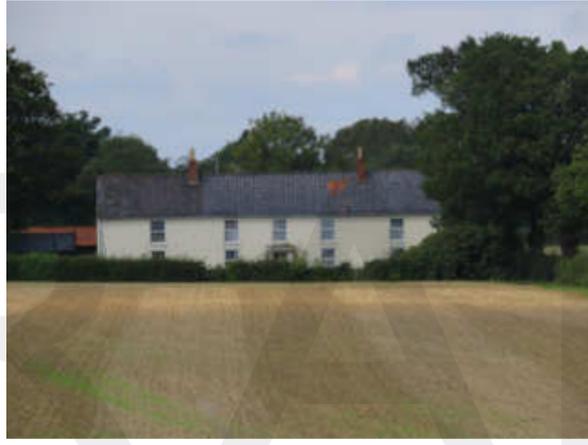
Address / Building Name	Manor Farm
Street-by-Street Area	Sweetbriar Lane
Status	Locally listed
List Entry Link	N/A
Brief History	The farmhouse dates from the eighteenth century date and is set within a complex of farm buildings which built in the eighteenth and nineteenth centuries.
Brief Description	Large eighteenth century farmhouse of five bays and two storeys with complete set of sash windows. Rendered exterior painted white. Blue glazed pantile roof.

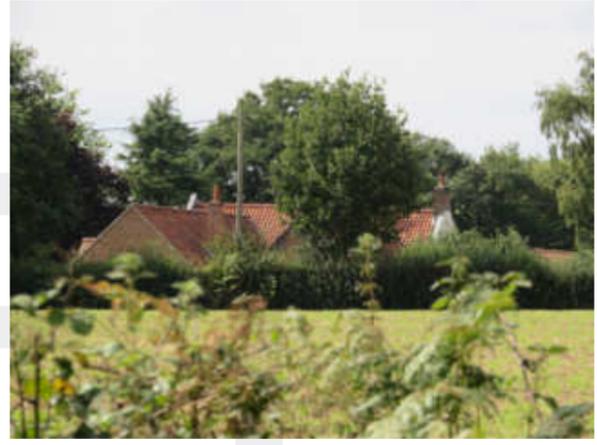
Address / Building Name	Church Farm House
Street-by-Street Area	Sweetbriar Lane
Status	Grade II
List Entry Link	https://historicengland.org.uk/listing/the-list/list-entry/1049205
Brief History	1704, renovated 1970
Brief Description	Two storey house. Flint and brick, pantile roof. Wing to east converted from C19 barn. Casement windows c.1970. Included on list for south gable wall which has decorated brick pattern work with lozenges, E F for Elizabeth Fenn and the date 1704.

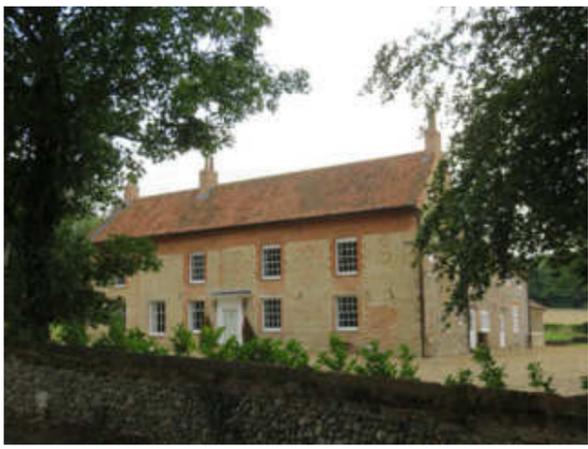
Address / Building Name	Merrisons Farm House 150m north-west of parish church of St. Peter and St. Paul
Street-by-Street Area	Sweetbriar Lane
Status	Grade II
List Entry Link	https://historicengland.org.uk/listing/the-list/list-entry/1152661
Brief History	C18
Brief Description	Two storey house. Brick with black glazed pantiles. Sash windows.

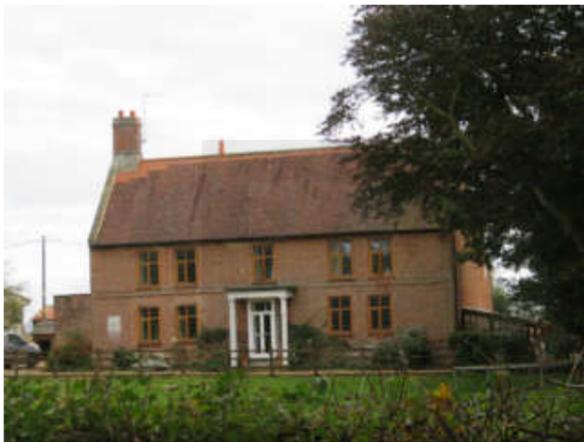
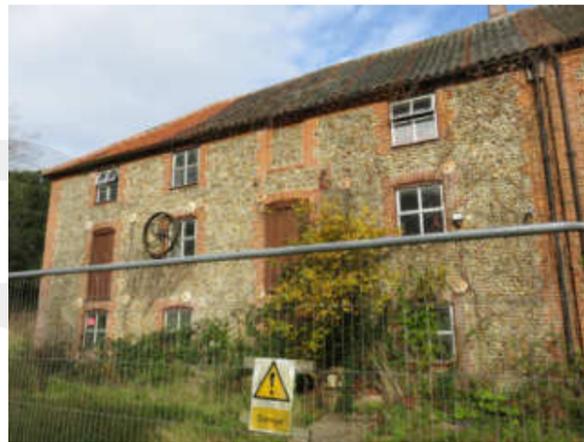
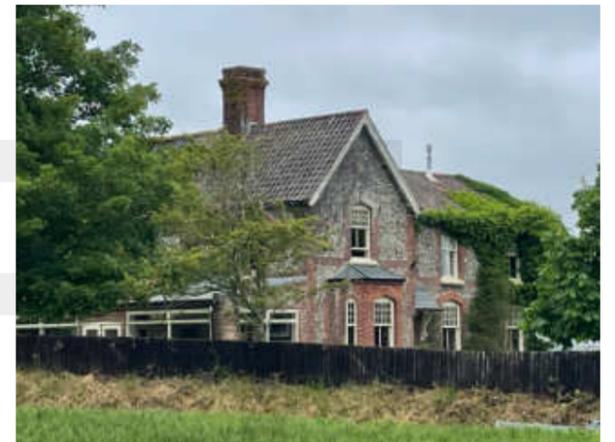
Address / Building Name	The Red House
Parish	Hempstead
Status	Grade II
List Entry Link	https://historicengland.org.uk/listing/the-list/list-entry/1373806
Brief History	C18
Brief Description	Early C18 brick house with patterned headers, plain tiles to front, pantiles to rear. Single range, 3 bays. 2 storeys with attic and cellar.

Address / Building Name	Watermill and Mill House
Parish	Hempstead
Status	Grade II
List Entry Link	https://historicengland.org.uk/listing/the-list/list-entry/1373734
Brief History	C18
Brief Description	House and mill in a continuous range of flint and chert with red brick dressings and hipped pantile roof.

Address / Building Name	Beckett's Farmhouse and barns
Parish	Hempstead
Status	Proposed Local Listing
List Entry Link	N/A
Brief History	Buildings are indicated on Faden's 1797 map of Norfolk and the buildings included for local listing appear on the 1882 OS map.
Brief Description	The Farmhouse is a multi-phase flint and brick building with a pantile roof. A front range with a gabled roof has three perpendicular ranges under separate hipped roofs to the north. The barns comprise flint and brick barns and cattlesheds with pantile roofs.

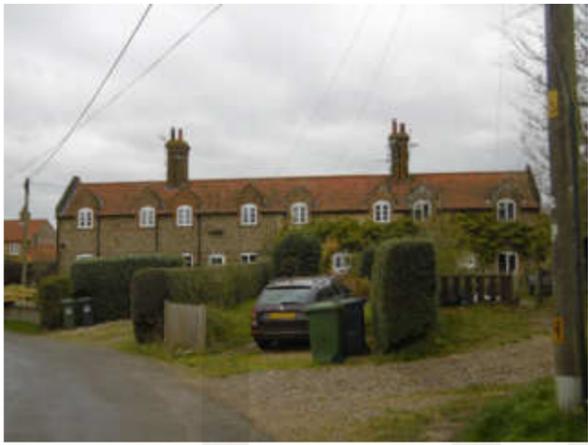
Address / Building Name	White Horse Cottage
Street-by-Street Area	The Street (North)
Status	Proposed Locally Listed
List Entry Link	N/A
Brief History	18th/early-19th century
Brief Description	Complete row of flint cottages with red brick dressings. They have distinctive stepped gables to dormer windows and end gables. The building is a focal point at the north end of The Street and forms a local landmark in the village.

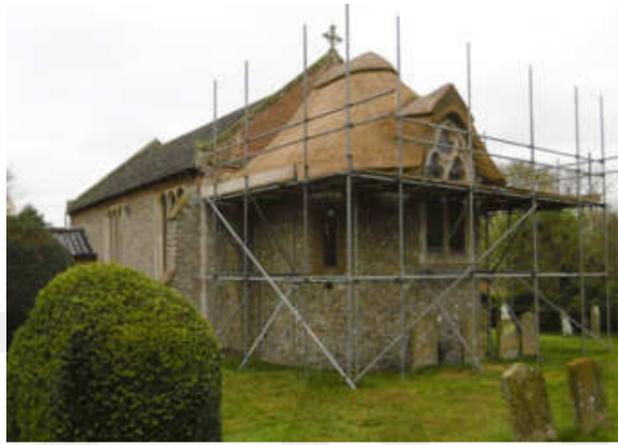
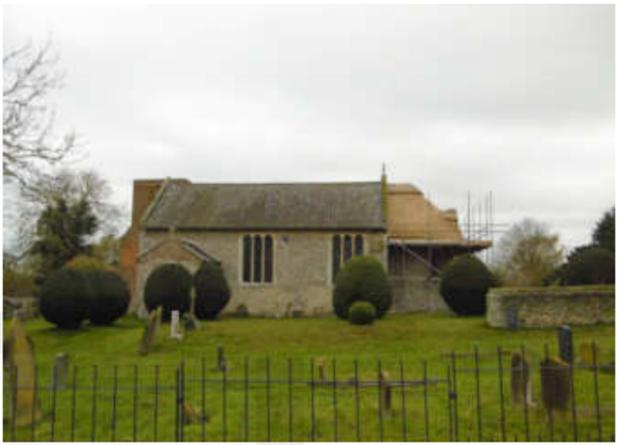
Address / Building Name	Church of All Saints
Street-by-Street Area	The Street (South)
Status	Grade II*
List Entry Link	(or N/A for locally listed) https://historicengland.org.uk/listing/the-list/list-entry/1049211
Brief History	Built in the 14th century with later 18th century roof and alterations. The west tower rebuild is dated 1744.
Brief Description	Coursed flint and brick with black glazed pantile roof. North-west tower and vestry, nave (formerly south aisle) with apse, and south porch. Medieval east half of tower is of flint, the later rebuilt to the west is red brick. Unusual thatched apse, built 1925 in pebble flint with brick dressings.

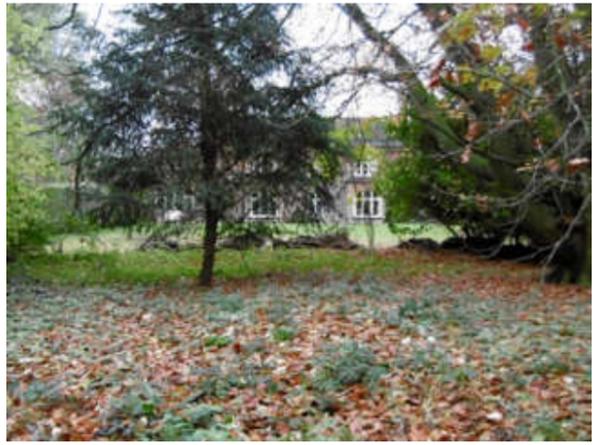
Address / Building Name	Hempstead Lodge
Street-by-Street Area	The Street (South)
Status	Proposed Locally Listed
List Entry Link	N/A
Brief History	Pre-1841, with 20th century extensions
Brief Description	Large red brick country house, in red brick, set in large grounds. One of the grandest buildings in the village with a potentially older core than the external red brick frontage.

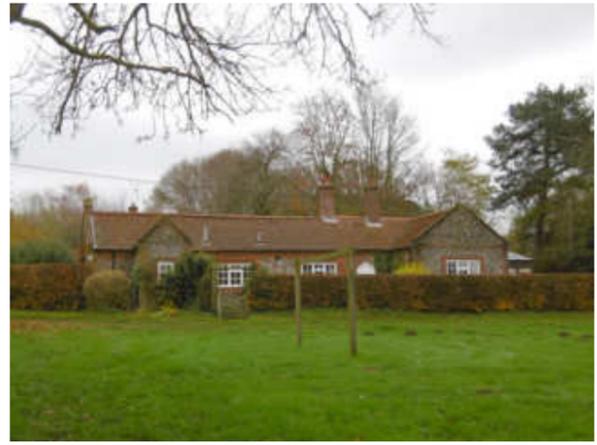
Address / Building Name	The Old School Room
Street-by-Street Area	The Street (South)
Status	Proposed Locally Listed
List Entry Link	N/A
Brief History	Between 1841 and 1886
Brief Description	Single storey school room of flint with red brick dressing. Formerly the village school converted to dwelling and therefore has a connection to local social history. Has an attractive red brick bell motif built into the north-west facing gable, with the old school bell still intact to the rear.

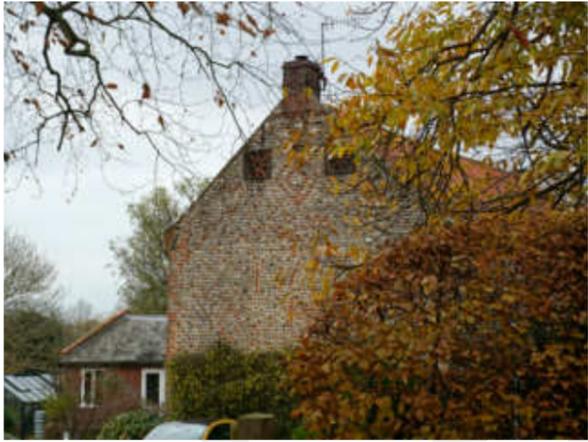
Address / Building Name	Brownwood
Street-by-Street Area	Ponds Hills Road
Status	Grade II
List Entry Link	https://historicengland.org.uk/listing/the-list/list-entry/1049213
Brief History	House dated to 1674, as shown on gable.
Brief Description	Flint with brick dressings, pantile roof, gable parapets. Single range with 4 bays. 19th century cross windows and a 20th century rear extension. House is attached to farm buildings that have been converted to dwellings.

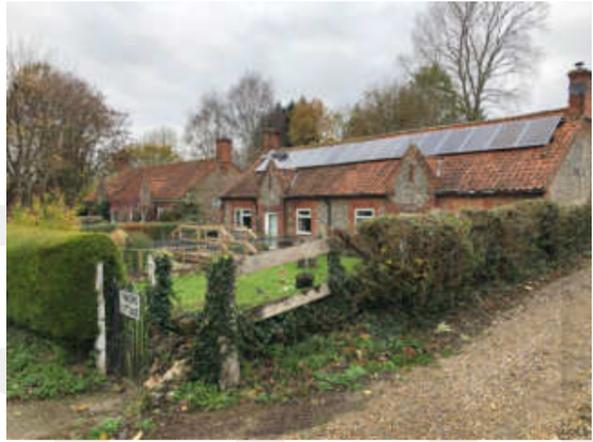
Address / Building Name	43-44, & 45 & Tinker's Cottage
Street-by-Street Area	Marlpit Road
Status	Proposed Locally Listed
List Entry Link	N/A
Brief History	Between 1841 and 1886
Brief Description	Row of single storey flint cottages with red pantile roof. Small decorative gables to front and red brick dressings. Uniform design indicates these could be estate cottages built for workers.

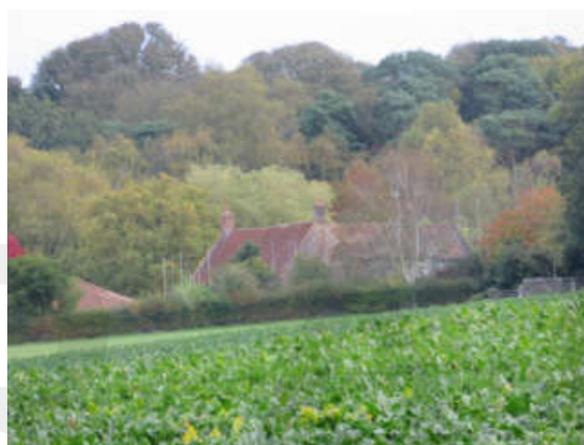
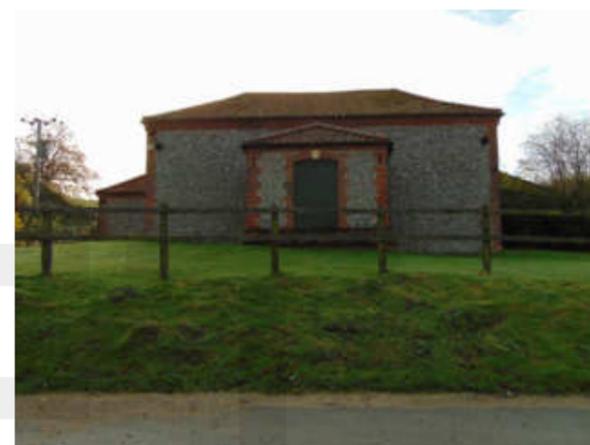
Address / Building Name	Holt Hall
Parish	Holt
Status	Grade II
List Entry Link	https://historicengland.org.uk/listing/the-list/list-entry/1169415
Brief History	C19
Brief Description	Red brick hall of two storeys fenestrated with casements in mullions and transoms.

Address / Building Name	Lawn Farm
Parish	Holt
Status	Grade II
List Entry Link	https://historicengland.org.uk/listing/the-list/list-entry/1049343
Brief History	C17 and earlier
Brief Description	House of red brick and flint with steep pitched pantile roof. Two storeys and attic.

Address / Building Name	Tithe Barn, Letheringsett Hill
Parish	Holt
Status	Grade II
List Entry Link	https://historicengland.org.uk/listing/the-list/list-entry/1306496
Brief History	1851
Brief Description	Barn with pebble flint with red brick quoins and eaves courses. Hipped pantiled roofs. Projecting porch on N. side with segmental-headed door

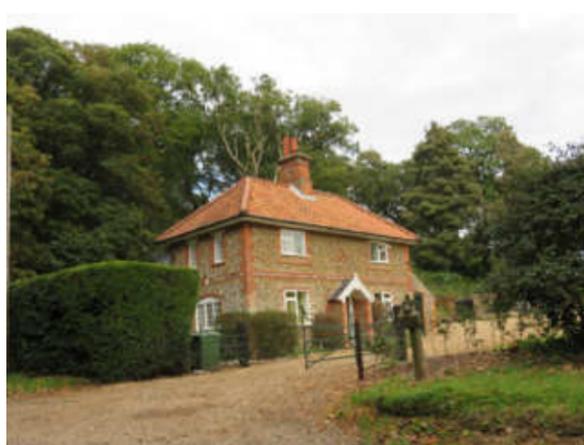
Address / Building Name	The Old Rectory, Letheringsett Hill
Parish	Holt
Status	Grade II*
List Entry Link	https://historicengland.org.uk/listing/the-list/list-entry/1049316
Brief History	C18 with earlier core
Brief Description	House of red brick with stuccoed east facade and roof of black-glazed pantiles. Rear elevations partly rendered flint and brick.

Address / Building Name	The Watering, Cley Road, Holt, NR25 7DY
Parish	Holt
Status	Proposed Local Listing
List Entry Link	N/A
Brief History	Pre-1886
Brief Description	House of flint and brick with hipped pantile roof, plaque on front, visible from road. Very Visible

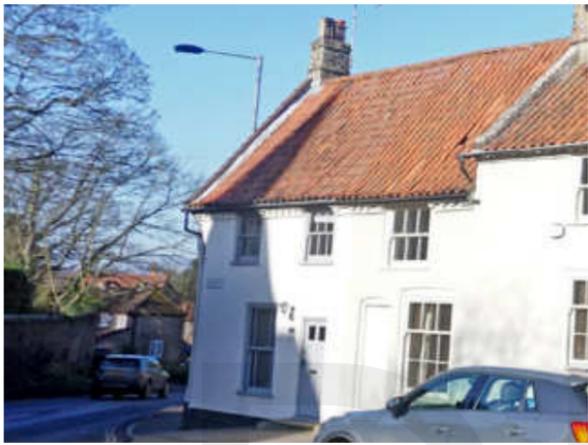
Address / Building Name	52 High Street
Status	Grade II
List Entry Link	https://historicengland.org.uk/listing/the-list/list-entry/1169461
Brief History	C18
Brief Description	End terrace, two storeys, rendered, timber sash windows and timber panelled door with toplights. Red clay pantile roof.

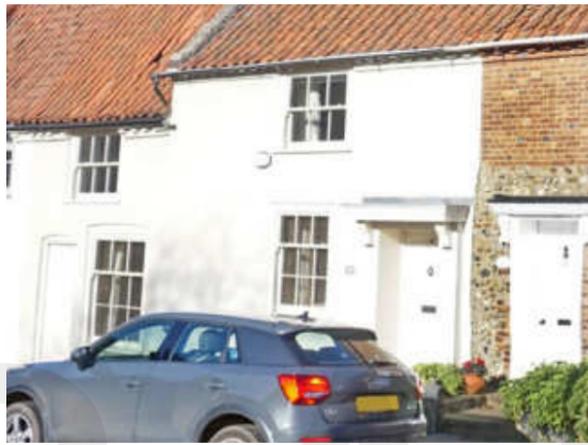
Address / Building Name	50 High Street
Status	Grade II
List Entry Link	https://historicengland.org.uk/listing/the-list/list-entry/1049311
Brief History	C18
Brief Description	Two terraced houses incorporated in one. Two storey, with step down between the two former houses. Rendered, timber sash windows, timber panelled door with architrave, red clay pantiles.

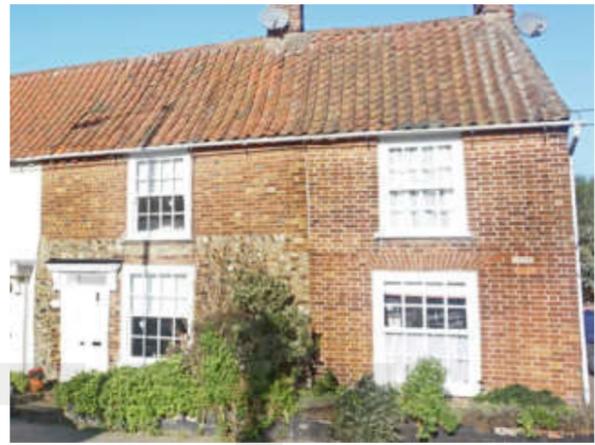
Address / Building Name	48 High Street
Status	Grade II
List Entry Link	https://historicengland.org.uk/listing/the-list/list-entry/1169460
Brief History	C18
Brief Description	Cottage part of terrace. Two storey, flint to ground floor, red brick above. Timber sash windows and timber panelled door with architrave, red clay pantiles.

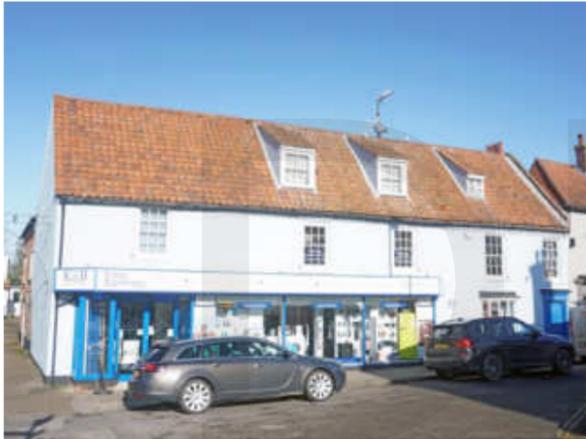
Address / Building Name	34 and 36 High Street
Status	Grade II
List Entry Link	https://historicengland.org.uk/listing/the-list/list-entry/1373737
Brief History	C18
Brief Description	Pair of shops, two storey, hipped red clay pantile roof, rendered walls, timber sash windows to first floor. Shop front to No. 36 central door, flanked by timber windows and pilasters, with fascia above and retractable canvas awning. Shop front to No. 34 has central recessed door, mainly glazed, with flanking oriel shop front windows either side and retractable canvas awning.

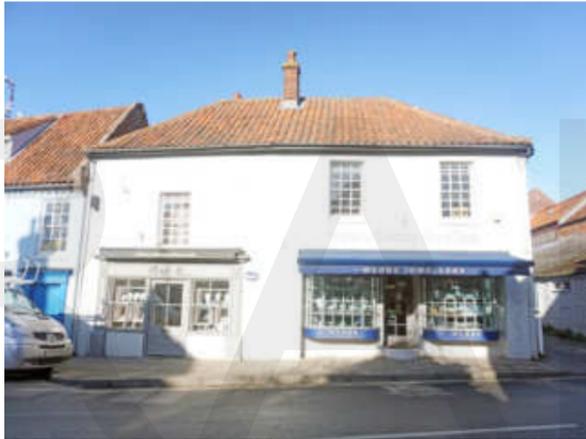
Address / Building Name	26 and 28 High Street
Status	Grade II
List Entry Link	https://historicengland.org.uk/listing/the-list/list-entry/1049309
Brief History	C19, GF No.26 rebuilt late-C20
Brief Description	Two shops. Two storeys, both rendered with red clay pantiles. Timber sash windows to first floor. Shop front to No.28 is timber with door to side and three windows adjacent, flanked by pilasters and topped by a fascia and retractable canvas awning. Ground floor of No.26 completely rebuilt late-C20 in red brick with dark timber frame to windows. This and the plastic printed fascia sign above are unsympathetic.
