Glaven Valley

Conservation Area Appraisal and Management Plan

Eighth Draft: May 2023

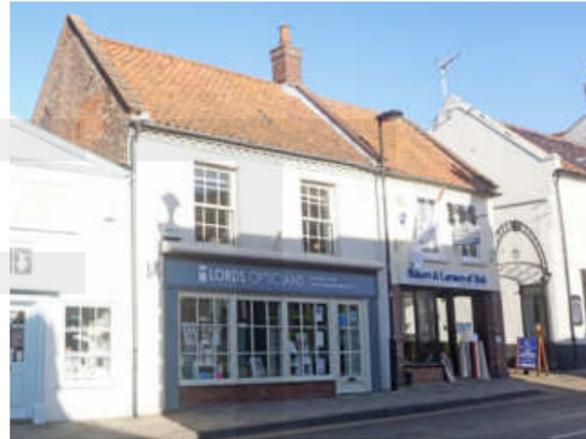
Address / Building Name	24 High Street
Status	Grade II
List Entry Link	https://historicengland.org.uk/listing/the-list/list-entry/1373736
Brief History	Late C18
Brief Description	End terrace shop. Two storeys, red clay pantiles with some black glazed. Unsympathetic pebbledash render. Timber sash window to first floor. Timber shop front with simple pilasters and fascia to ground floor.

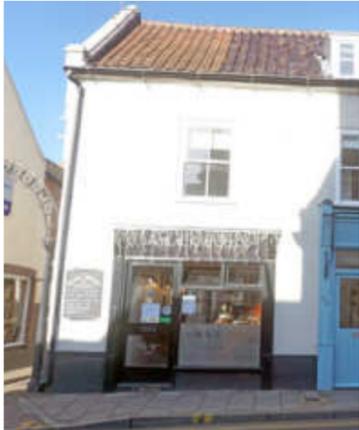
Address / Building Name	20 and 22 High Street
Status	Grade II
List Entry Link	https://historicengland.org.uk/listing/the-list/list-entry/1049308
Brief History	Late C18
Brief Description	<p>No.22 two storey with catslide dormers indicating attic floor. Unsympathetic pebbledash render. Timber sash windows to first and second floors. Good timber shop front with pilasters, fascia, stall riser and features indicating historic retractable awning. Timber and glazed door to right with semi-circular fanlight.</p> <p>No.20 is left hand side of a larger building with No. 18. Three storeys, brick painted, with quoins and string courses also in brick. Timber sash windows, timber and glazed recessed door in architrave, railings around front area.</p>

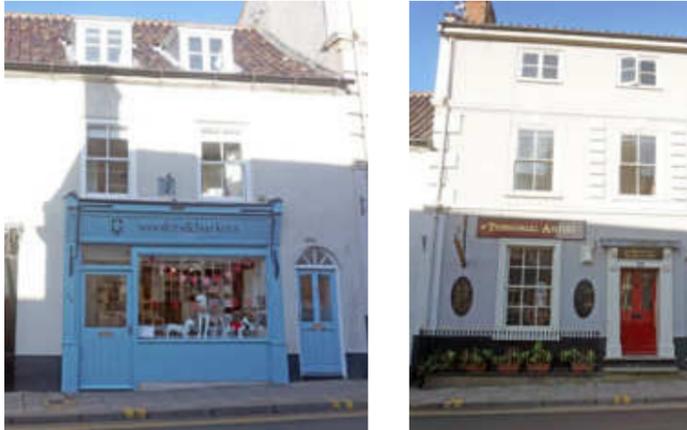
Address / Building Name	18 High Street
Status	Grade II
List Entry Link	https://historicengland.org.uk/listing/the-list/list-entry/1373735
Brief History	C18 & C19
Brief Description	Right hand side of building with No.20. Three storeys, brick painted, with quoins and string courses also in brick. Timber sash windows, timber and glazed recessed door with arched head. Single glazed pane in arched window to right.

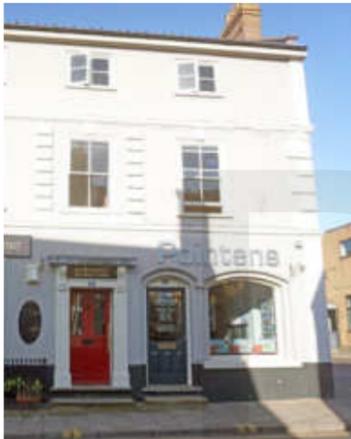
Address / Building Name	6 and 8 High Street
Status	Grade II
List Entry Link	https://historicengland.org.uk/listing/the-list/list-entry/1049307
Brief History	Early C19
Brief Description	Two shops. Three storeys, brick painted, black glazed pantiles, timber sash windows with four blind windows. Shop fronts on ground floor either side of an arched entrance with timber panelled door and fanlight over. Shop front to No. 8 timber framed with pilasters and fascia. To No.6 shop front is more modern in style though not inappropriate, with retractable canvas awning.

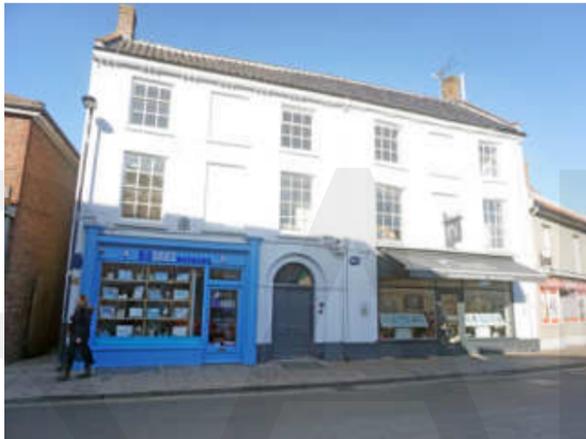
Address / Building Name	2 and 4 High Street
Status	Grade II
List Entry Link	https://historicengland.org.uk/listing/the-list/list-entry/1049306
Brief History	Early C19
Brief Description	Tow shops. Both two storeys, rendered, red clay pantiles, timber sash windows, two blind windows to No. 2. Central shop door with flanking windows and fascia above to both properties, No.2 with additional timber and glazed door to right.

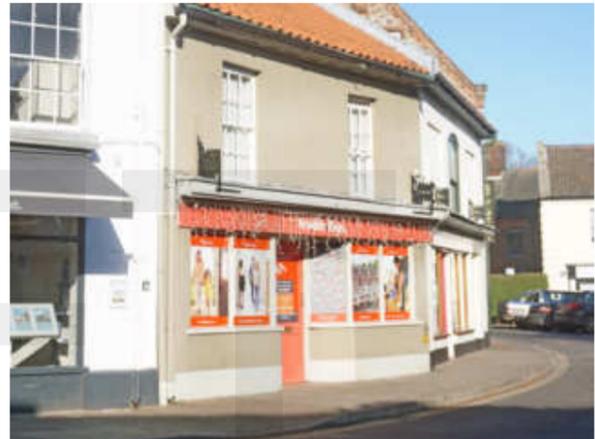
Address / Building Name	Lloyds Bank (No.1)
Status	Grade II
List Entry Link	https://historicengland.org.uk/listing/the-list/list-entry/1373738
Brief History	Late C18
Brief Description	Now TSB bank. Two storeys, hipped red clay pantile roof, rendered walls with dentil cornice at first and ground floors. Timber sash windows mainly, though some altered on ground floor to casements with decorative toplights. Classical style doorcases with modern doors.

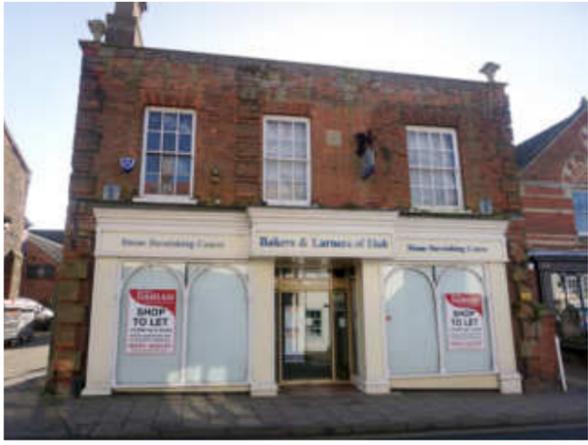
Address / Building Name	33 High Street
Status	Grade II
List Entry Link	https://historicengland.org.uk/listing/the-list/list-entry/1169500
Brief History	Mid C19
Brief Description	Shop. Gable end facing street in polychrome brick with Gothic feel. Timber sash windows. Good timber shop front to ground floor with central door and decorative arched timber mullions to the windows.

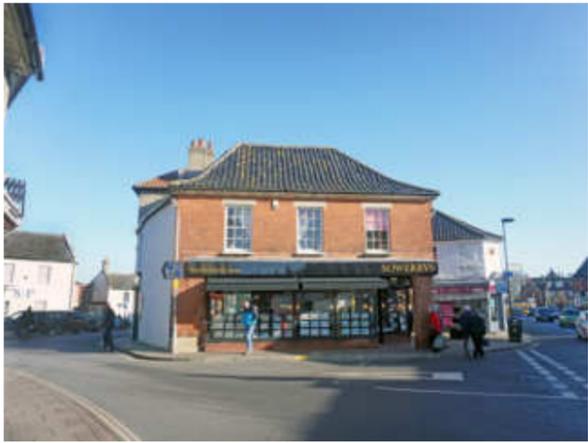
Address / Building Name	3 and 3A Market Place
Status	Grade II
List Entry Link	https://historicengland.org.uk/listing/the-list/list-entry/1373740
Brief History	Early C19
Brief Description	Shop set on corner. Two storeys, black glazed pantiles, painted brick, timber sash windows, timber shop fronts to ground floor. That to No.3 is particularly good with decorative pilasters, pediment above door set on corner containing barometer, clock face above.

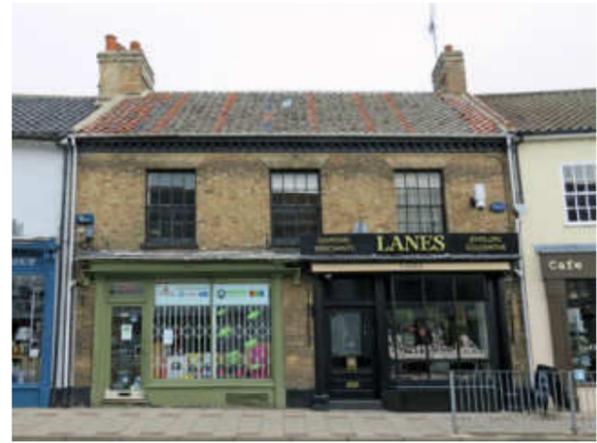
Address / Building Name	11 and 13 Market Place
Status	Grade II
List Entry Link	https://historicengland.org.uk/listing/the-list/list-entry/1049321
Brief History	C18
Brief Description	Shop (formerly two converted into one). Two storey with attic denoted by dormers, hipped roof with black glazed pantiles, timber sash windows, good shop front on ground floor featuring ionic columns, slender columned mullions and side doors.

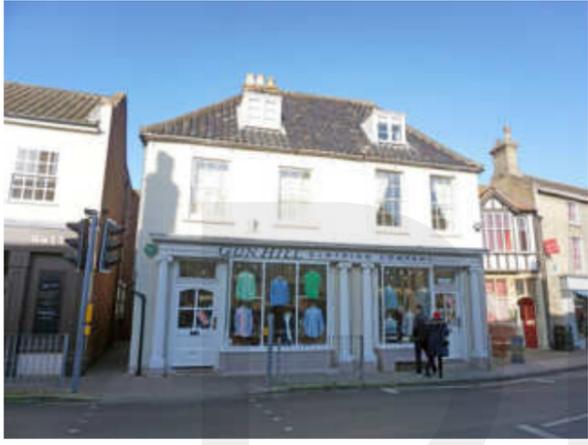
Address / Building Name	17, 19 and 21 Market Place
Status	Grade II
List Entry Link	https://historicengland.org.uk/listing/the-list/list-entry/1169565
Brief History	Early C19
Brief Description	Two shops and office. Three storeys, black glazed pantiles, gault brick, timber sash windows, timber panelled door with fanlight between shop fronts. Larger shop front to left is late-C20 with chamfered windows to recessed central entrance, flanking pilasters and fascia above. To right is smaller shop front with modern glazed window and Dutch canopy.

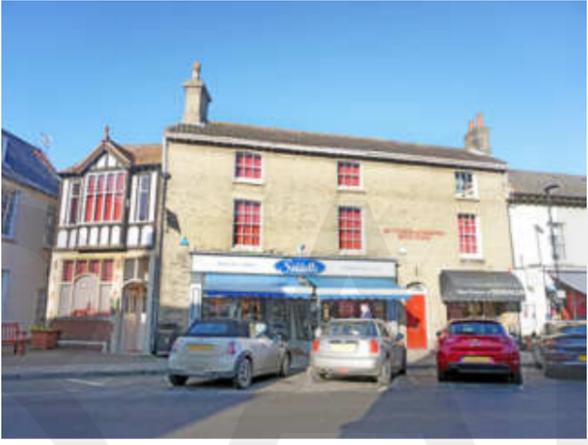
Address / Building Name	23 Market Place
Status	Grade II
List Entry Link	https://historicengland.org.uk/listing/the-list/list-entry/1049322
Brief History	Early/mid C19, with mid/late C19 shop front
Brief Description	Shop. Two storey, black glazed pantiles, painted brick, timber sash windows, central door with flanking shop windows with slender columned mullions and retractable canvas awning.

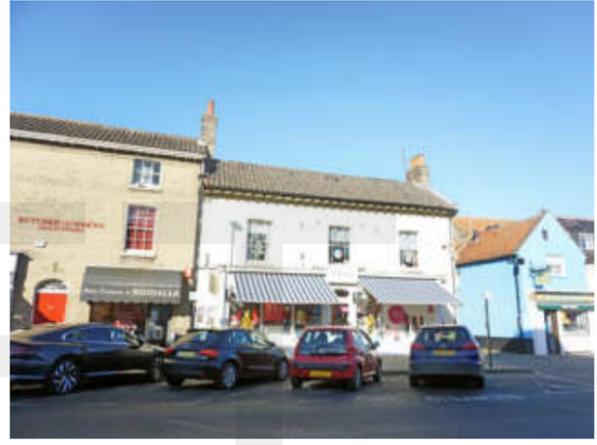
Address / Building Name	27 Market Place
Status	Grade II
List Entry Link	https://historicengland.org.uk/listing/the-list/list-entry/1169572
Brief History	C18
Brief Description	Detached shop. Two storeys with attic denoted by window in gable end. Black glazed pantiles, unsympathetic pebbledash render, timber sash windows, mid-C20 bay window shop fronts. Dutch canopies with bulky timber housings, large volume of signage in windows and security grille could all be improved.

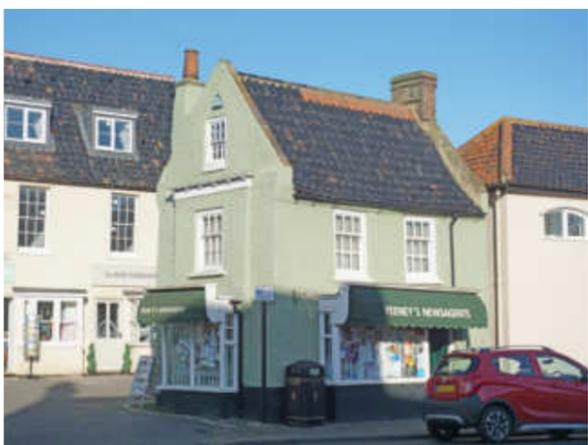
Address / Building Name	31 and 33 Market Place
Status	Grade II
List Entry Link	https://historicengland.org.uk/listing/the-list/list-entry/1373741
Brief History	C18
Brief Description	Shop (vacant in 2020 but under renovation). Two storeys, red clay pantiles, rendered, timber sash windows, timber shop fronts to south and west sides.

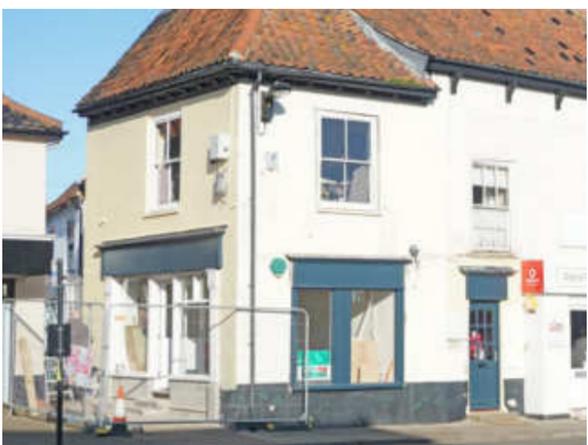
Address / Building Name	35 Market Place
Status	Grade II
List Entry Link	https://historicengland.org.uk/listing/the-list/list-entry/1169578
Brief History	C18 and later
Brief Description	Shops. Main part two storeys, red pantile roof, painted brick, timber sash windows, modern shop front to ground floor u=with unsympathetic signage. Single storey lean-to shop to right hand side with timber and glazed door and casement window to shop.

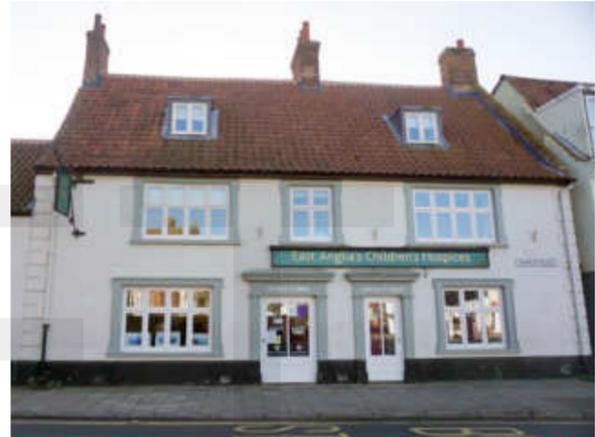
Address / Building Name	Fighting Henry Public House (No. 2 Station Road)
Status	Grade II
List Entry Link	https://historicengland.org.uk/listing/the-list/list-entry/1169633
Brief History	C18
Brief Description	Now shop. Two storeys with attics denoted by dormers. Red glazed pantiles, rendered, timber casement windows, two timber and glazed doors set in architraves. Single storey extension to the left.

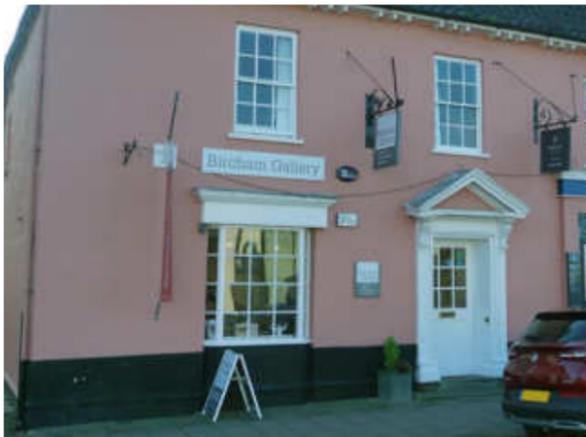
Address / Building Name	14 Market Place
Status	Grade II
List Entry Link	https://historicengland.org.uk/listing/the-list/list-entry/1306472
Brief History	C18
Brief Description	Gallery. Two storeys, hipped roof with pantiles, rendered, timber sash windows, timber and glazed door in pedimented architrave, ground floor window is shallow bay with cornice above.

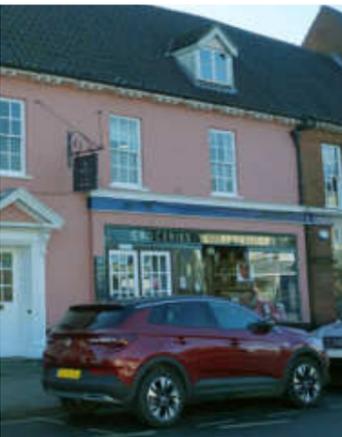
Address / Building Name	12 Market Place
Status	Grade II
List Entry Link	https://historicengland.org.uk/listing/the-list/list-entry/1049319
Brief History	C18 with mid-C20 shop front
Brief Description	Shop, part of Bakers and Larners to right. Two story with attic, black glazed pantile roof, rendered, timber sash window. Good quality mid-C20 shop front with fascia with glided lettering.

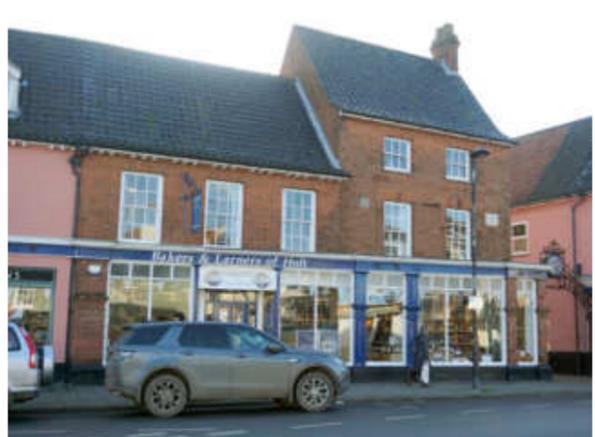
Address / Building Name	10 Market Place
Status	Grade II
List Entry Link	https://historicengland.org.uk/listing/the-list/list-entry/1306469
Brief History	C18
Brief Description	Shop, part of Bakers and Larners which connects to No. 8 behind an alley. Part two and part three storeys. Black glazed pantiles, red brick, Ground floor shop front projecting slightly at west end. Features recessed door and timber and brick pilasters.

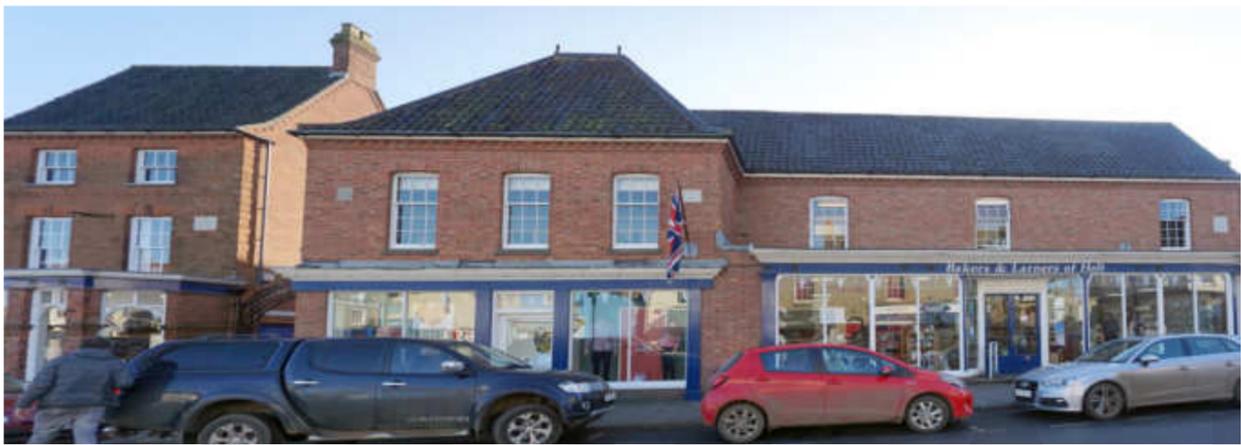
Address / Building Name	8 Market Place
Status	Grade II
List Entry Link	https://historicengland.org.uk/listing/the-list/list-entry/1049318
Brief History	Early C18, restored 1977
Brief Description	Bakers and Lerner shop. Two storey, with left hand side projecting forward. Black glazed pantiles, red brick, timber sash windows, timber shop fronts, that to right projecting forward to line of right hand building.

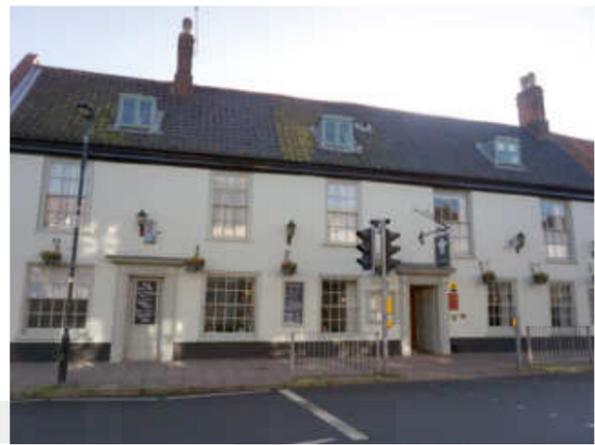
Address / Building Name	Feathers Hotel
Status	Grade II
List Entry Link	https://historicengland.org.uk/listing/the-list/list-entry/1169534
Brief History	C18
Brief Description	Public house. Two storeys with attics denoted by dormer. Mix of red clay and black glazed pantiles. Rendered, timber sash windows, two timber panelled doors with architraves.

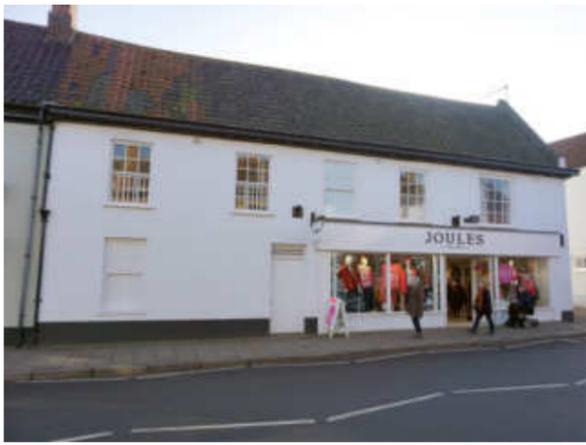
Address / Building Name	2 Market Place
Status	Grade II
List Entry Link	https://historicengland.org.uk/listing/the-list/list-entry/1049317
Brief History	C18
Brief Description	Shop. Two storey. Mix of red clay and black glazed pantiles. Rendered, timber sash windows. Timber shop front to right hand side of ground floor, timber door to left of this with louver over.

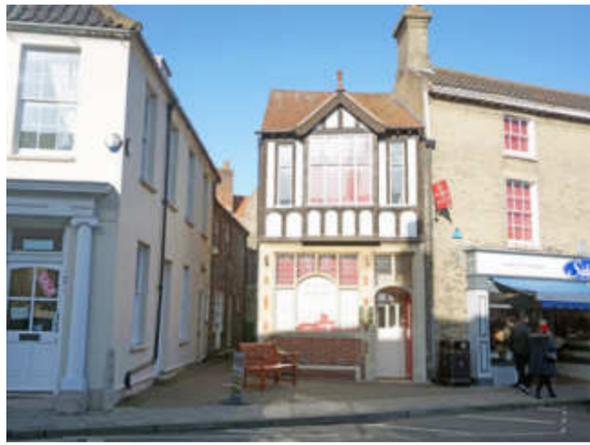
Address / Building Name	15 Market Place
Status	Locally Listed
List Entry Link	N/A
Brief History	Late Victorian or Edwardian
Brief Description	Office. Narrow two storey building. Stone and red brick to ground floor, mock timber framing to first floor, red clay tile roof. Stone or timber mullioned windows, with leaded toplights. Recessed door with brass name plate of original occupiers to right.

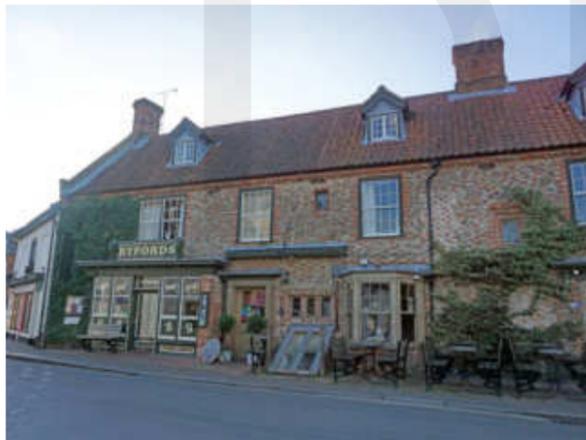
Address / Building Name	1, 3 and 5 Shirehall Plain
Status	Grade II
List Entry Link	https://historicengland.org.uk/listing/the-list/list-entry/1049289
Brief History	Late C17 – Possibly earlier core. C20 additions.

Brief Description Café, deli and hotel. Two storey with attics denoted by dormers. Flint and brick walls with brick around windows. Pantile roof with brick chimneys. Timber casements to dormers timber sash windows to first floor, plus two small brick framed windows which are earlier. Additional brick mullioned window on ground floor. Timber sash bay window and timber framed French window to ground floor. Timber and glazed door with architrave. To left is shop front with central door, sash windows and a fascia board projecting above. Good glided lettering.

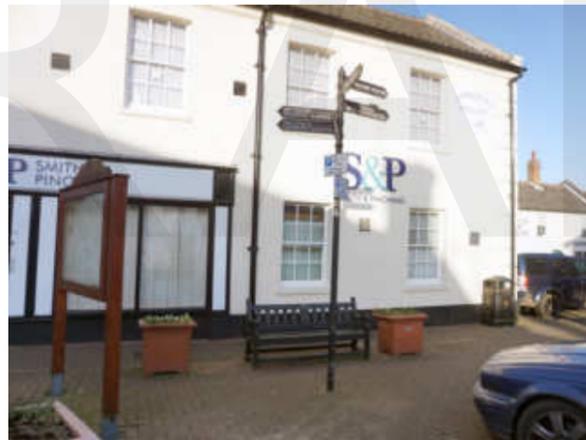
Address / Building Name	The Shirehall
Status	Grade II
List Entry Link	https://historicengland.org.uk/listing/the-list/list-entry/1169620
Brief History	C18 with later additions

Brief Description Former Shirehall now offices. Two storey, rendered with pantile roof. Quoins to edges. Sash windows to ground and first floor. Timber and glazed shop front to left. Gable end to east has sash windows on ground floor, with a timber and glazed door with arched fanlight above, doorcase with quoins. Arched window surrounded by quoins on second floor. Rear fairly plain, with two sash and two small casement windows. Several added downpipes are unsympathetic.

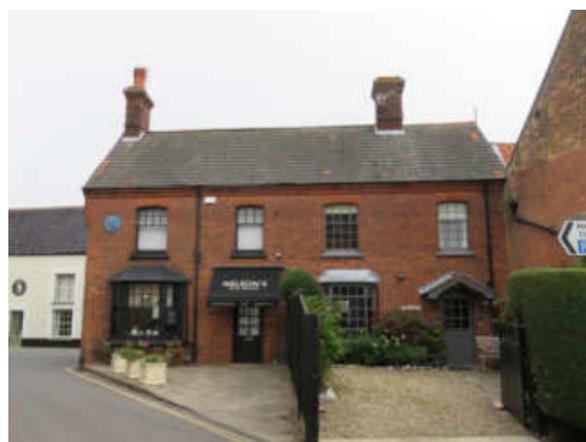
Address / Building Name	Shire House/Shire Cottage
Status	Locally Listed
List Entry Link	N/A
Brief History	C19

Brief Description Shire House is a shop, Shire Cottage is a residence. Semi-detached units with brick dentil cornice, modern pantile roof and two red brick chimneys. Red brick principal façade with flint cobble walls with red brick dressings to other elevations. Chamfered corner to the junction with Albert Street. Timber doors and sash and casement windows with bay shop windows to ground floor.

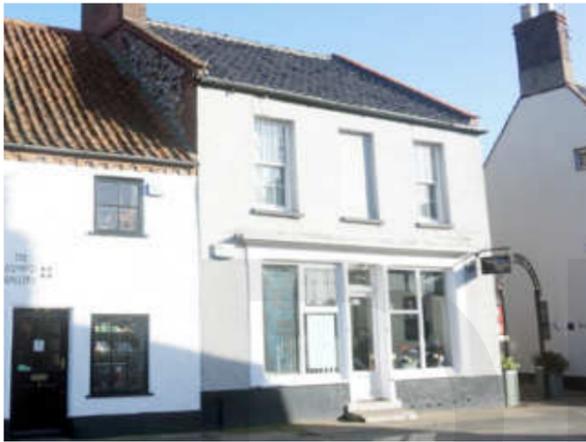
Address / Building Name	4 Albert Street
Status	Grade II
List Entry Link	https://historicengland.org.uk/listing/the-list/list-entry/1049328
Brief History	Early C19
Brief Description	Shop. Two storey. Pebbledash render, black glazed pantile roof with brick chimney. Two timber sash windows to first floor with one blind window. Timber shop front to ground floor with central door.

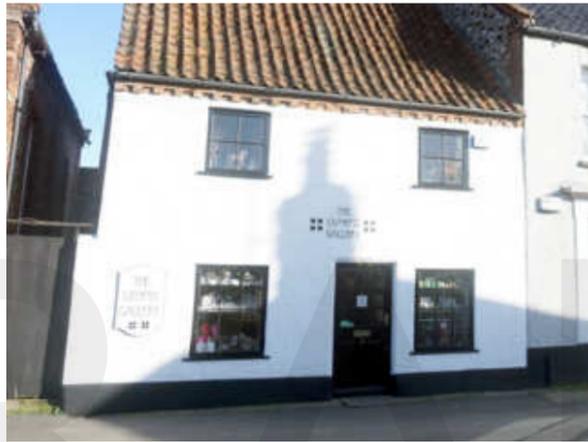
Address / Building Name	Osokozi, 6 Bull Street
Status	Grade II
List Entry Link	https://historicengland.org.uk/listing/the-list/list-entry/1049329
Brief History	C18
Brief Description	Shop. Two storey. Rendered, red clay pantile roof with brick chimney. Timber casement and sash windows. Timber and glazed central front door.

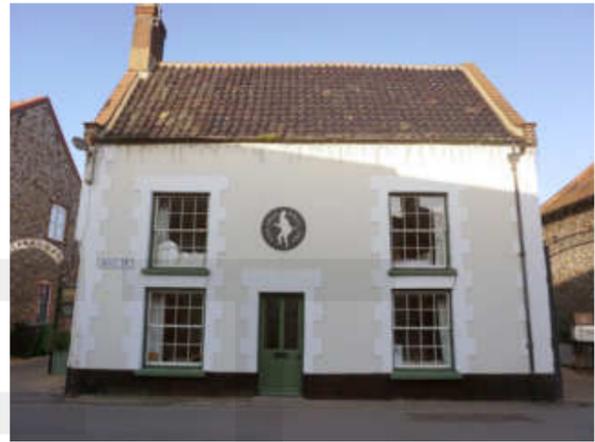
Address / Building Name	1 Bull Street
Status	Grade II
List Entry Link	https://historicengland.org.uk/listing/the-list/list-entry/1168890
Brief History	Early C19
Brief Description	House, formerly the Old Paul Fry public house. Two storey. Rendered with quoins to edges and around openings. Black glazed pantile roof with brick chimney. Timber sash windows timber and glazed door. Attractive metal sign showing a man and 'The Old Paul Fry' above door.

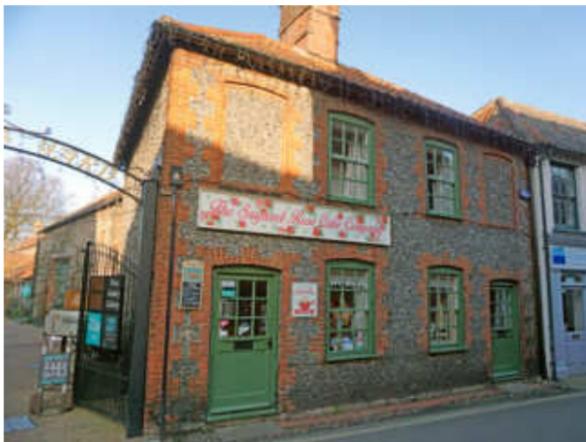
Address / Building Name	3 Bull Street
Status	Grade II
List Entry Link	https://historicengland.org.uk/listing/the-list/list-entry/1049337
Brief History	C18 Later addition to north
Brief Description	Shop, formerly two cottages. Two storey. Flint and red brick. Hipped red clay pantile roof. Timber sash windows, with two blind windows to first floor. Two timber and glazed doors. Painted timber fascia above left hand door and window is sympathetic.

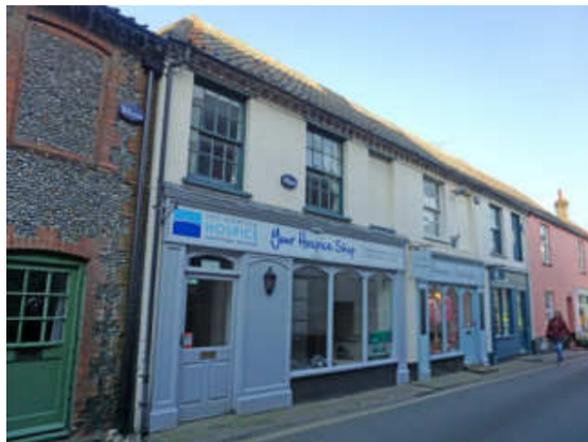
Address / Building Name	5-11 Albert Street
Status	Locally Listed
List Entry Link	N/A
Brief History	Late Victorian or Edwardian
Brief Description	Row of four shops. All two storeys. Nos. 5-7 painted brick with hipped red clay pantile roof. Timber sash windows with two blind windows to the first floor. Three timber shop fronts, good quality though modern. No. 11 rendered with side wall flint. Hipped red clay pantile roof with gault brick chimney. Timber shop front with chamfered corner where door is located. Top hung uPVC windows are unsympathetic.

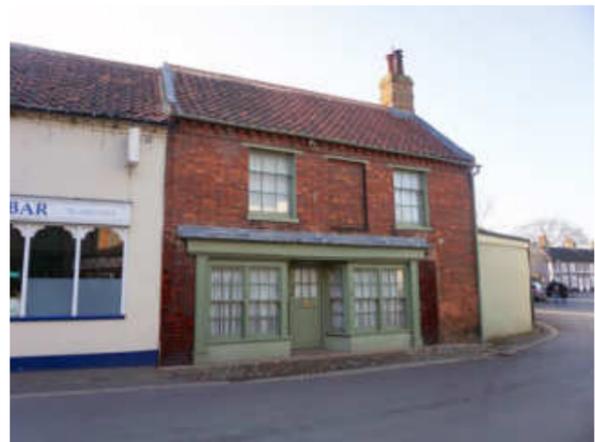
Address / Building Name	13 Albert Street
Status	Locally Listed
List Entry Link	N/A
Brief History	Early C19
Brief Description	Former shop now house. Two storey, red brick, red clay pantile roof, brick chimney. Timber sash windows to first floor with one blind window. Attractive timber shop front to the ground floor with central recessed entrance and timber sash windows either side.

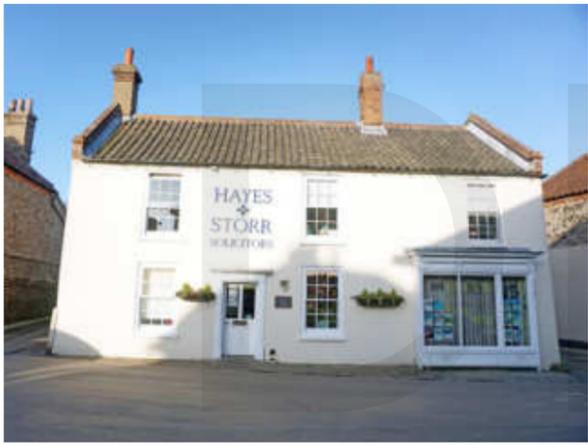
Address / Building Name	27 Bull Street
Status	Grade II
List Entry Link	https://historicengland.org.uk/listing/the-list/list-entry/1049338
Brief History	C18
Brief Description	Office. Two storey. Rendered, pantiles, brick chimneys. Timber sash windows and timber/glazed door with architrave. To right is timber shop front.

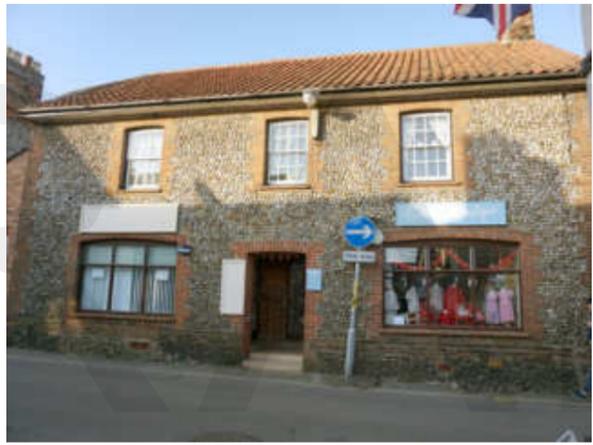
Address / Building Name	37 Bull Street
Status	Grade II
List Entry Link	https://historicengland.org.uk/listing/the-list/list-entry/1168892
Brief History	C19
Brief Description	Two shops (one to the left vacant in 2020). Flint with red brick dressings, red clay pantile roof and brick chimney. Timber sash windows to first floor. Two windows and entrance on ground floor likely modern updates. Windows are wide with shallow arched heads, timber casements. Entrance is recessed with doors opening either side into the two shops. Modern tiled steps. Painted timber signs and fascia boards sympathetic.

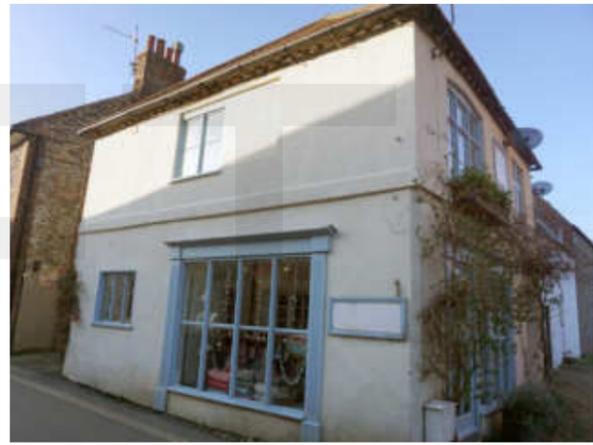
Address / Building Name	39 Bull Street
Status	Grade II
List Entry Link	https://historicengland.org.uk/listing/the-list/list-entry/1049339
Brief History	C18
Brief Description	Shop with ranges behind probably originally stables, now residence. Two storey. Rendered. Hipped red clay pantile roof. Mixture of window designs, mainly different forms of casement window, all timber. Timber shop fronts to south and east sides.

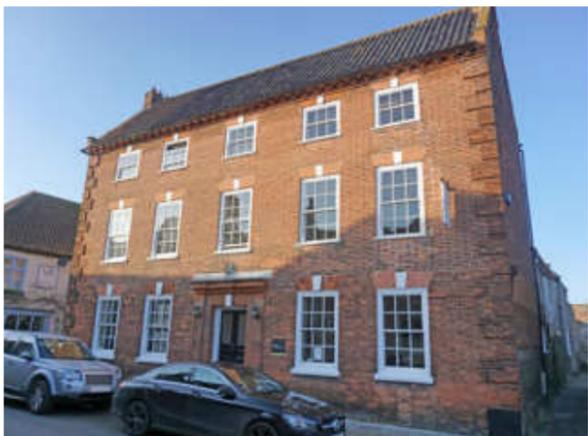
Address / Building Name	Hanworth House
Status	Grade II
List Entry Link	https://historicengland.org.uk/listing/the-list/list-entry/1168900
Brief History	Mid C18 - 1744
Brief Description	Office, formerly house. Three storeys. Red brick with brick quoins, lintels and architrave to door. Black glazed pantiles and brick chimneys. Timber sash windows, timber and glazed door.

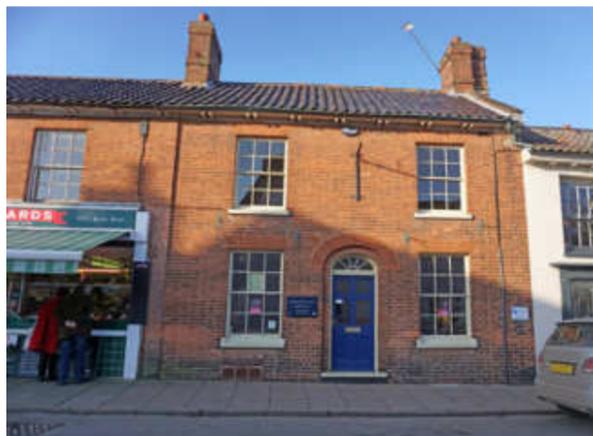
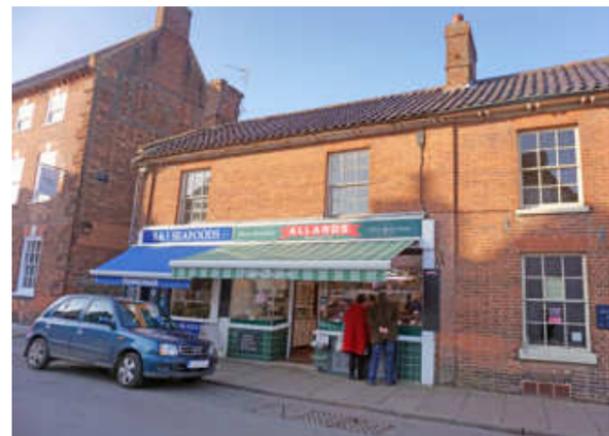
Address / Building Name	45 and 47 Bull Street
Status	Grade II
List Entry Link	https://historicengland.org.uk/listing/the-list/list-entry/1049340
Brief History	Early C19
Brief Description	Office and shop. Both two storey, red brick, black glazed pantile roof, brick chimneys, timber sash windows. No. 45 has two shops to ground floor with mid-late C20 shop fronts, retractable canvas awnings. Printed fascias above could be improved by being painted timber. No.47 retains windows to ground floor with central timber and glazed door with fanlight under brick arch.

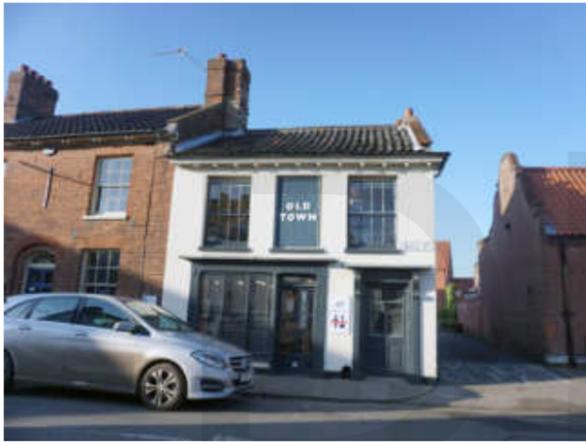
Address / Building Name	49 and 49A Bull Street
Status	Grade II
List Entry Link	https://historicengland.org.uk/listing/the-list/list-entry/1168906
Brief History	C18
Brief Description	Shop. Two storey. Rendered, black glazed pantile roof. Sash windows and one blind window to first floor. Blind window has timber boards across. Timber and glazed door to ground floor with bracketed timber architrave. Timber shop front.

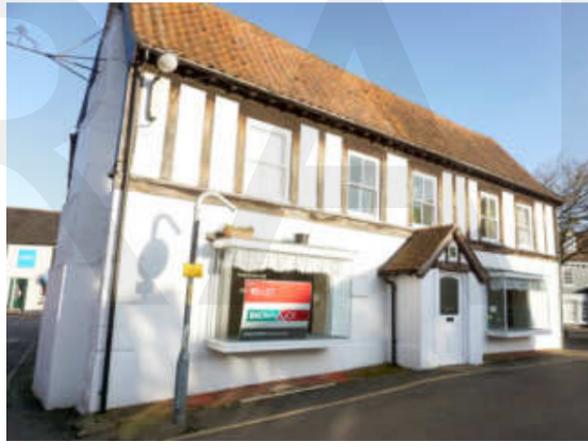
Address / Building Name	8 Fish Hill
Status	Grade II
List Entry Link	https://historicengland.org.uk/listing/the-list/list-entry/1049304
Brief History	C18 with later additions
Brief Description	Vacant shop. Two storey. Unusual in being set on an 'island' surrounded by roads. Rendered, with first floor to west side having mock timber framing. Red clay pantiles. Timber sash windows to first floor, north elevation and ground floor south gable. Unsympathetic late C20 projecting windows to west and south sides. Timber panelled doors on south and east sides, with timber architraves. Gabled porch added to west side with mock timber framing and modern timber and glazed door.

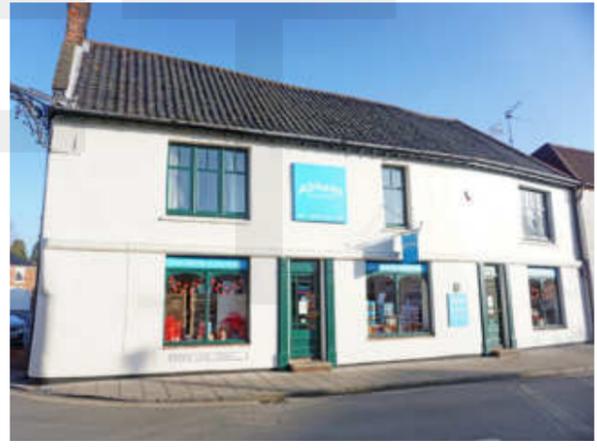
Address / Building Name	White Lion Public House
Status	Grade II
List Entry Link	https://historicengland.org.uk/listing/the-list/list-entry/1049292
Brief History	C18 and later
Brief Description	Former public house, now shop. Two storeys. Rendered, black glazed pantile roof with brick chimney. Timber casement windows to first floor and widened timber shop windows on ground floor. Two timber and glazed doors flanked by fluted pilasters. Distinctive hanging pub sign on corner in metal with decorative ironwork.

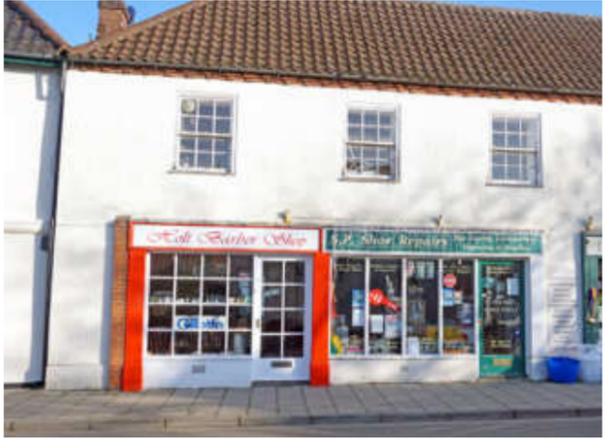
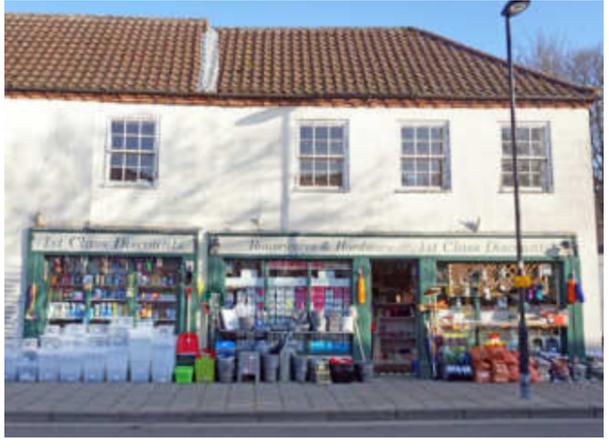
Address / Building Name	Wansbeck House
Status	Grade II
List Entry Link	https://historicengland.org.uk/listing/the-list/list-entry/1169660
Brief History	C18
Brief Description	Former house, now three shops. Two storeys. Pebbledash render, brick cornice. Red clay pantile roof. Timber sash windows. Timber shop fronts of various designs. Signage not very sympathetic.

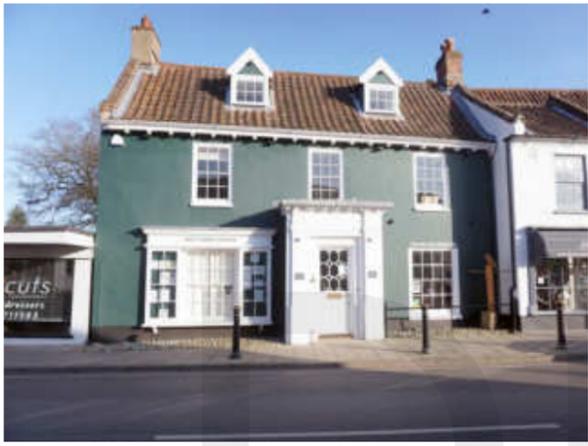
Address / Building Name	Nelson House
Status	Grade II
List Entry Link	https://historicengland.org.uk/listing/the-list/list-entry/1049291
Brief History	C18
Brief Description	Office. Two storeys with attic denoted by dormer. Rendered, red clay pantile roof with rendered chimney. Timber sash windows, with casements to dormers. Larger timber shop front window to left. Large central porch with timber and glazed door.

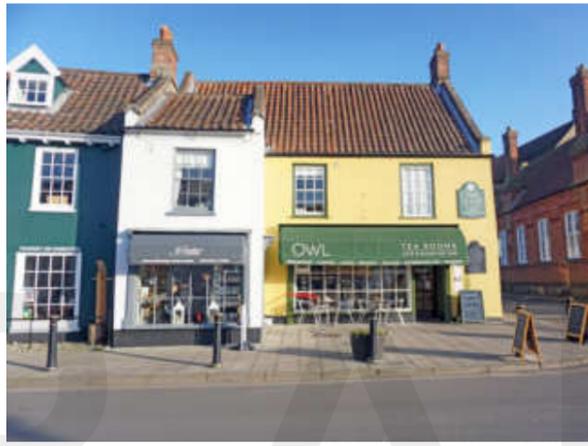
Address / Building Name	Janaway House
Status	Grade II
List Entry Link	https://historicengland.org.uk/listing/the-list/list-entry/1169650
Brief History	C18
Brief Description	Two shops. Two storeys with smaller element projecting out on left hand side containing one of the shops. Rendered, red clay pantile roof, brick chimneys. Timber sash windows timber shop fronts with Dutch canopies.

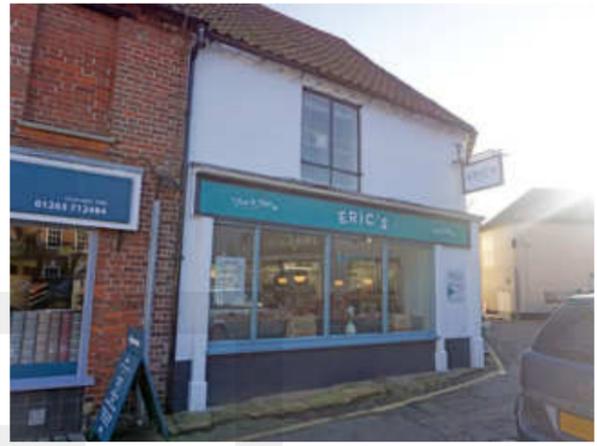
Address / Building Name	Premises occupied by Spar Foodmarket (No. 4 Fish Hill)
Status	Grade II
List Entry Link	https://historicengland.org.uk/listing/the-list/list-entry/1049347
Brief History	C18 and later
Brief Description	Restaurant. Two storeys. Rendered, red clay pantile roof. Metal casement window to north, timber sash windows to west. Timber shop fronts with timber and glazed door to west.

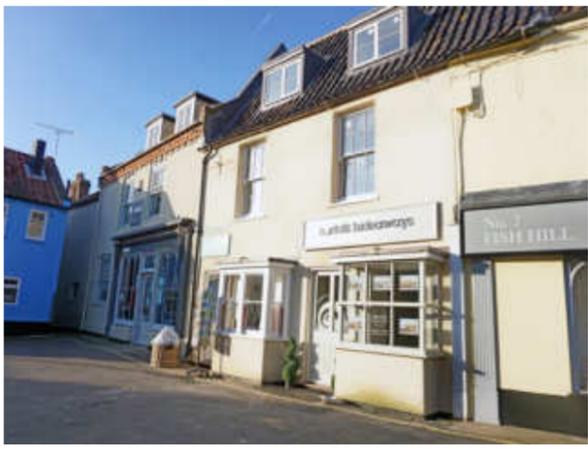
Address / Building Name	3 and 5 Fish Hill
Status	Grade II
List Entry Link	https://historicengland.org.uk/listing/the-list/list-entry/1169433
Brief History	C18
Brief Description	Shop. Two storeys. Rendered. Black glazed pantile roofs with attic floors denoted by dormers with timber casements. Central timber and glazed door, with flanking square bay windows with timber sash and casement windows. Timber fascia board above.

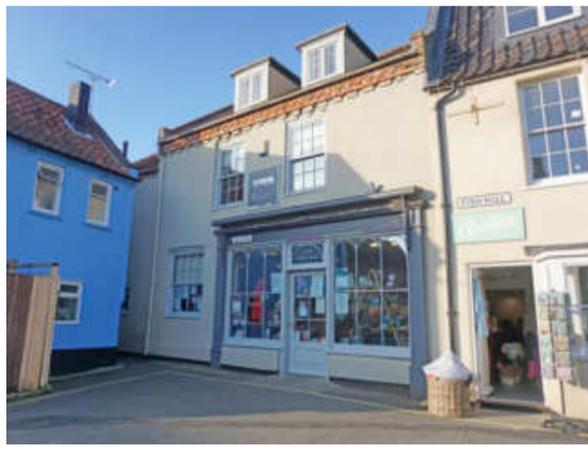
Address / Building Name	1 Fish Hill
Status	Grade II
List Entry Link	https://historicengland.org.uk/listing/the-list/list-entry/1049346
Brief History	C18 and later
Brief Description	Shop. Two storey with attic floor denoted by dormers. Rendered with brick cornice. Timber sash windows. Timber shop front with arched detail to mullions and central timber and glazed door.

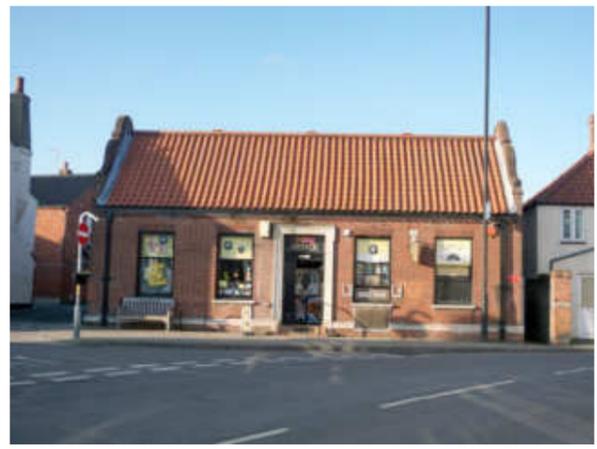
Address / Building Name	Former Post Office
Status	Locally Listed
List Entry Link	N/A
Brief History	Inter-War
Brief Description	Former post office, now shop. Single storey. Red brick, red clay pantile roof. Dutch gables to east and west ends. Central door with stone architrave. Modern timber door. Timber sash windows to left, timber windows with adaptations to right. Stickers/signage in windows is unsympathetic.

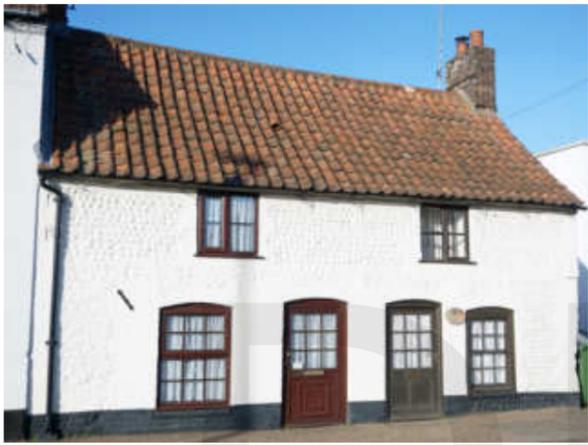
Address / Building Name	13 Cromer Road
Status	Grade II
List Entry Link	https://historicengland.org.uk/listing/the-list/list-entry/1306563
Brief History	Late C18
Brief Description	Two cottages. Two storeys. Painted flint, red clay pantile roof with brick chimney. No. 13A (left) has uPVC windows and door. No. 13B (right) has timber and glazed door, timber sash window on ground floor, timber casement window first floor.

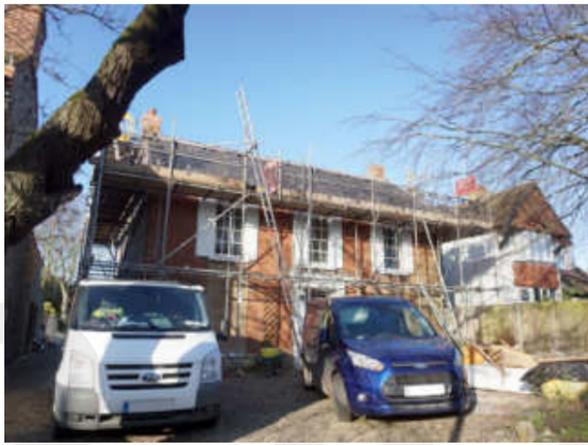
Address / Building Name	29 Cromer Road
Status	Grade II
List Entry Link	https://historicengland.org.uk/listing/the-list/list-entry/1049344
Brief History	Early C19
Brief Description	House. Two storey. Red brick black glazed pantile roof, brick chimneys, timber sash windows with timber shutters on first floor. Panelled timber door with fanlight and architrave.

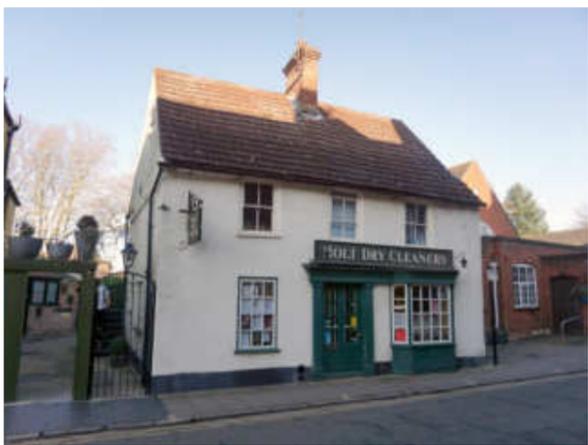
Address / Building Name	3 Church Street
Status	Grade II
List Entry Link	https://historicengland.org.uk/listing/the-list/list-entry/1373751
Brief History	C18
Brief Description	Shop. Two storeys. Pebbledash render, concrete (?) tile roof. Timber sash windows on first floor, timber framed window on ground floor. Shop front consisting of timber bay window, timber and glazed door flanked by pilasters, both topped with cornice and timber fascia board.

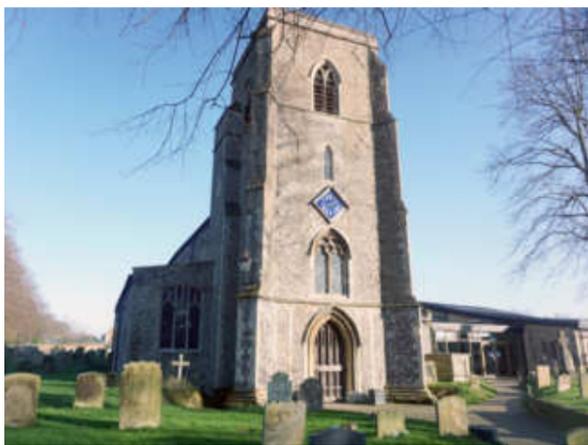
Address / Building Name	Parish Church of St Andrew
Status	Grade II*
List Entry Link	https://historicengland.org.uk/listing/the-list/list-entry/1306557
Brief History	C14 and much later. Restored 1864
Brief Description	Church. Typical layout with tower at west end. Flint with stone dressings. Gothic style including pointed arches to doors and windows. Tracery to windows. Panelled timber doors. Clock on west end. To south is C21 church hall with curved roof. Uses flint and stone in a modern design.

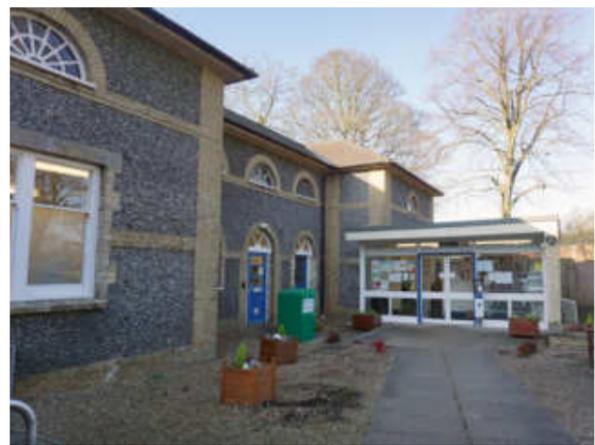
Address / Building Name	Holt Library
Status	Locally Listed
List Entry Link	N/A
Brief History	c.1800
Brief Description	Library, former stables. One and a half storeys. Flint with gault brick dressings, slate roof, timber sash windows to ground door, timber framed semi-circular windows on first floor. Modern timber and glazed doors, plus modern single storey extension unsympathetic.

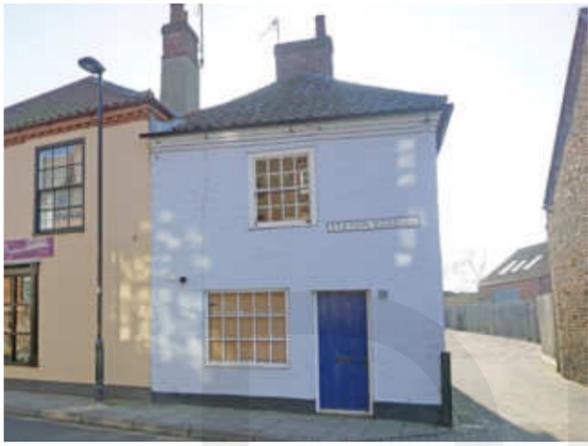
Address / Building Name	4 and 6 Station Road
Status	Grade II
List Entry Link	https://historicengland.org.uk/listing/the-list/list-entry/1373767
Brief History	Late C18
Brief Description	Cottage. Two storey. Painted brick, hipped black glazed pantile roof with brick chimney. Timber sash windows and timber door.

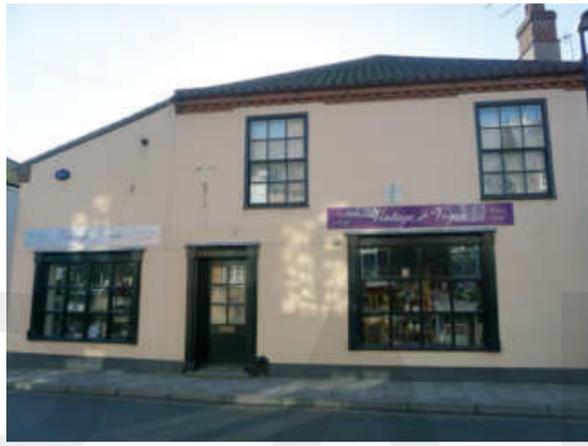
Address / Building Name	8 Station Road
Status	Grade II
List Entry Link	https://historicengland.org.uk/listing/the-list/list-entry/1169644
Brief History	C18
Brief Description	Shops. Two storey. Rendered with brick cornice. Hipped black glazed pantile roof. Timber sash windows to first floor and wider timber framed shop windows on ground floor. Timber and glazed door with architrave. Printed fascia boards unsympathetic.

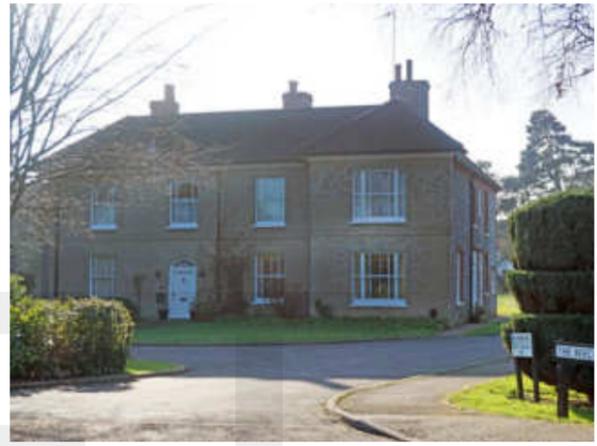
Address / Building Name	Shrublands
Status	Grade II
List Entry Link	https://historicengland.org.uk/listing/the-list/list-entry/1373768
Brief History	Early C19
Brief Description	House. Two storey. Gault brick, pantile roof, brick chimneys. Timber sash windows, timber panelled door with fanlight.

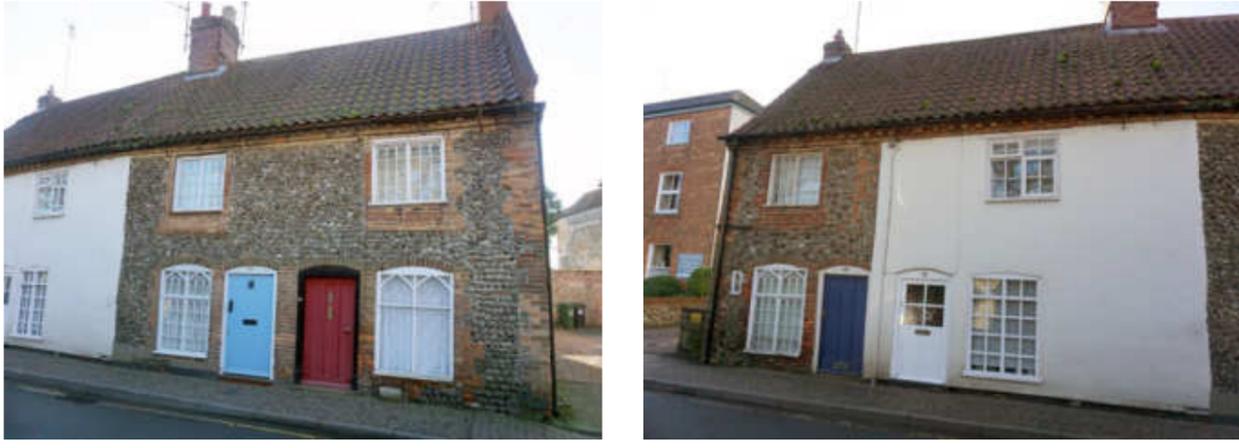
Address / Building Name	12 – 18 Station Road
Status	Grade II
List Entry Link	https://historicengland.org.uk/listing/the-list/list-entry/1049290
Brief History	C18
Brief Description	Row of four cottages. Two storeys. Nos. 12, 14, and 18: flint with brick dressings, timber panelled doors, interesting metal framed casement windows with pointed arch details, except ground floor No. 12 which is timber framed with pointed arch. No. 16 rendered, timber and glazed door, timber casement windows. All red clay pantiles and brick chimneys.

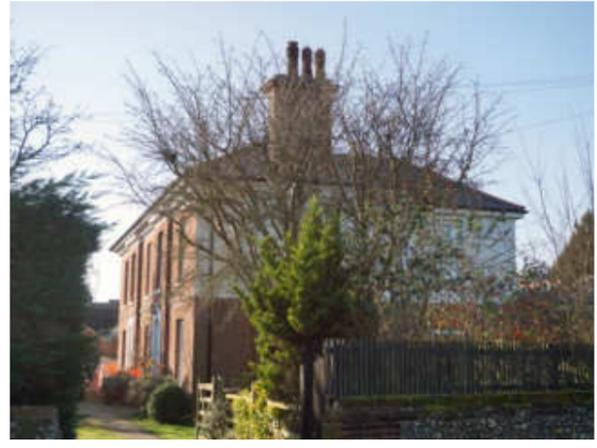
Address / Building Name	Former Police Station (No. 32a Station Road)
Status	Adopted Locally Listed
List Entry Link	N/A
Brief History	1855
Brief Description	House, former police station. Two storeys. Brick part rendered on north elevation, slate roof, brick chimney, timber sash windows. Doors not seen.
