Glaven Valley

Conservation Area Appraisal and Management Plan

Eighth Draft: May 2023

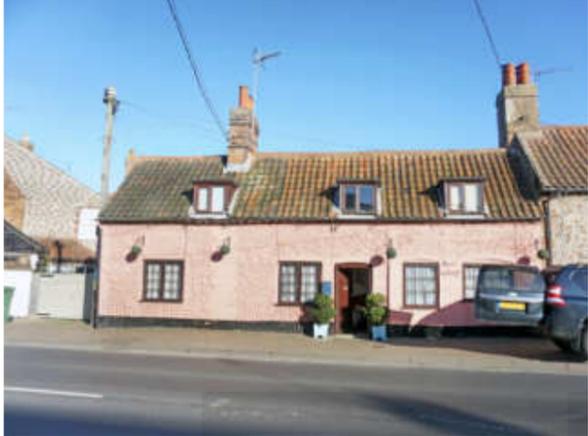
Address / Building Name	Barn Cottage
Status	Grade II
List Entry Link	https://historicengland.org.uk/listing/the-list/list-entry/1049283
Brief History	C18/ early C19
Brief Description	House. One storey with attics denoted by dormers. Painted flint and brick, red clay pantile roofs brick chimney. Timber casement windows timber door.

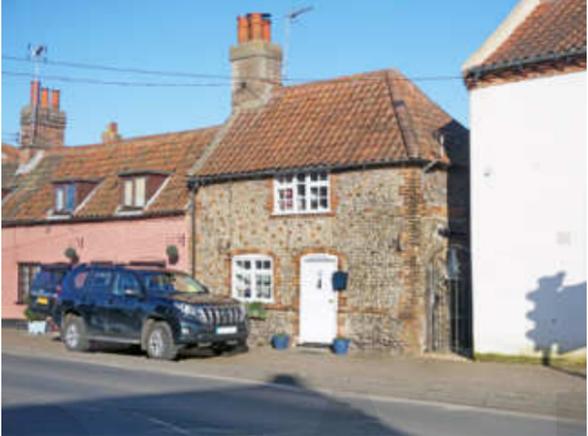
Address / Building Name	3 Norwich Road
Status	Grade II
List Entry Link	https://historicengland.org.uk/listing/the-list/list-entry/1373763
Brief History	C18/ early C19
Brief Description	House. Two storey. Flint and brick red clay pantile roof, rendered chimney, timber casement window, timber door.

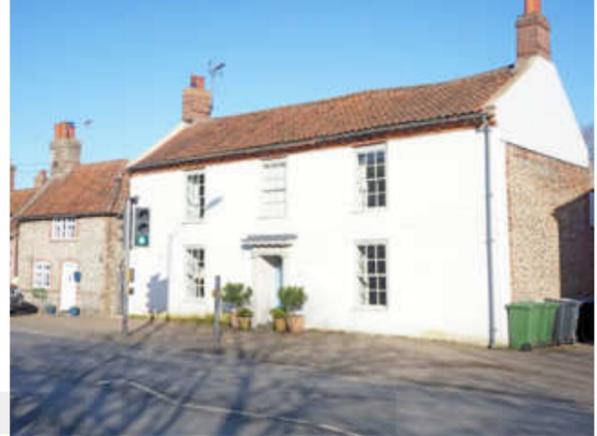
Address / Building Name	5 Norwich Road
Status	Grade II
List Entry Link	https://historicengland.org.uk/listing/the-list/list-entry/1049284
Brief History	C18 or early C19
Brief Description	House. Two storey. Rendered, with flint south wall. Red clay pantile roof with brick chimneys. Timber sash windows, timber panelled door with timber doorcase.

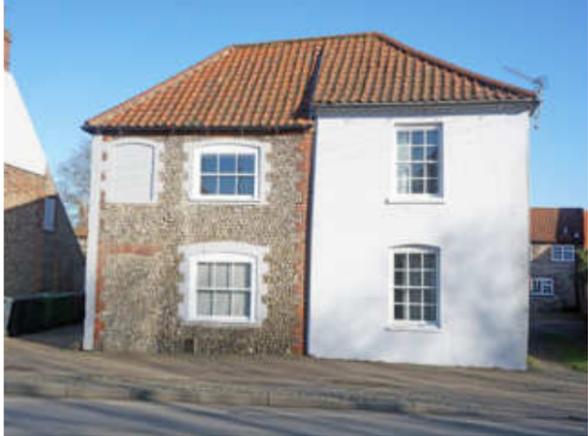
Address / Building Name	27 and 29 Norwich Road
Status	Grade II
List Entry Link	https://historicengland.org.uk/listing/the-list/list-entry/1373764
Brief History	C18/ early C19
Brief Description	Houses. Both two storey, hipped red clay pantile roof. No.27 flint and red brick dressings timber sash windows. No.29 refaced with brick (painted), timber sash windows.

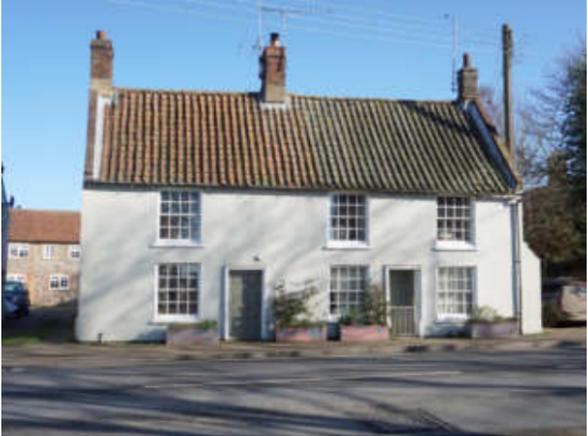
Address / Building Name	37 and 39 Norwich Road
Status	Grade II
List Entry Link	https://historicengland.org.uk/listing/the-list/list-entry/1049285
Brief History	Probably C18 – C18/19 additions to rear
Brief Description	Two houses. Two storeys. Rendered, red clay pantile roof, brick chimneys, timber sash windows, timber panelled doors in simple architraves.

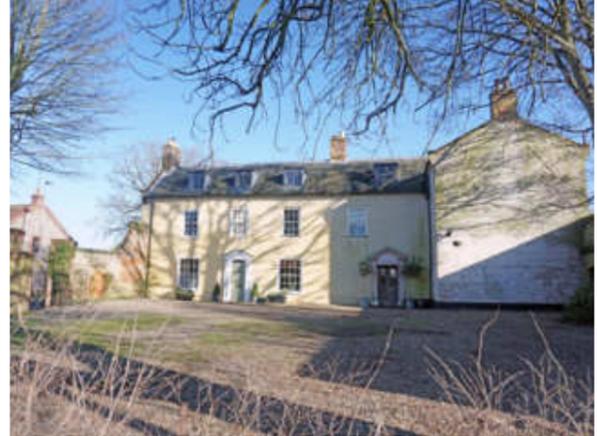
Address / Building Name	Bacon's House
Status	Grade II
List Entry Link	https://historicengland.org.uk/listing/the-list/list-entry/1049286
Brief History	Early C18, owned in 1703. C19 additions
Brief Description	Two houses. Two storeys with attic floor denoted by dormers. Rendered, slate roof, brick chimneys, timber sash windows, timber panelled door with fanlight and pedimented architrave to left, timber and glazed door with pedimented architrave to right.

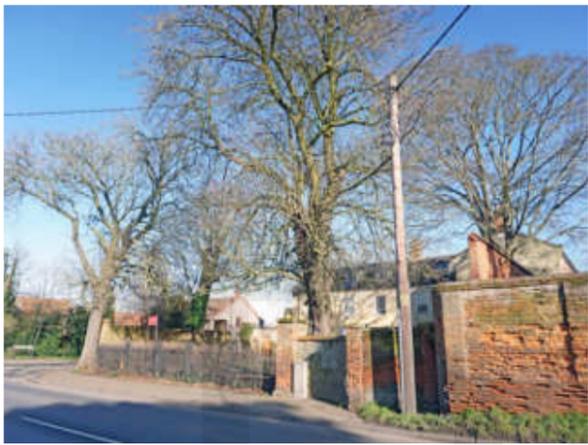
Address / Building Name	Garden Wall Fronting No. 41 Norwich Road
Status	Grade II
List Entry Link	https://historicengland.org.uk/listing/the-list/list-entry/1373765
Brief History	Probably C19
Brief Description	Red brick and flint wall, with iron railings to west, with wrought iron piers. Wall continues south to roundabout.

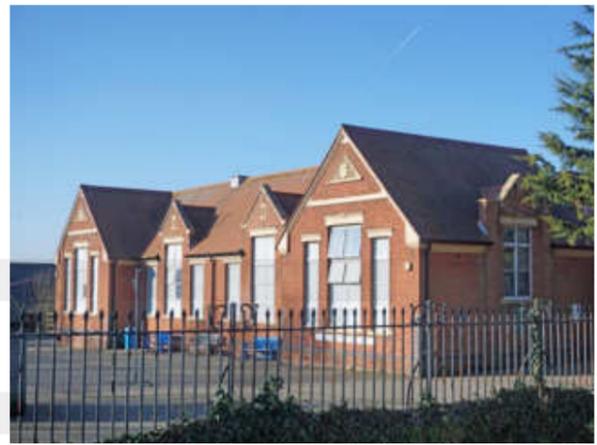
Address / Building Name	Holt Community Primary School
Status	Locally Listed
List Entry Link	N/A
Brief History	1928
Brief Description	School. Single storey. Red brick with buff terracotta dressings. Four gables to south end with tall windows, probably uPVC frames (unsympathetic). Porch with timber panelled double door on east side with buff terracotta doorcase. Timber casement windows on east side. Tile roof. Red and black brick piers, with low wall topped by railings to boundary.

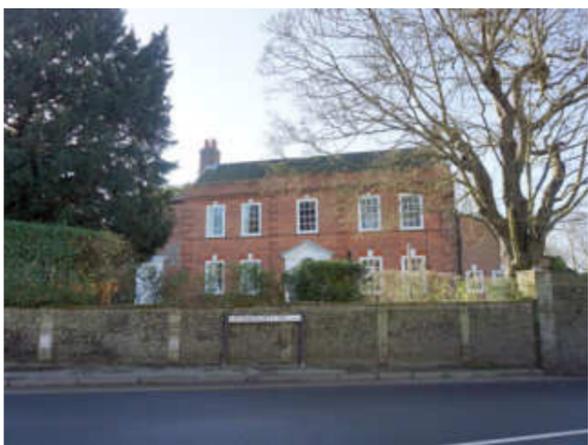
Address / Building Name	Hill House
Status	Grade II
List Entry Link	https://historicengland.org.uk/listing/the-list/list-entry/1049315
Brief History	C18
Brief Description	House. Two storeys. Red brick with brick quoins and strong courses. Black glazed pantile roof, brick chimneys. Timber sash windows. Timber panelled door with fanlight in architrave.

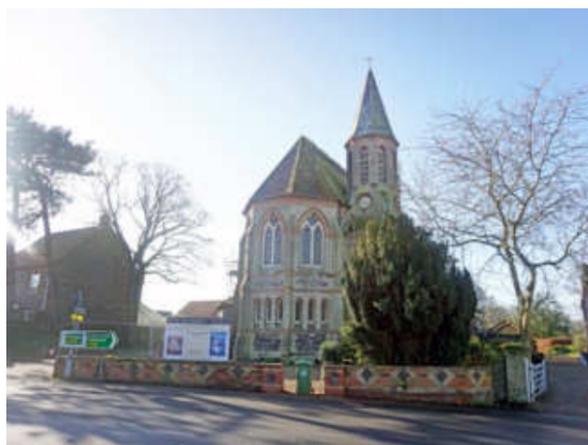
Address / Building Name	Methodist Church
Status	Grade II
List Entry Link	https://historicengland.org.uk/listing/the-list/list-entry/1373766
Brief History	1862
Brief Description	Church. Two storey with turret to north-east corner. Polychrome brickwork, slate roof to nave, fishscale tiles to turret. Gothic windows with stone mullions and leaded glass. Polychrome brick boundary wall.

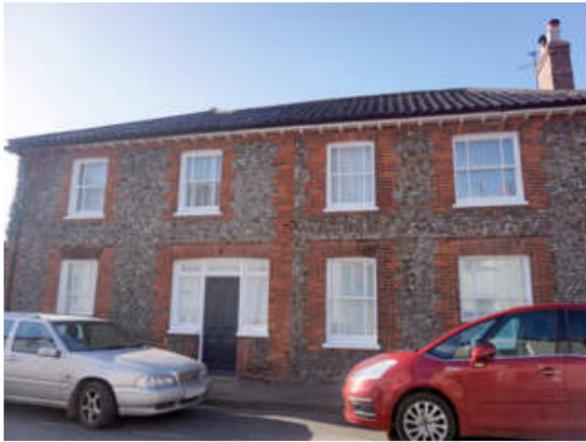
Address / Building Name	11 New Street
Status	Grade II
List Entry Link	https://historicengland.org.uk/listing/the-list/list-entry/1169595
Brief History	Early C19 with later additions
Brief Description	House. Two storey. Flint with red brick dressings, pantile roof, brick chimney, timber sash windows, timber panelled door with timber framed side and fanlights.

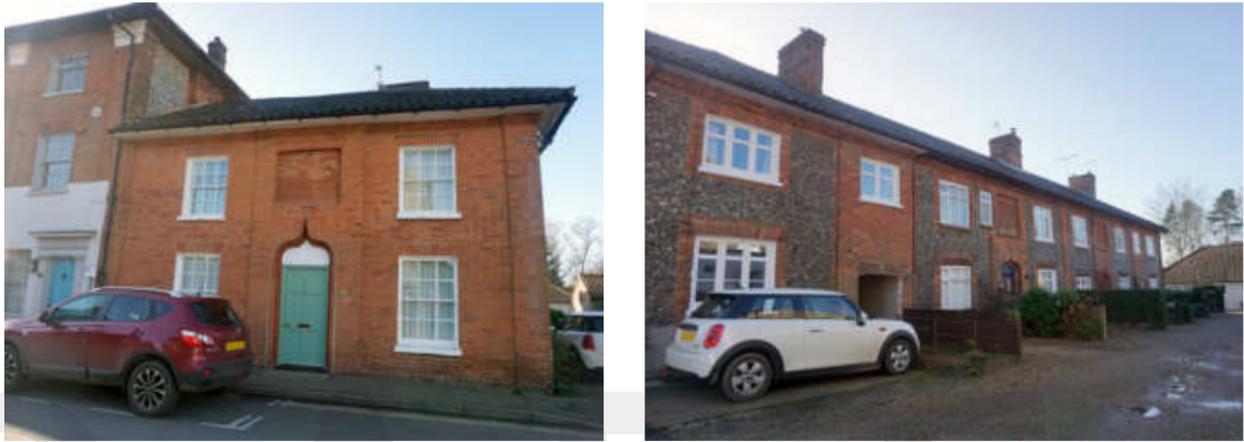
Address / Building Name	17-27 New Street
Status	Grade II
List Entry Link	https://historicengland.org.uk/listing/the-list/list-entry/1373743
Brief History	Early C19
Brief Description	Row of cottages. No.17 facing on to New Street, the rest facing north onto a yard. Two storey. Red brick and flint with pantile roof and brick chimneys. Timber sash windows and timber panelled door to No.17. Timber casement windows and timber and glazed doors to the rest. All doors have ogee shaped doorcase.

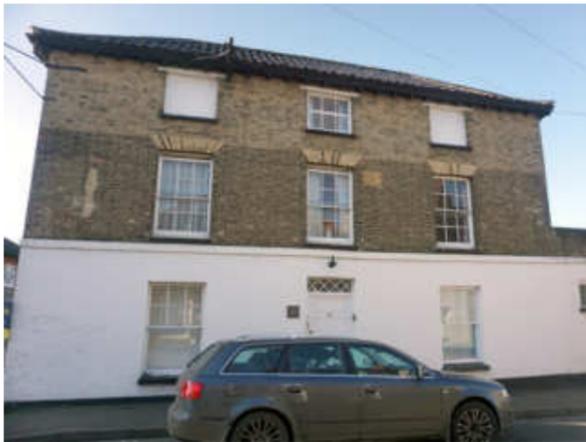
Address / Building Name	33 New Street
Status	Grade II
List Entry Link	https://historicengland.org.uk/listing/the-list/list-entry/1049282
Brief History	Early C19
Brief Description	House. Three storeys. Gault brick with ground floor painted. Black glazed pantile roof. Timber sash windows, except for two blind windows on second floor, timber panelled door with fanlight.

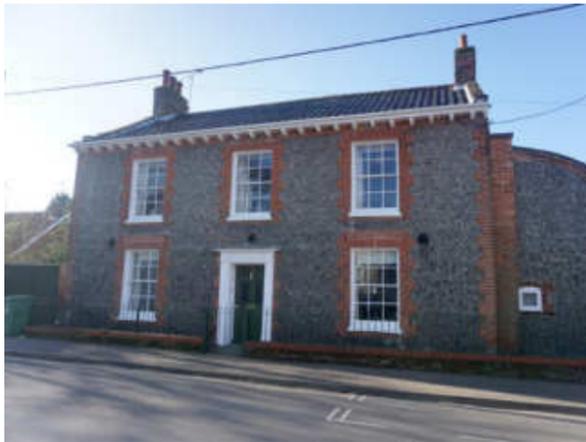
Address / Building Name	35 New Street
Status	Grade II
List Entry Link	https://historicengland.org.uk/listing/the-list/list-entry/1373762
Brief History	Early C19
Brief Description	House. Two storeys. Flint with red brick dressings, black glazed pantile roof, brick chimneys, bracketed cornice, timber sash windows, timber and glazed panelled door with architrave.

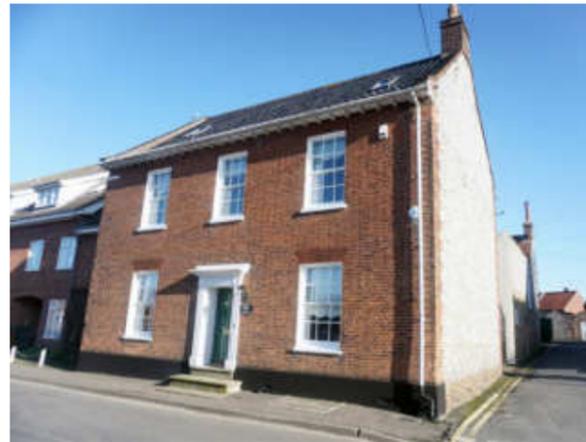
Address / Building Name	28 New Street
Status	Grade II
List Entry Link	https://historicengland.org.uk/listing/the-list/list-entry/1049325
Brief History	Early C19
Brief Description	House. Two storeys. Red brick, black glazed pantile roof, brick chimney, bracketed cornice, timber sash windows, timber panelled door with architrave.

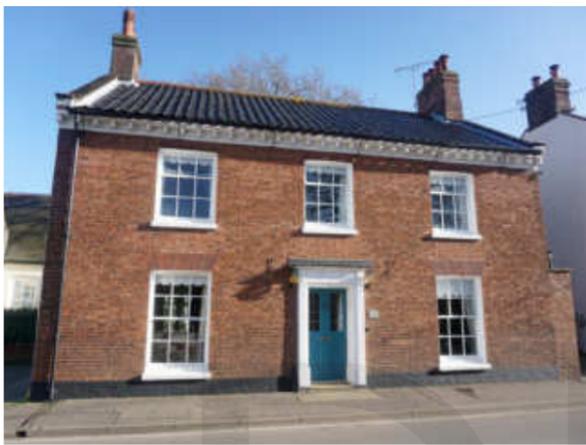
Address / Building Name	Pear Tree Cottage
Status	Grade II
List Entry Link	https://historicengland.org.uk/listing/the-list/list-entry/1169593
Brief History	Early C19
Brief Description	House. Two storeys. Red brick, black glazed pantile roof, brick chimneys, bracketed cornice, timber sash windows, timber and glazed panelled door with architrave.

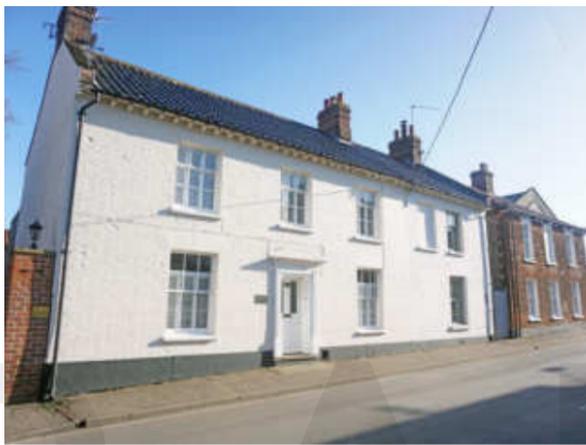
Address / Building Name	Cranmer House
Status	Grade II
List Entry Link	https://historicengland.org.uk/listing/the-list/list-entry/1049324
Brief History	Early C19
Brief Description	House. Two storeys. Painted brick, black glazed pantile roof, brick chimneys, bracketed cornice, timber sash windows, one blind window on first floor, timber and glazed panelled door with architrave.

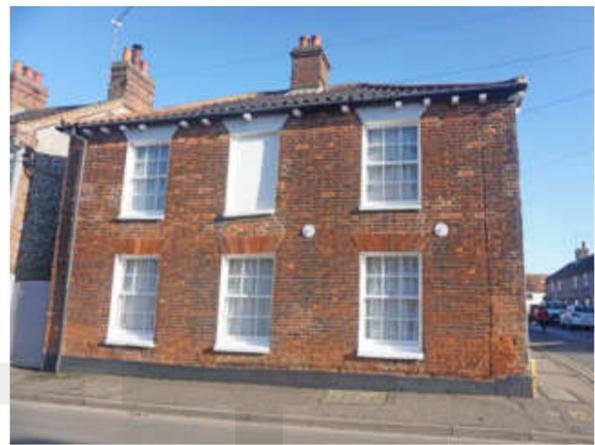
Address / Building Name	4 Cross Street
Status	Grade II
List Entry Link	https://historicengland.org.uk/listing/the-list/list-entry/1373713
Brief History	Early C19
Brief Description	House. Two storeys. Red brick to west and rendered south end, black glazed pantile roof, brick chimneys, bracketed eaves, timber sash windows, one blind window on first floor, timber panelled door on south end.

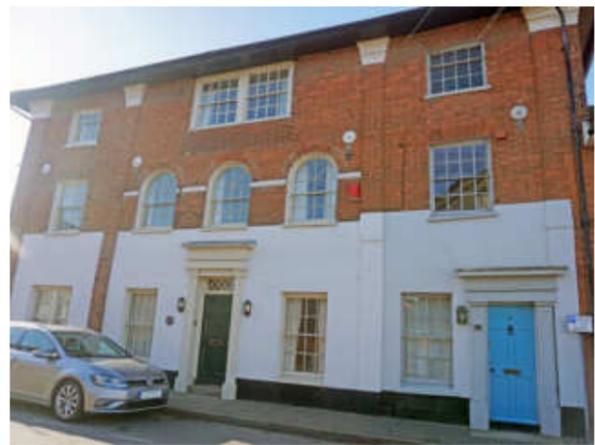
Address / Building Name	Gallery House, Nos. 13-15 New Street
Status	Locally Listed
List Entry Link	N/A
Brief History	Early C19
Brief Description	Two houses. Three storey. Red brick with ground floor rendered. Some flint to side walls. Four brick pilasters. Timber sash windows, three in centre bay on first floor arched, pair of sash windows in centre bay on second floor. Two timber panelled doors in architraves, that to centre has fanlight. Pantile roof, brick chimneys.

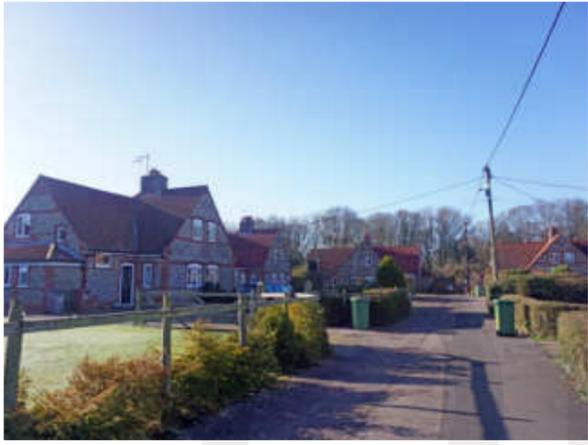
Address / Building Name	The Fairstead: Nos. 1-12 The Fairstead and Nos 1-7 (odd) Cley Road
Status	Locally Listed
List Entry Link	N/A
Brief History	Inter-War
Brief Description	Twelve houses. Semi-detached arrangement around a cul-de-sac. Two storeys, with upper floor in roof level. Flint with red brick dressings, including diamond patterns. Brick chimneys, red clay pantile roofs. Mix of windows, some timber casements some uPVC. Mix of doors, some timber and glazed, some uPVC. Each set in garden to front, side and rear.

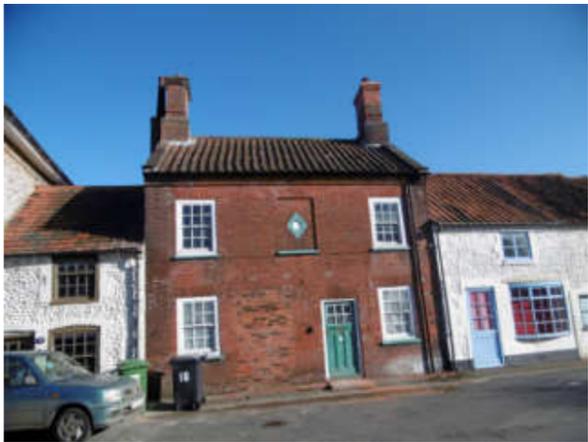
Address / Building Name	14 Albert Street
Status	Grade II
List Entry Link	https://historicengland.org.uk/listing/the-list/list-entry/1373747
Brief History	Mid C19
Brief Description	House, formerly two houses. Two storey. Brick, red clay pantile roof, brick chimneys. Timber sash windows, timber and glazed door. Central window on first floor is blind with diamond pattern detail. To the left of the door is a scar in brickwork showing where there was formerly a door to the second cottage which has since been bricked in.

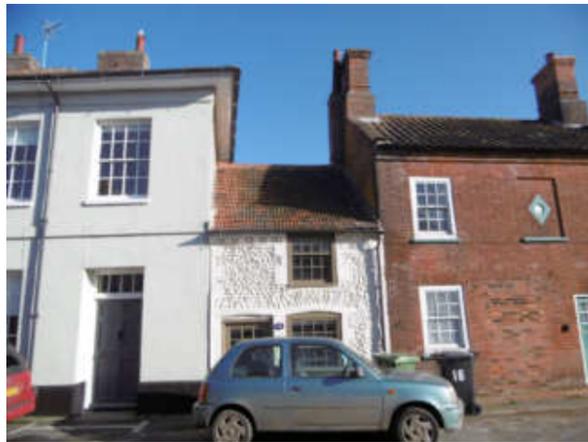
Address / Building Name	16 Albert Street
Status	Grade II
List Entry Link	https://historicengland.org.uk/listing/the-list/list-entry/1049331
Brief History	Early C19
Brief Description	Small cottage. Two storeys but on a very small scale. Painted flint and brick dressings, red clay pantile roof. Timber sash windows, timber and glazed door.

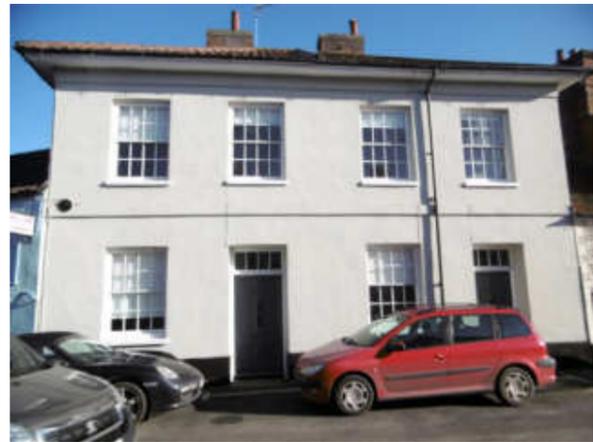
Address / Building Name	18 and 20 Albert Street
Status	Grade II
List Entry Link	https://historicengland.org.uk/listing/the-list/list-entry/1049332
Brief History	Early C19
Brief Description	Two houses. Two storey. Rendered, hipped red clay pantile roof, brick chimneys. Timber sash windows, timber panelled doors with fanlights.

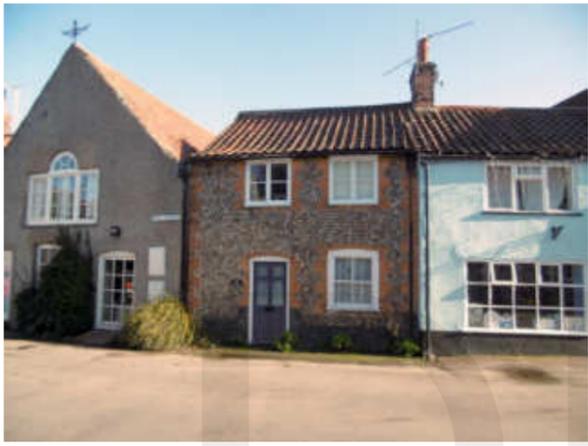
Address / Building Name	The Nook
Status	Grade II
List Entry Link	https://historicengland.org.uk/listing/the-list/list-entry/1373748
Brief History	Mid C19
Brief Description	House. Two storeys. Flint with brick dressings, red clay pantile roof, timber casement windows, timber and glazed front door.

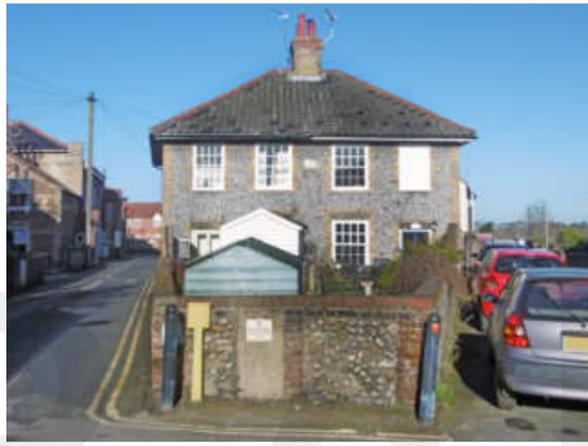
Address / Building Name	28 and 30 Albert Street
Status	Grade II
List Entry Link	https://historicengland.org.uk/listing/the-list/list-entry/1373749
Brief History	Mid C19
Brief Description	Two houses. Two storey. Flint with red brick dressings, red clay pantile roof, brick chimneys, timber sash windows, timber and glazed doors. No. 30 has flint and brick boundary wall. No. 28's front garden has been replaced with parking bay.

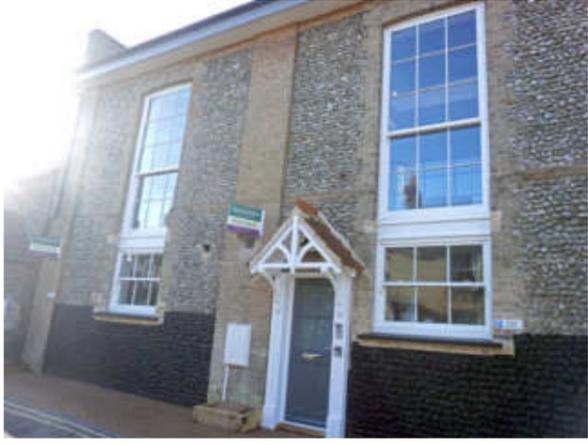
Address / Building Name	Oddfellows Hall
Status	Grade II
List Entry Link	https://historicengland.org.uk/listing/the-list/list-entry/1049336
Brief History	Mid C19
Brief Description	Former chapel, now house. Tall single storey, though now divided internally with a floor level. Flint with gault brick dressings, black glazed pantile roof, modern timber sash windows, modern timber and glazed door with porch over.

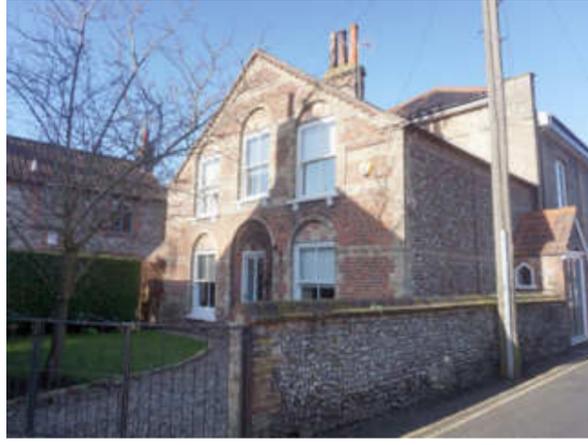
Address / Building Name	33 Albert Street
Status	Grade II
List Entry Link	https://historicengland.org.uk/listing/the-list/list-entry/1306786
Brief History	Mid C19
Brief Description	Former chapel, now house. Two storeys. Red with gault brick patterns to main façade, flint with brick dressings to sides. Pantile(?) roof, brick chimney, timber sash windows set in slightly recessed arches, timber and glazed door.

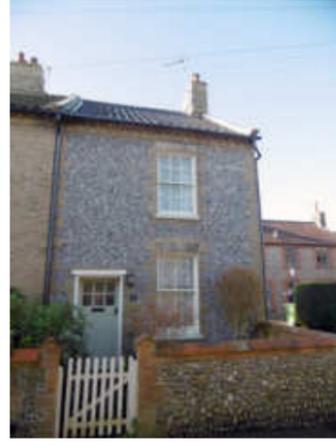
Address / Building Name	29 Albert Street
Status	Grade II
List Entry Link	https://historicengland.org.uk/listing/the-list/list-entry/1049335
Brief History	Early C19
Brief Description	House, part of a terrace of four. Two storey. Flint with gault brick dressings, black glazed pantile roof, gault brick chimney, timber sash windows, timber and glazed door, flint and brick boundary wall to front garden.

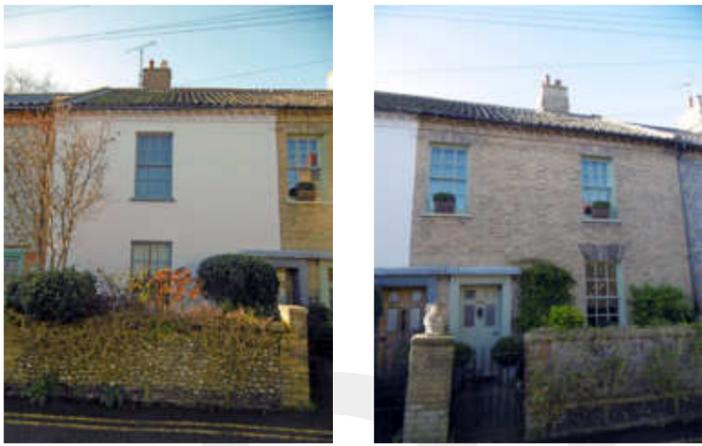
Address / Building Name	25 and 27 Albert Street
Status	Grade II
List Entry Link	https://historicengland.org.uk/listing/the-list/list-entry/1168885
Brief History	Late C18
Brief Description	Two houses. Both two storey, gault brick (though brickwork to No.25 is painted), black glazed pantile roof, brick chimneys, timber and glazed doors, No.27 has brick, flint and concrete block front boundary wall, while the one to No.25 is brick and flint.

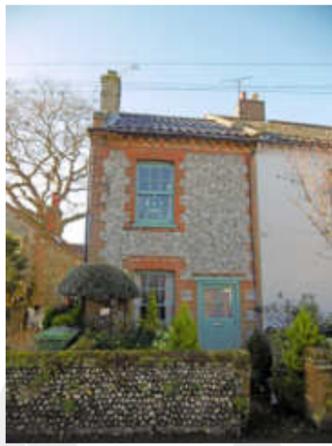
Address / Building Name	23 Albert Street
Status	Grade II
List Entry Link	https://historicengland.org.uk/listing/the-list/list-entry/1373750
Brief History	Early C19
Brief Description	House, part of a terrace of four. Two storey. Flint with red brick dressings, black glazed pantile roof, gault brick chimney, timber sash windows, timber and glazed door, flint and brick boundary wall to front garden.

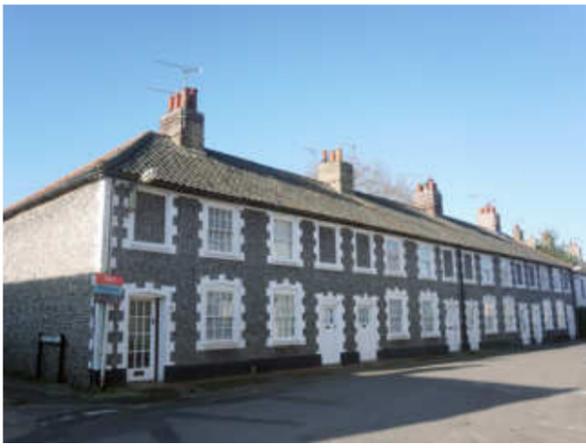
Address / Building Name	5-19 Albert Street
Status	Grade II
List Entry Link	https://historicengland.org.uk/listing/the-list/list-entry/1168881
Brief History	Early to mid C19
Brief Description	Terrace of eight houses. Two storey. Flint with white painted brick dressings, hipped black glazed pantile roof and gault brick chimneys. Timber sash windows with blind windows above front doors on first floor. Most front doors are timber with glazed upper section, though the southernmost door is mainly glazed.

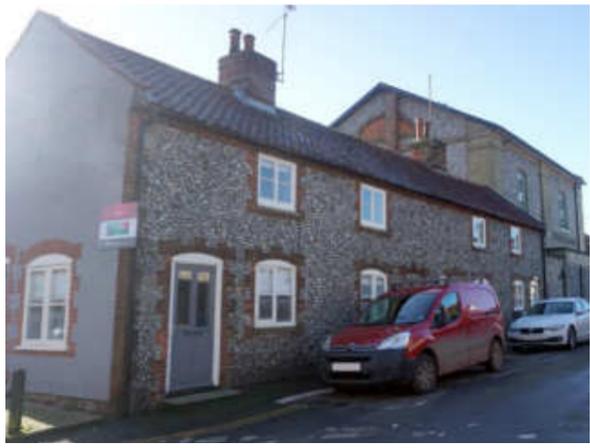
Address / Building Name	1 and 3 Cross Street
Status	Grade II
List Entry Link	https://historicengland.org.uk/listing/the-list/list-entry/1169430
Brief History	Early to mid C19
Brief Description	Two houses, originally four. Two storeys. Flint with red brick dressings, red clay pantile roof, brick chimneys, timber casement windows, timber and glazed doors, with two central doors blocking in with flint walls. East gable is rendered and is the entrance for an office, with timber casement window and timber and glazed door. Ceramic plaque made by local school children on this wall.

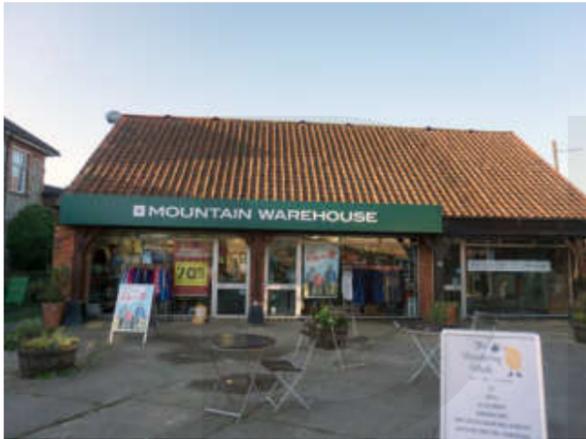
Address / Building Name	12 Albert Street
Status	Grade II
List Entry Link	https://historicengland.org.uk/listing/the-list/list-entry/1049330
Brief History	C18
Brief Description	Former barn, now shop. Single storey. Brick but much of the main (south) façade has had large modern glazing added for shop fronts. Timber posts added to the main facade are probably modern and large printed fascia is not in-keeping. Red clay pantile roof.

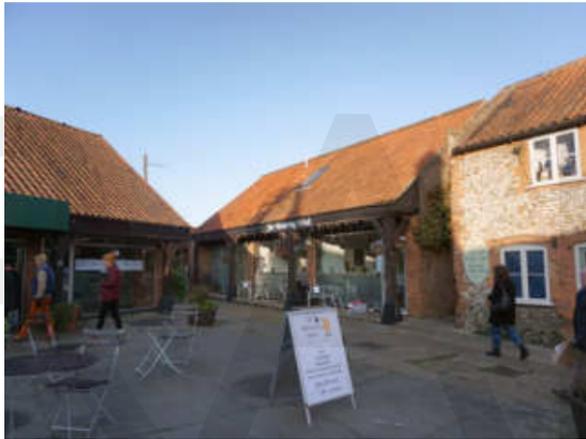
Address / Building Name	8 Albert Street
Status	Grade II
List Entry Link	https://historicengland.org.uk/listing/the-list/list-entry/1373746
Brief History	Mid C19
Brief Description	Former barn, now shop. Single storey. Brick but much of the main (south) façade has had large modern glazing added for shop fronts. Timber posts added to the main facade are probably modern. Red clay pantile roof with a modern rooflight.

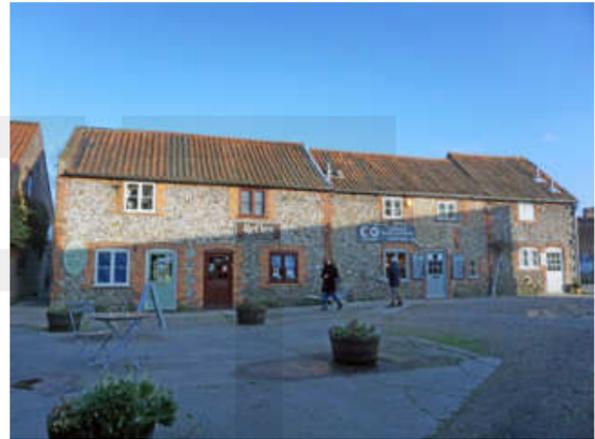
Address / Building Name	3,4, 5 and 6 Chapel Yard
Status	Grade II
List Entry Link	https://historicengland.org.uk/listing/the-list/list-entry/1168908
Brief History	C16 and later
Brief Description	Four shops, formerly houses. C16 structural timberwork inside, exterior is likely C19. Two storey, flint with red brick dressings, red clay pantile roofs, timber casement windows, timber and glazed doors. Printed signage boards are of reasonable quality. Ventilation pipes on roof are unsympathetic. Rear elevation to car park has less features, only a few small casement windows and some sign boards.

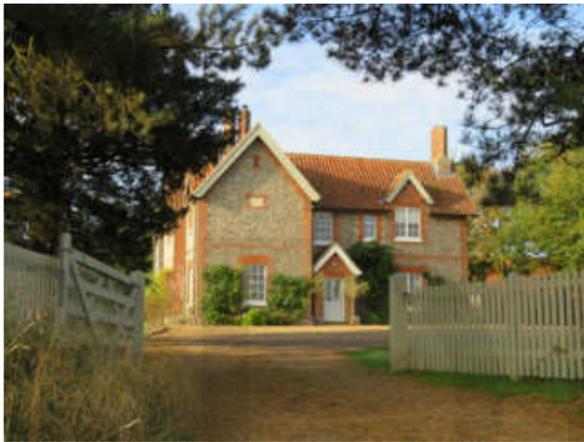
Address / Building Name	Beck Farm Cottage and barn
Parish	Hunworth
Status	Proposed Local Listing
List Entry Link	N/A
Brief History	Pre-1886
Brief Description	Two storey flint and red brick house with steeply pitched red clay pantile roof. Large barn to the west of red brick with red clay pantile roof. c17/c18. Visible

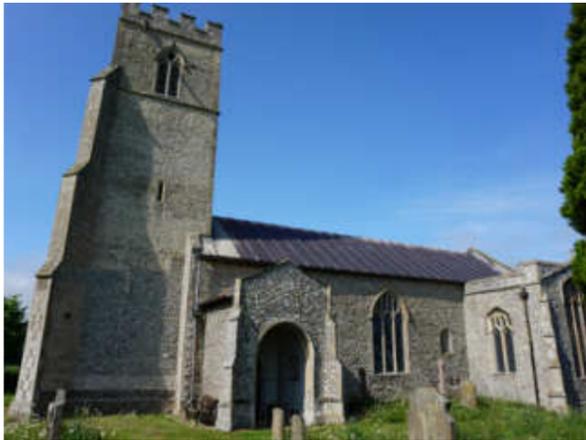
Address / Building Name	Church of St. Lawrence
Street-by-Street Area	Stody Road/King Street Junction
Status	Grade II*
List Entry Link	https://historicengland.org.uk/listing/the-list/list-entry/1049189
Brief History	C11-C15
Brief Description	Parish church. Flint with stone dressings. Lead roof. Square tower with crenellations. Traceried windows.

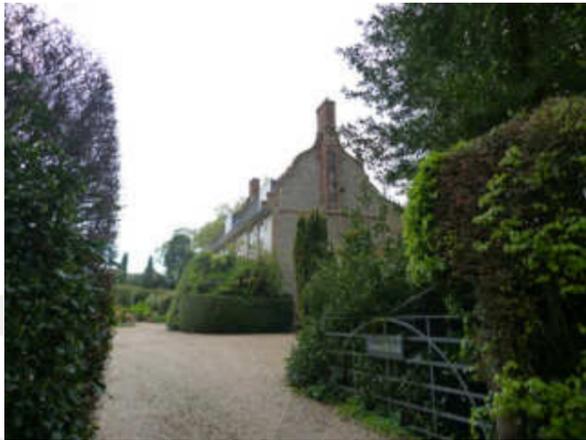
Address / Building Name	Hunworth Hall
Street-by-Street Area	Stody Road/King Street Junction
Status	Grade II
List Entry Link	https://historicengland.org.uk/listing/the-list/list-entry/1152900
Brief History	c.1700. Centre and left to rear infilled c1930.
Brief Description	House. Two storeys with attic and cellar. Brick, front rendered, black unglazed pantiles. Dutch gables to ends of main range. Timber sash windows and casements.

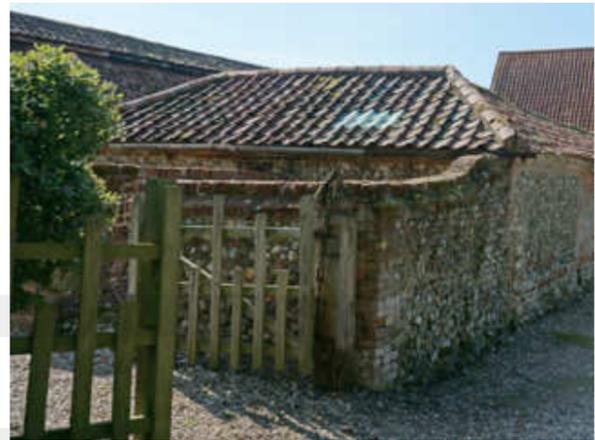
Address / Building Name	Pig Sties c50m north of Hunworth Hall
Street-by-Street Area	Stody Road/King Street Junction
Status	Grade II
List Entry Link	https://historicengland.org.uk/listing/the-list/list-entry/1152911
Brief History	Early C19.
Brief Description	Pair of pigsties. Flint with brick dressings. Hipped pantile roof. Enclosed yards to front.

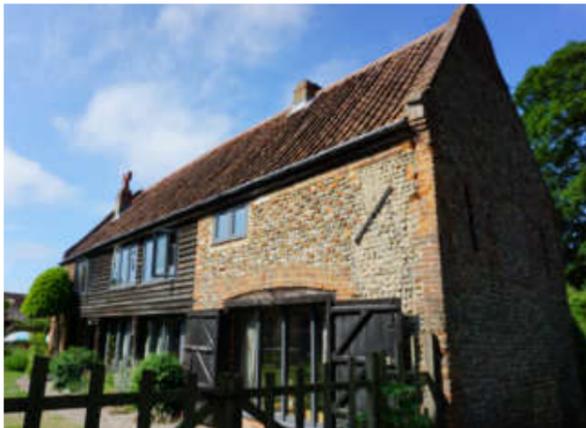
Address / Building Name	The Plant House and attached cow shed c20m north of Hunworth Hall
Street-by-Street Area	Stody Road/King Street Junction
Status	Grade II
List Entry Link	https://historicengland.org.uk/listing/the-list/list-entry/1304541
Brief History	Dated 1700.
Brief Description	Agricultural building converted to house. Two storeys. Flint and brick with pantile roof. South-east gable of flint with decorative brickwork of hearts and lozenges. Date 1700 and initials BER for Edmund and Rebecca Britiffe.

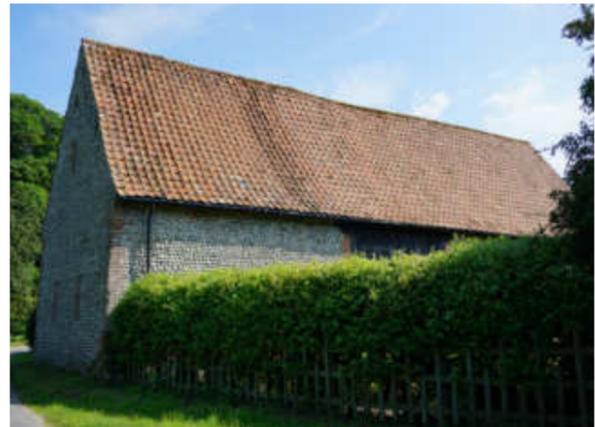
Address / Building Name	Barn c70 north of Hunworth Hall
Street-by-Street Area	Stody Road/King Street Junction
Status	Grade II
List Entry Link	https://historicengland.org.uk/listing/the-list/list-entry/1049190
Brief History	C1700.
Brief Description	Barn. Flint with brick dressings, pantile roof. Ventilation slits. North-east gable with initials EB for Edmund Britiffe.

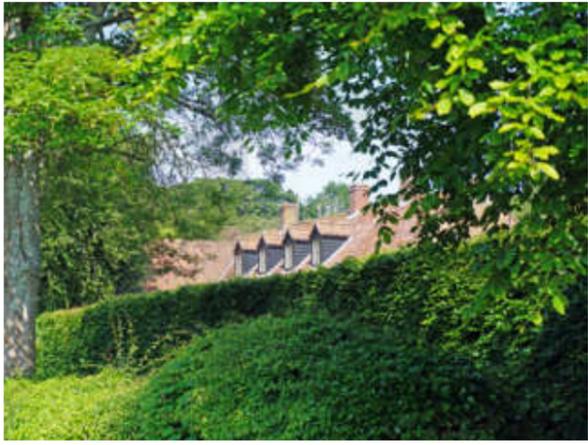
Address / Building Name	Hunworth Mill
Street-by-Street Area	Stody Road/King Street Junction
Status	Grade II*
List Entry Link	https://historicengland.org.uk/listing/the-list/list-entry/1049191
Brief History	Watermill, mid C18. Millhouse, late C18/early C19.
Brief Description	Two storey mill to the north-east, set over River Glaven, with two sluice arches and a large weatherboarded gabled loft projecting forward to north. A rare type of installation for the mill equipment which has the drive to the stones from above. The mill house is five bays and two storeys with attic. Brick with pantiles. All windows renewed late-C20.

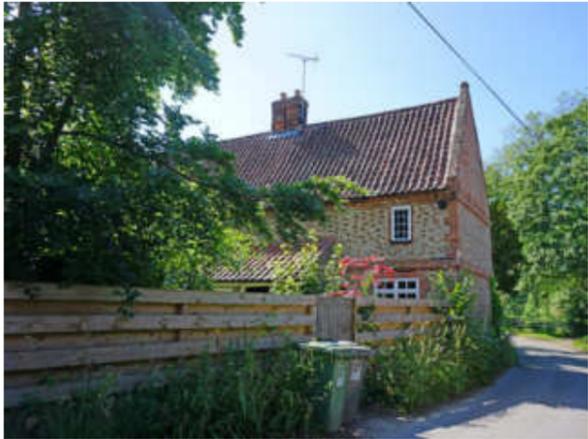
Address / Building Name	The Firs
Street-by-Street Area	North end of the Green Area
Status	Grade II
List Entry Link	https://historicengland.org.uk/listing/the-list/list-entry/1049192
Brief History	C17/C18. C19 porch.
Brief Description	House. Two storeys. Flint with brick dressings and pantile roof. C19 gabled porch to north elevation.

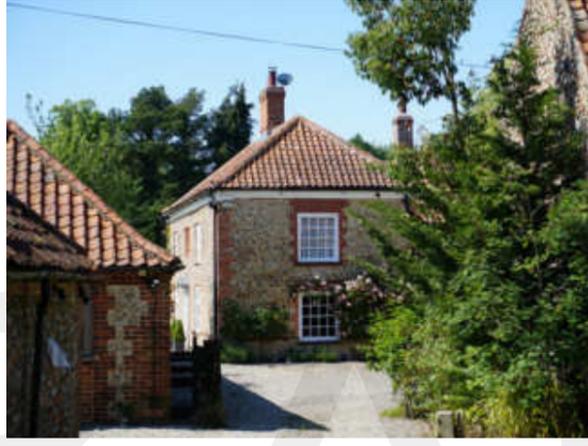
Address / Building Name	Green House Farm
Street-by-Street Area	North end of the Green Area
Status	Grade II
List Entry Link	https://historicengland.org.uk/listing/the-list/list-entry/1152936
Brief History	Early C17 with later additions and alterations. Late C18 rear wing. C19 and C20 additions to the rear.
Brief Description	House. Two storeys. Flint with brick dressings. Pantile roof. L-plan. Timber sash and casement windows.

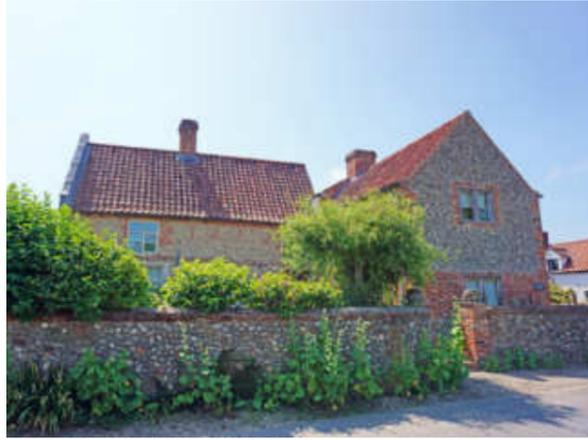
Address / Building Name	Dickers
Street-by-Street Area	North end of the Green Area
Status	Grade II
List Entry Link	https://historicengland.org.uk/listing/the-list/list-entry/1373796
Brief History	Date 1682. C19 and C20 additions.
Brief Description	House. Two storeys. Flint and red brick with pantile roof.

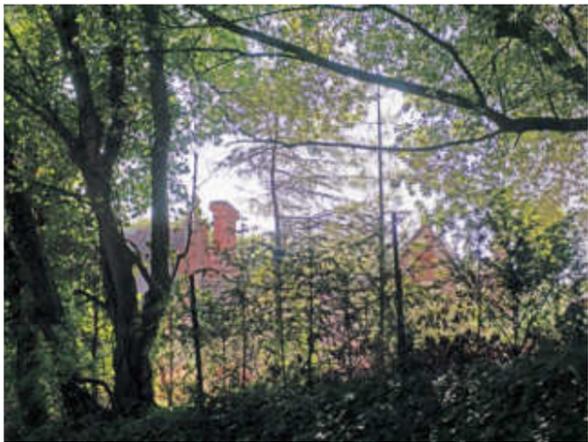
Address / Building Name	The Old Rectory and attached walls and stable block
Street-by-Street Area	Hunworth Common
Status	Grade II
List Entry Link	https://historicengland.org.uk/listing/the-list/list-entry/1253197
Brief History	Dated 1849 on the entrance porch.
Brief Description	Two and three storeys. Brick in Flemish bond with tile roofs. Leaded casements. Tudor Revival Style. Adjacent service wing in more modest style to the north. Stable block to north.

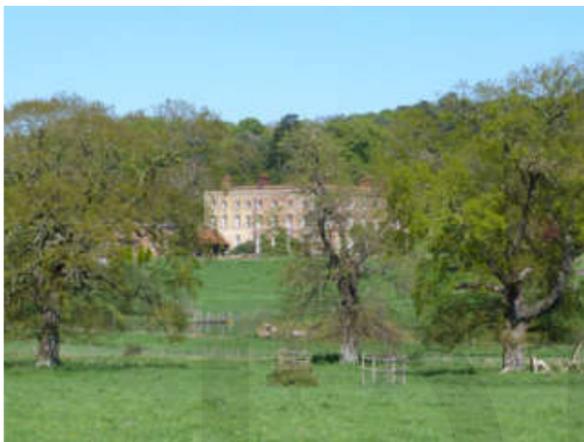
Address / Building Name	Bayfield Hall
Parish	Letheringsett with Glandford
Status	Grade II
List Entry Link	https://historicengland.org.uk/listing/the-list/listentry/1152147
Brief History	Mid-c18 enlargement of sixteenth century house.
Brief Description	Brick with stone rusticated quoins and stone architraves surrounding windows. 3 storeys with 5 wide symmetrical bays.

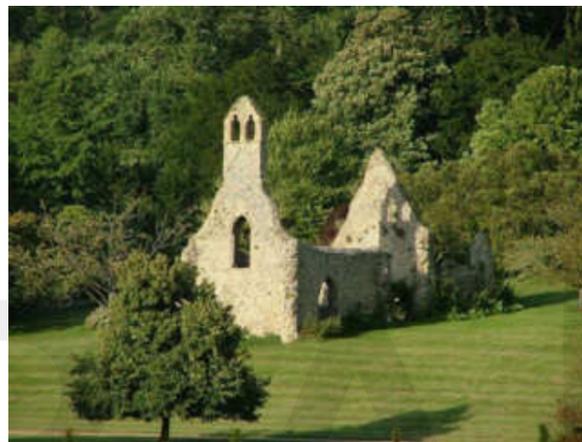
Address / Building Name	Ruins of St Margaret's
Parish	Letheringsett with Glandford
Status	Grade II
List Entry Link	https://historicengland.org.uk/listing/the-list/listentry/1049829
Brief History	Medieval
Brief Description	Ruined medieval parish church. Flint with stone dressings with some glacial erratic stones. Double bell cote with two stone dressed openings.

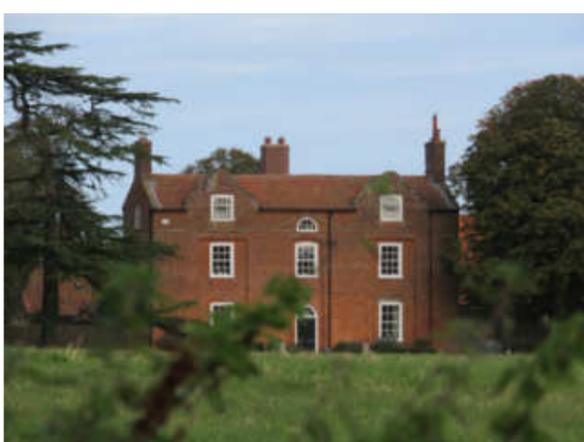
Address / Building Name	Bayfield Brecks
Parish	Letheringsett with Glandford
Status	Grade II
List Entry Link	https://historicengland.org.uk/listing/the-list/list-entry/1152157
Brief History	1799
Brief Description	Two storey red brick house with shaped gables Central 4 panelled door with semi-circular fanlight.

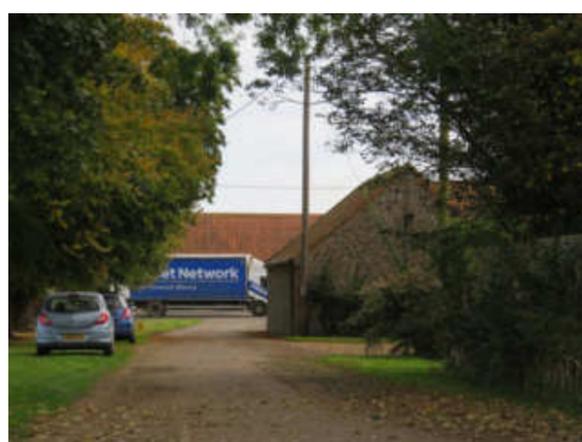
Address / Building Name	Barns and attached stables and stocksheds at Bayfield Brecks
Parish	Letheringsett with Glandford
Status	Grade II
List Entry Link	https://historicengland.org.uk/listing/the-list/list-entry/1049830
Brief History	1799 and c19
Brief Description	Two attached barns, 3 attached ranges of stables and stock sheds, 1799 and laid C19

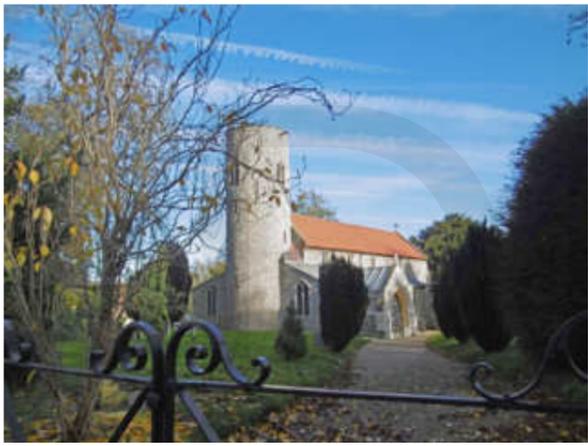
Address / Building Name	Church of St. Andrew
Street-by-Street Area	Church Lane
Status	Grade II*
List Entry Link	https://historicengland.org.uk/listing/the-list/list-entry/1047927
Brief History	Church with 12th century nave and 13th century chancel. North aisle and chapel built 14th century, with 15th century tower. Knapped and cobble flint with stone dressings, lead sheet roof.
Brief Description	Flint church with round tower, dating to the 12th century with later additions. The round tower is Romanesque and features remains of the original double bell openings.

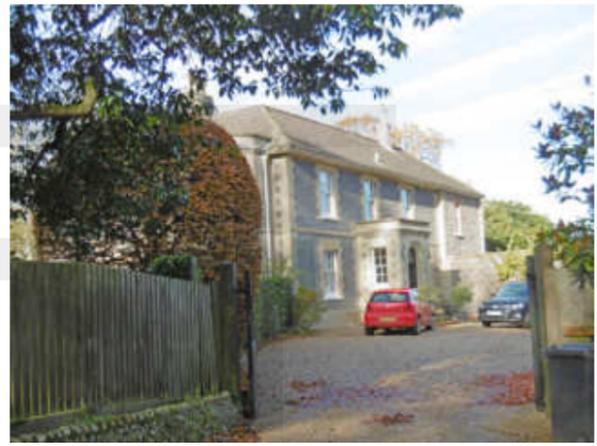
Address / Building Name	The Old Rectory
Street-by-Street Area	Church Lane
Status	Proposed Locally Listed
List Entry Link	N/A
Brief History	c1835
Brief Description	Impressive grey flint house with ashlar dressings and central porch. South elevation features double height canted bay window. Surrounded by high fence and mature gardens. Proposed for the Local List for its early 19h century date, impressive Georgian design, historic relationship with the church and prominence of position in the streetscape.

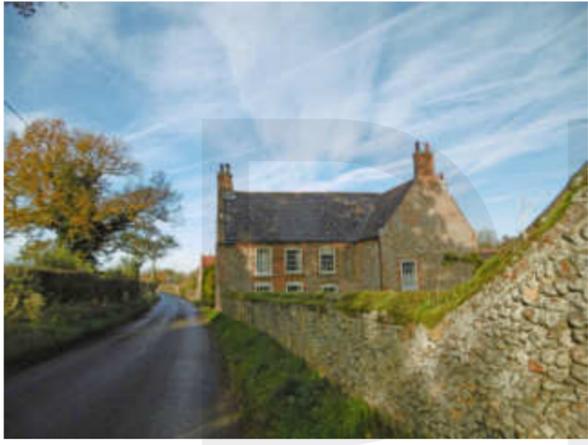
Address / Building Name	Meadow Farmhouse
Street-by-Street Area	Blakeney Road
Status	Grade II
List Entry Link	https://historicengland.org.uk/listing/the-list/list-entry/1304844
Brief History	Farmhouse dating to the 17th and 18th centuries, formerly dated 1664 on gables with initials W/EM for Edward Worsley, Rector.
Brief Description	Flint and brick, black glazed pantiles gable parapets. Irregular plan. Main range of 6 bays plus chimney bays to left and right. Two storeys and attic, forward wing to front (south) bays 4 and 5, 19th century wing to rear.

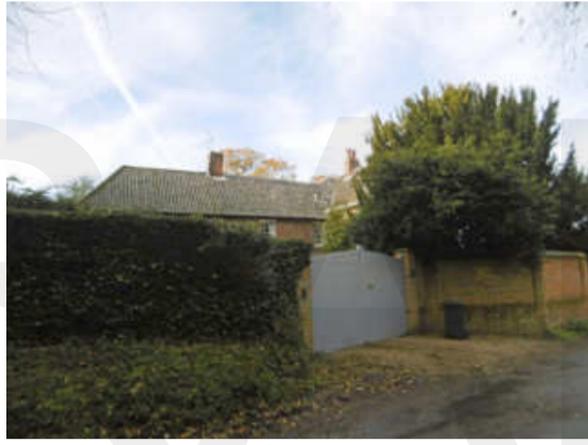
Address / Building Name	Letheringsett Lodge
Street-by-Street Area	Thornage Road
Status	Grade II
List Entry Link	https://historicengland.org.uk/listing/the-list/list-entry/1049835
Brief History	House dating to 16th and 18th centuries. Iron letters JB on each gable for John Burrell (1734 – 86).
Brief Description	Flint with brick dressings, black glazed pantiles, T-plan. Front range facing north of 7 irregular bays, 2 storeys and attic having 2 ridgelines, bays mainly 3 – 5 mainly in brick forming a polygonal projection with polygonal roof.

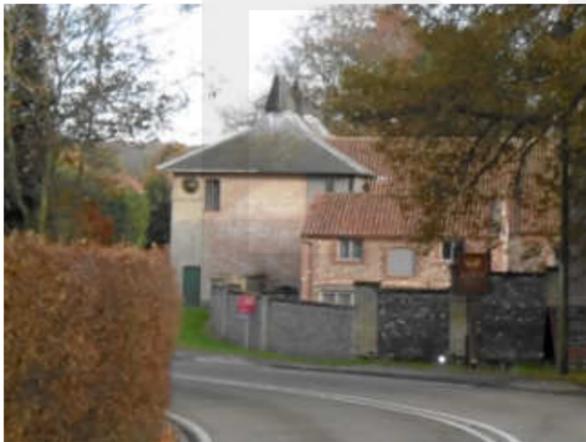
Address / Building Name	Malt Kilns attached Brewery and Glaven Cottage
Street-by-Street Area	Holt Road
Status	Grade II
List Entry Link	https://historicengland.org.uk/listing/the-list/list-entry/1049837
Brief History	Malt Kilns c. 1800 for William Hardy, brewery c. 1783 for William Hardy. Glaven Cottage originally 1792 for brewery clerk, renewed 1870 as brewer's cottage. Now converted for residential use.
Brief Description	Malt Kilns to north adjacent to road; gault brick with corrugated tiles, hipped roof with wide eaves; battered walls with clasping pilasters of gault brick, 2 panels of knapped flint to each of west and east facades. Clock of 1937 with a face on both east and west returns, chiming bells to centre north.

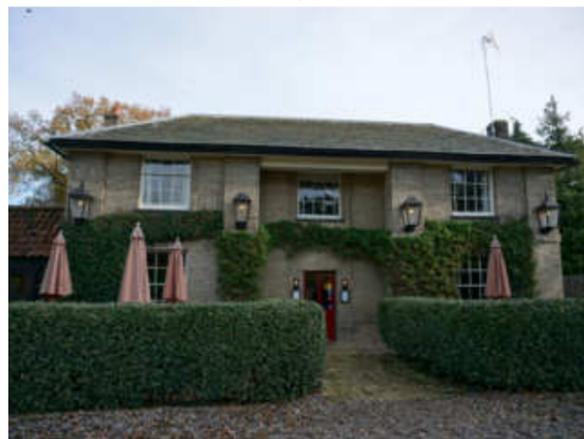
Address / Building Name	The King's Head public house
Street-by-Street Area	Holt Road
Status	Proposed Locally Listed
List Entry Link	N/A
Brief History	1805, rebuilt by William Hardy Junior when he diverted the Holt Road around new pleasure grounds for Letheringsett Hall
Brief Description	Two storeys, three bays wide. Georgian style. Stock brick with slate roof. Timber sash windows and timber door with glazed upper panels. Recessed central bay. Proposed for inclusion on the Local List as a key social building within the village, for its elegant Georgian style and its link with William Hardy Junior.

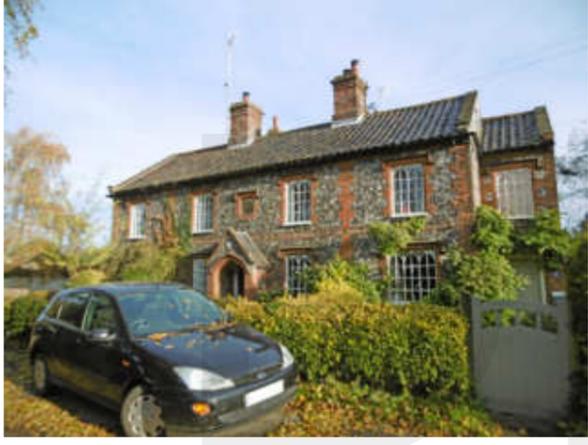
Address / Building Name	1, 2 and 3 Riverside Road
Street-by-Street Area	Riverside Road
Status	Grade II
List Entry Link	https://historicengland.org.uk/listing/the-list/list-entry/1304825
Brief History	Estate cottages dated 1870.
Brief Description	Flint with brick dressings, black glazed pantiles. Four bays plus set back bay either end with door. Gable parapets, axial stacks between bays 2 and 3, 3 and 4 in brick with oversailing cap and a thick cross in flint flushwork to each face. Casement windows with cast iron glazing bars having gothic heads.

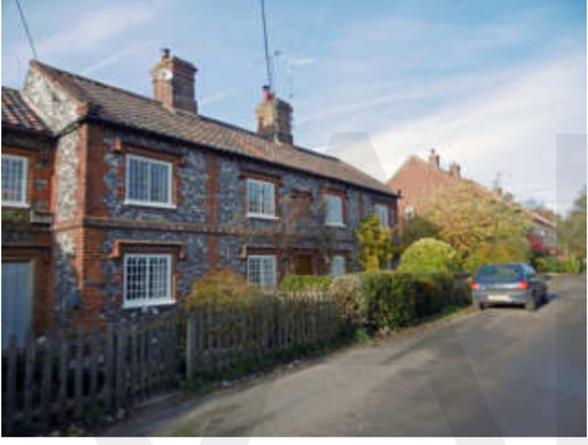
Address / Building Name	4, 5 and 6 Riverside Road
Street-by-Street Area	Riverside Road
Status	Grade II
List Entry Link	https://historicengland.org.uk/listing/the-list/list-entry/1049839
Brief History	Estate cottages dated 1870.
Brief Description	Flint with brick dressings, black glazed pantiles. Four bays plus set back bay either end with door. Gable parapets, axial stacks between bays 2 and 3, 3 and 4 in brick with oversailing cap and a thick cross in flint flushwork to each face. Casement windows with cast iron glazing bars having gothic heads.

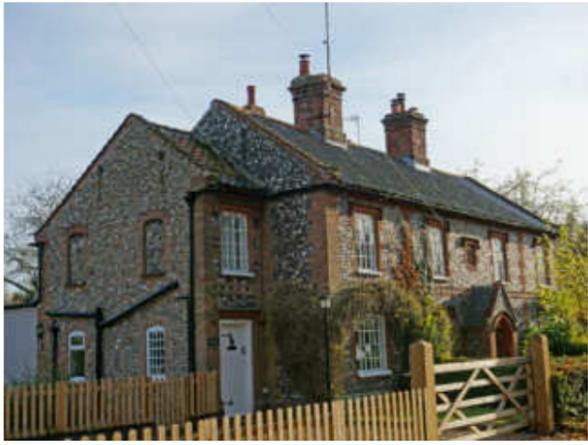
Address / Building Name	Hobbs Cottage, Middle Cottage and Honeysuckle Cottage
Street-by-Street Area	Riverside Road
Status	Grade II
List Entry Link	https://historicengland.org.uk/listing/the-list/list-entry/1068824
Brief History	Terraced estate houses c. 1870 – 75.
Brief Description	Knapped flint with red brick dressings. Pantile roof with tiled coping to gable ends. Two symmetrical red brick axial stacks to right and left of centre.
