Glaven Valley

Conservation Area Appraisal and Management Plan

Eighth Draft: May 2023

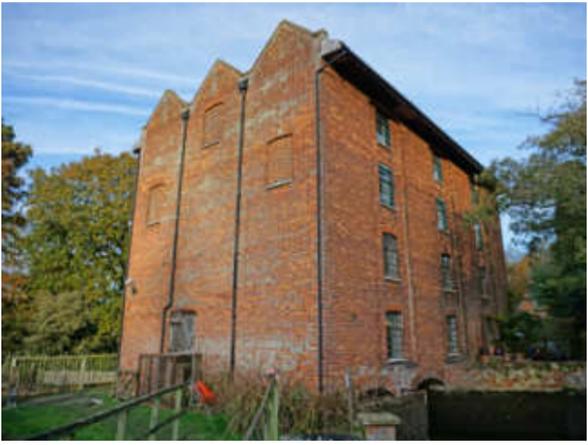
Address / Building Name	Letheringsett Mill
Street-by-Street Area	Riverside Road
Status	Grade II*
List Entry Link	https://historicengland.org.uk/listing/the-list/list-entry/1049838
Brief History	Built 1802.
Brief Description	Working watermill. Four storeys in brick with black glazed pantile roof. Metal framed windows. Water wheel and driving mechanism survives internally.

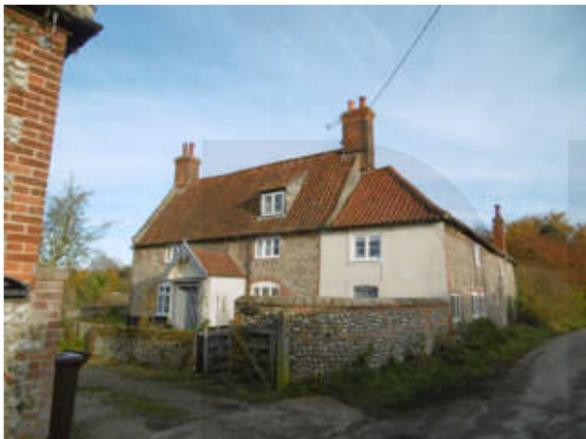
Address / Building Name	Glaven Farmhouse
Street-by-Street Area	Little Thornage
Status	Grade II
List Entry Link	https://historicengland.org.uk/listing/the-list/list-entry/1152266
Brief History	Farmhouse built late 17th century.
Brief Description	Flint with brick dressings, pantiles, 2 cell plan with end internal stacks, 2 storeys and attic plus one bay to right of rear wing. Rendered plinth. Central porch rebuilt c. 20th century, rendered, pantiles, boarded gable with bargeboards, small 20th century light with glazing bars to right return.

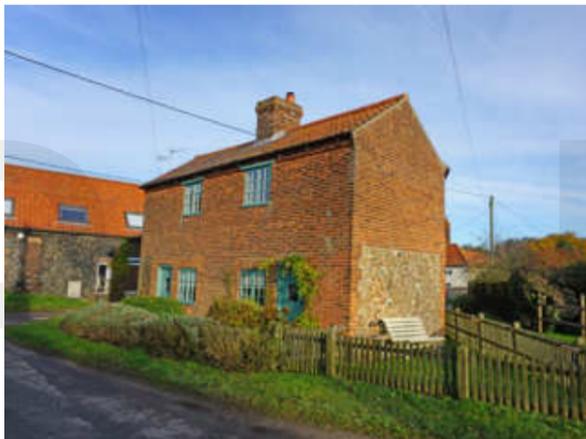
Address / Building Name	Honeysuckle Cottage
Street-by-Street Area	Little Thornage
Status	Proposed Locally Listed
List Entry Link	N/A
Brief History	Early 19th century
Brief Description	Small cottage, formed from two cottages, built on a former green so the layout has an unusual wedge shape to fit the triangular plot. Red brick with a small amount of flint cobbles. Red pantile roof. Timber casement windows and plank doors. Proposed for inclusion on the Local List for its unusual plan form and prominent position at the centre of Little Thornage.

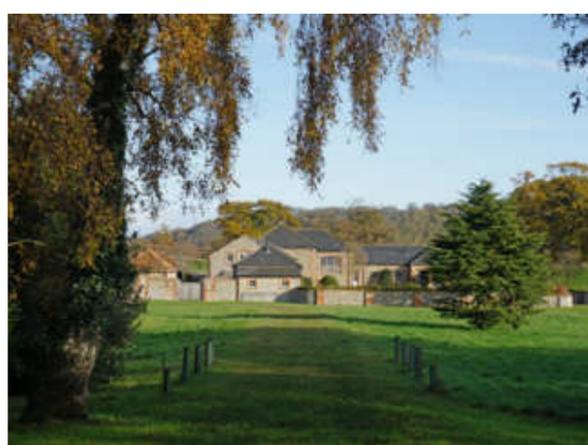
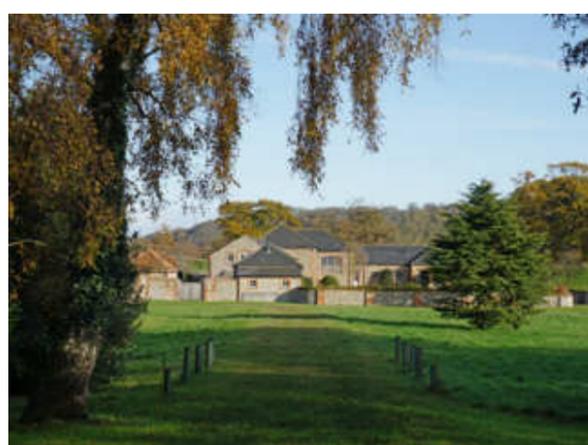
Address / Building Name	Stables at Hall Farm c60m north of Hall Farmhouse
Street-by-Street Area	Garden Lane and Hall Farm Area
Status	Grade II
List Entry Link	https://historicengland.org.uk/listing/the-list/list-entry/1304889
Brief History	Early 19th century
Brief Description	Stables. Gault brick with corrugated tiles. Single storey with loft. 8 bays with two bays either end projecting forward.

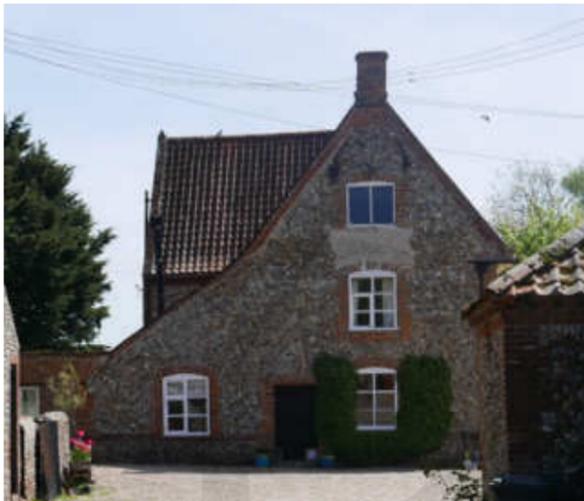
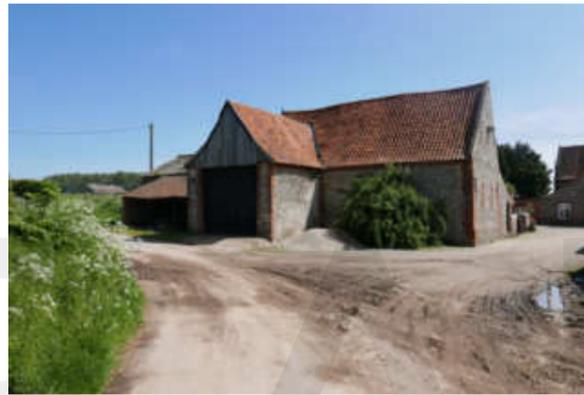
Address / Building Name	Valley Farmhouse
Parish	Sharrington
Status	Grade II
List Entry Link	https://historicengland.org.uk/listing/the-list/list-entry/1049432?section=official-list-entry
Brief History	C17 with later alterations
Brief Description	Flint with brick dressings and a plastered garden front, the high pitched roof has black glazed pantiles to the front and red pantiles to the rear. Clustered four chimney stack to the east gable. The north wing is gabled and also C17.

Address / Building Name	Barn to South-west of Valley Farmhouse
Parish	Sharrington
Status	Grade II
List Entry Link	https://historicengland.org.uk/listing/the-list/list-entry/1170728
Brief History	Late C18 or C19
Brief Description	Red brick barn with red pantile roof and off centre cart entrance.

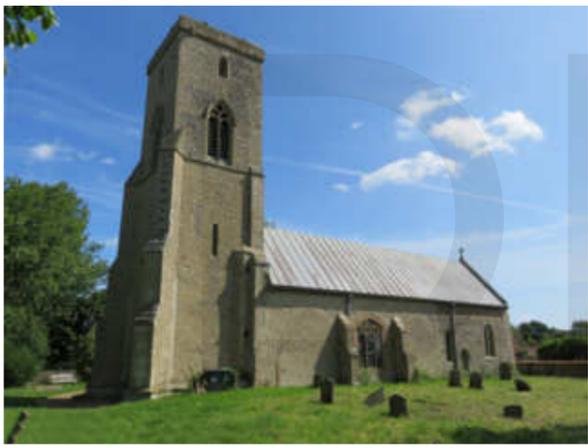
Address / Building Name	Church of All Saints
Street-by-Street Area	Bale Road
Status	Grade I
List Entry Link	https://historicengland.org.uk/listing/the-list/list-entry/1305969
Brief History	Nave and chancel of c1300 with later details, C14 Decorated west tower
Brief Description	Church. Flint with stone dressings, lead roof. Four stage tower.

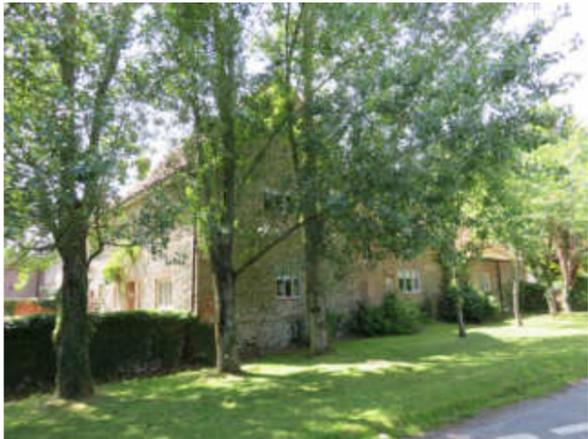
Address / Building Name	Barn to north-west of Sharrington Hall
Street-by-Street Area	Lower Hall Lane
Status	Grade II
List Entry Link	https://historicengland.org.uk/listing/the-list/list-entry/1049431
Brief History	C17, C20 conversion to domestic use.
Brief Description	Barn, now house. Flint with brick dressings and red pantile roof. Some earlier brick dressed blocked openings suggest earlier domestic use.

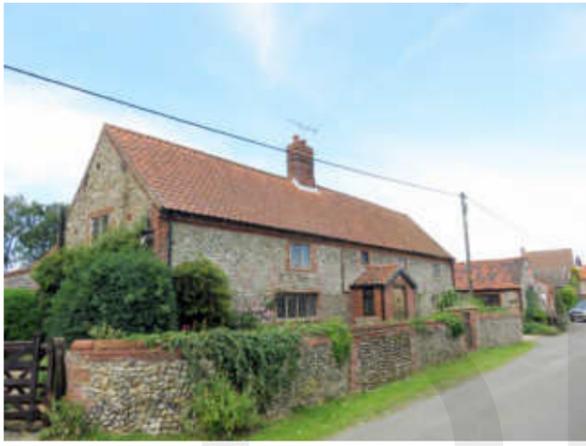
Address / Building Name	16 and 17, The Street
Street-by-Street Area	The Street (east-west)
Status	Locally Listed
List Entry Link	N/A
Brief History	1871
Brief Description	Pair of semi-detached estate cottage of red brick and cobble flint. Two storeys. Attractive date stones in ceramic quatrefoils above the doorways. Original cobble flint and red brick wall to the front.

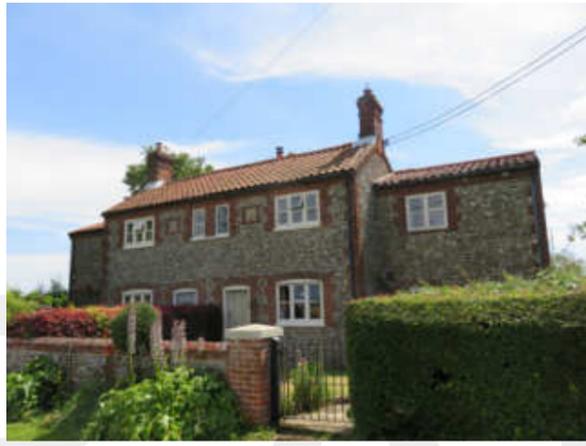
Address / Building Name	Chapel House
Street-by-Street Area	The Street (north-south)
Status	Locally Listed
List Entry Link	N/A
Brief History	1876 and C21 conversion to domestic use
Brief Description	Residential conversion of former Wesleyan Chapel. Two storeys. Red brick with polychrome strapwork and cobble flint. Tripartite blind lancet window arches and date stone above doorway. Stone plaque inlaid on central arch.

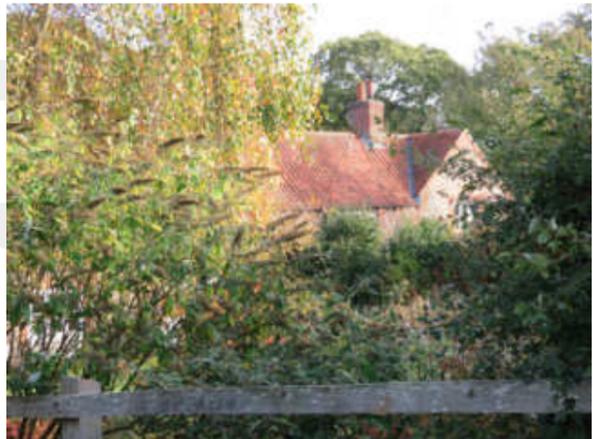
Address / Building Name	Breck Farm House
Parish	Thornage
Status	Grade II
List Entry Link	https://historicengland.org.uk/listing/the-list/list-entry/1049194
Brief History	c.1800
Brief Description	Two storey gault brick house with a roof of black glazed pantiles. Forms a group with barn and cart shed.

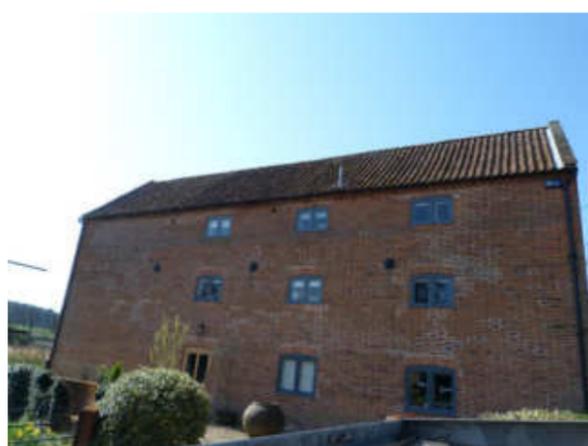
Address / Building Name	The White House
Street-by-Street Area	The Street
Status	Grade II
List Entry Link	https://historicengland.org.uk/listing/the-list/list-entry/1304483
Brief History	c.1635, of two builds.
Brief Description	House. Red brick and flint, though once colourwashed. Black glazed pantiles. Two storeys and attic. Main south front has sash windows. Asymmetric arrangement of windows to north.

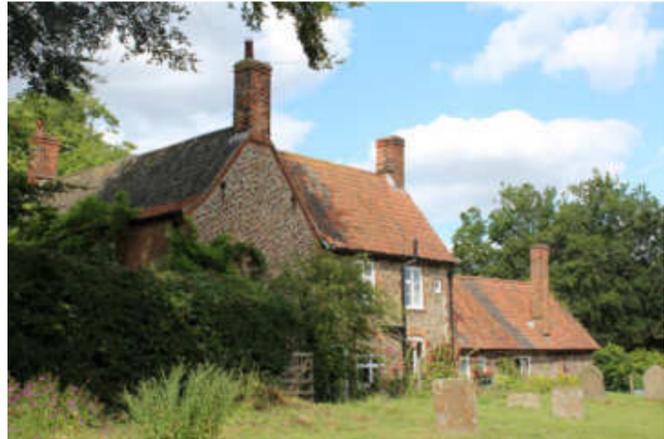
Address / Building Name	Thornage Hall
Street-by-Street Area	Thornage Hall
Status	Grade II*
List Entry Link	https://historicengland.org.uk/listing/the-list/list-entry/1304519
Brief History	c.1482, altered seventeenth and nineteenth centuries. Former grange of the Bishops of Norwich. Built for Bishop Goldwell (1472-99).
Brief Description	Flint with stone dressings, black glazed pantile roof. Stepped buttresses. Two storeys. Large stone traceried windows and pointed arch stone doorway on south front.

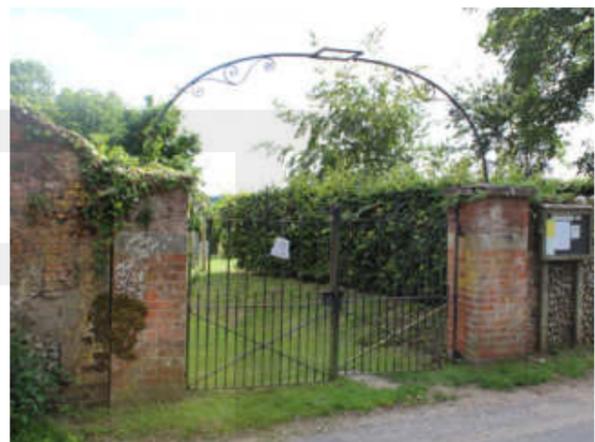
Address / Building Name	North Gate to the Churchyard
Street-by-Street Area	Thornage Hall
Status	Local listing
List Entry Link	N/A
Brief History	August 1902
Brief Description	Gate comprising two brick gate piers, decorative iron gates and overthrow. Inscribed stone on north gate pier reads: 'Erected by the Thornage parishioners in honour of the coronation of King Edward VII and Queen Alexandra 9th August 1902.'

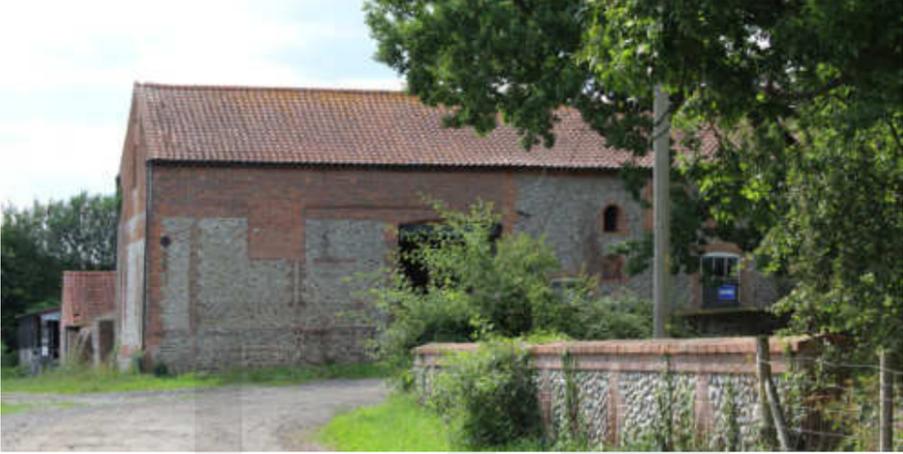
Address / Building Name	Dovecote, c30m south-east of Thornage Hall
Street-by-Street Area	Thornage Hall
Status	Grade II
List Entry Link	https://historicengland.org.uk/listing/the-list/list-entry/1049195
Brief History	1728
Brief Description	Dovecote. Red brick. Square hipped roof in red and black glazed pantiles terminating in square wooden glover. Moulded brick platbands and square wooden shuttered openings on each side. Stone plaque south side inscribed TA/1728. Small stone arched door to west. Internally 20 tiers of holes on all four sides.

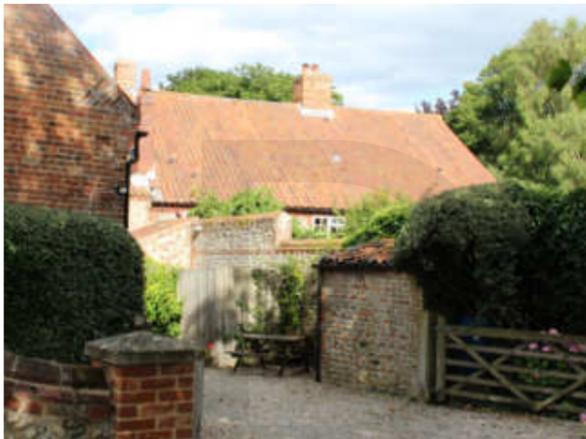
Address / Building Name	Town Farm House
Street-by-Street Area	Holt Road
Status	Grade II
List Entry Link	https://historicengland.org.uk/listing/the-list/list-entry/1153065
Brief History	Seventeenth century with nineteenth century additions.
Brief Description	House. Two storeys with attic. Rendered walls, pantile roof. Sash windows to ground floor and varied windows to first floor. Single storey nineteenth century extensions, including dairy to north-west.

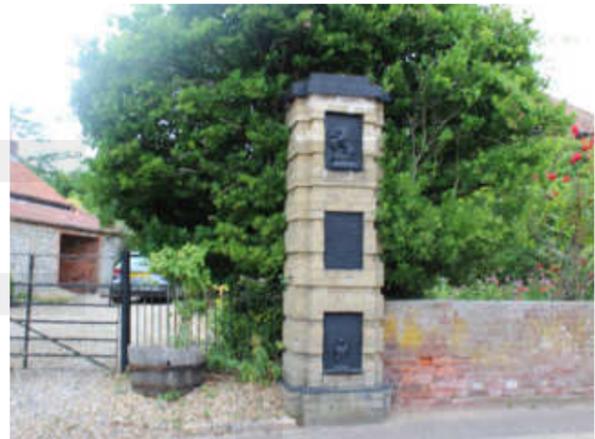
Address / Building Name	Old Foundry House and attached gate pier
Street-by-Street Area	Holt Road
Status	Grade II
List Entry Link	https://historicengland.org.uk/listing/the-list/list-entry/1153054
Brief History	Eighteenth century, with nineteenth century gatepier. There was an iron and brass foundry on the site in the nineteenth century, which would explain the unusual gatepiers.
Brief Description	House. Two storeys. Rendered and colourwashed. Red pantile roof. Sash windows, central panelled door. Gatepier in rusticated gault brick, cast iron double cap, 3 front panels with cast iron plaques showing decorative figurework, cast iron cap to plinth.

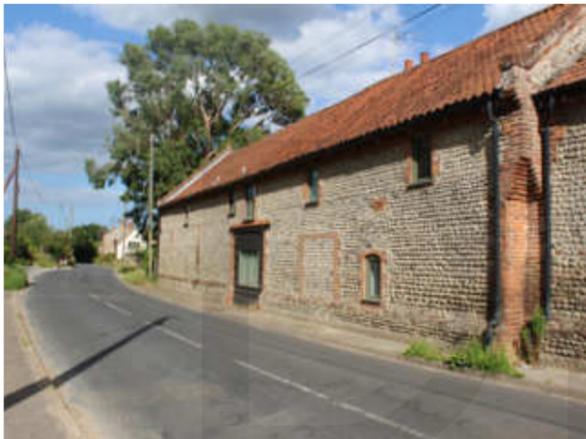
Address / Building Name	Barns at Town Farm with attached stable range
Street-by-Street Area	Holt Road
Status	Grade II
List Entry Link	https://historicengland.org.uk/listing/the-list/list-entry/1373822
Brief History	Eighteenth century
Brief Description	Range of two barns and stables along roadside. Flint and red brick with red pantile roof. North-east gable of diamond and heart patterns in brick.

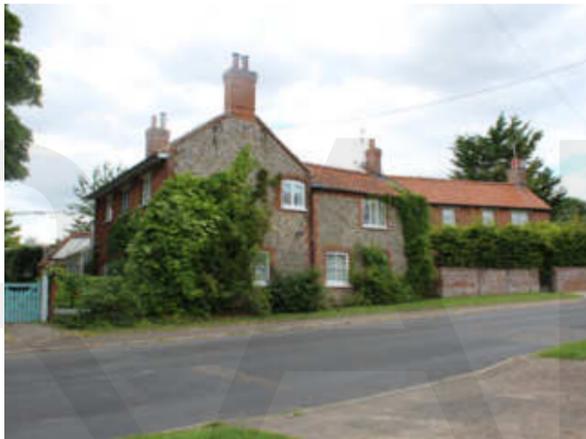
Address / Building Name	Former public house
Street-by-Street Area	Holt Road
Status	Local listing
List Entry Link	N/A
Brief History	Late eighteenth century
Brief Description	Former public house facing sideways to the road. Red brick front elevation with cobble flint gables. Casement windows set in cast iron frames serving as a reminder to the iron and brass foundry.

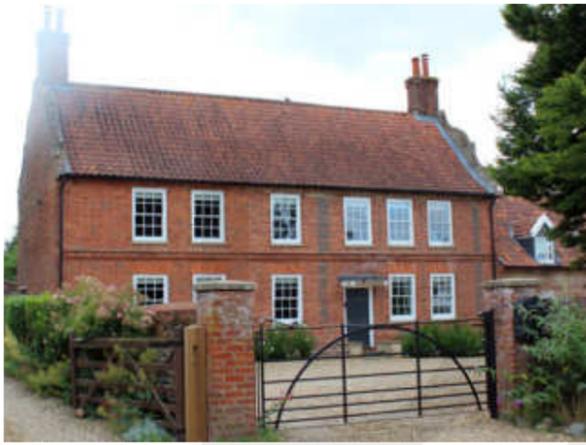
Address / Building Name	Thornage Grange
Street-by-Street Area	Letheringsett Road
Status	Grade II
List Entry Link	https://historicengland.org.uk/listing/the-list/list-entry/1049152
Brief History	Late seventeenth century.
Brief Description	House. Two storeys. Red brick, red pantiles. 6 bays. Shaped gables. Timber sash windows. Off-centre timber panelled door.

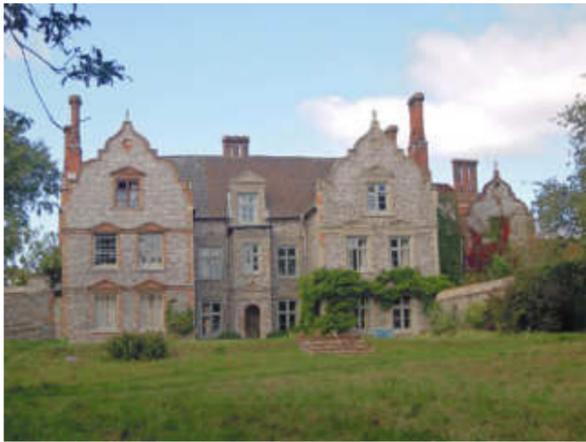
Address / Building Name	Wiveton Hall
Parish	Wiveton
Status	Grade II*
List Entry Link	https://historicengland.org.uk/listing/the-list/list-entry/1373519
Brief History	1653 date in hall and 1908 extension by Sir Guy Dawber.
Brief Description	H-shaped c17 plan, 7 bays and 2 storeys with attic. Knapped flints with red brick dressing and shaped gables.

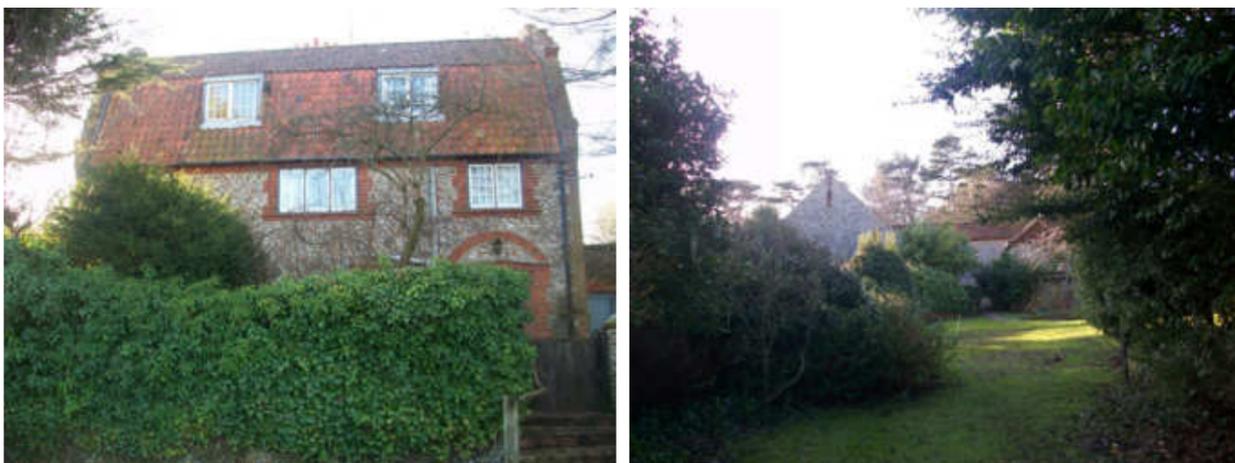
Address / Building Name	Wiveton Barn
Street-by-Street Assessment	Leatherpool Lane
Status	Locally Listed
List Entry Link	N/A
Brief History	House: Probably C17th with C19th frontage Barns: Pre-C19th
Brief Description	House: Flint with brick building of two storeys with attic under gambrel, pantile roof with dormers. Some of the casement windows have been replaced with uPVC windows. Beyond is a range with lower eaves height. It has a roughcast render exterior with a rendered brick dentil cornice and red brick chimney. Barns: Massive triple height barn of coursed flint with red brick dressings and clay pantile roof.

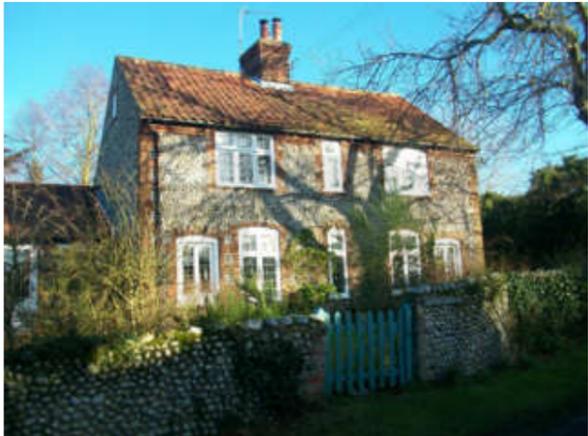
Address / Building Name	Glaven Cottage, The Street
Street-by-Street Assessment	The Street
Status	Locally Listed
List Entry Link	N/A
Brief History	Mid C19th
Brief Description	Two storey cottage of flint with red brick dressings. The windows are leaded casements under brick arches. The clay pantile roof has a central red brick chimney with dentil ornamentation. A predominantly brick single storey extension to the north has a timber weatherboarded gable.

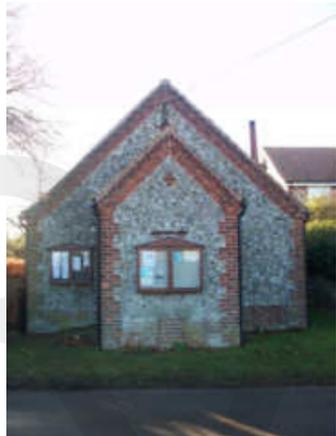
Address / Building Name	The Parish Room
Street-by-Street Assessment	The Street
Status	Locally Listed
List Entry Link	N/A
Brief History	1910
Brief Description	Single storey flint building with red brick dressings, including dentil cornice. Pantile roof with a red brick chimney with a very tall chimney pot. The Room was built in 1910 for the coronation of King George V, which is commemorated with an inscribed stone. The building has been extended at the rear with a flat roofed, brick addition, probably second half of the twentieth century.

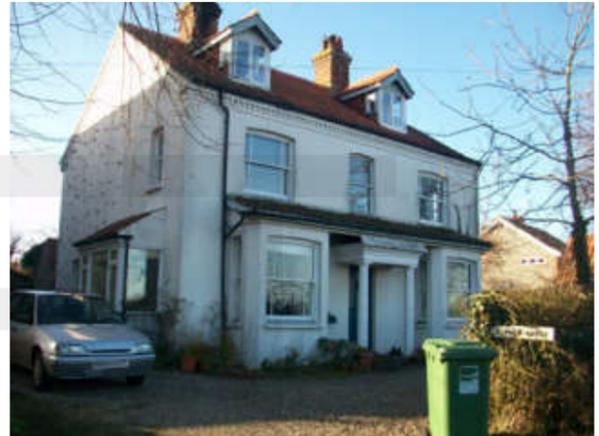
Address / Building Name	Glaven Lodge, The Street
Street-by-Street Assessment	The Street
Status	Locally Listed
List Entry Link	N/A
Brief History	Late C19th
Brief Description	Detached, three bay, two storey house with attic. White painted brick with dentil cornice and classical portico with octagonal columns. Windows are sashes, except the dormers, which are casement and the window in the modern side extension. Modern pantile roof with clay ridge and two original red brick chimneys with dentil ornamentation. Flint outbuilding to the rear.

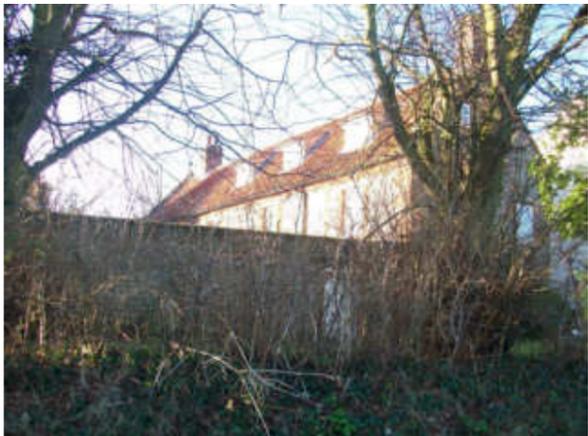
Address / Building Name	Welcome Cottage
Street-by-Street Assessment	The Street
Status	Locally Listed
List Entry Link	N/A
Brief History	Probably C18
Brief Description	Large cottage of coursed flint with brick dressings and leaded casement windows. Dormers in the pantile roof and two red brick chimneys. It occupies a commanding position on a rise at the point where the road forks. The flint wall defining the boundary of the property is also important to the cottage's setting and the streetscape.

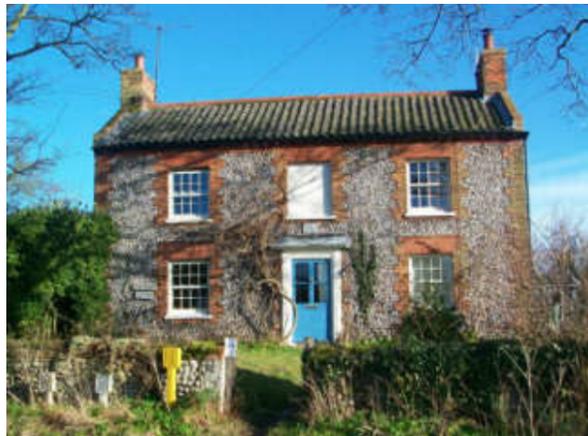
Address / Building Name	Sycamore Cottage, The Street
Street-by-Street Assessment	The Street
Status	Locally Listed
List Entry Link	N/A
Brief History	Late C18/Early C19
Brief Description	Two storey house to simple classical design. Flint with brick dressings, Dutch pantile roof and two red brick chimneys. Blakeney Housing Association plaque over the door.

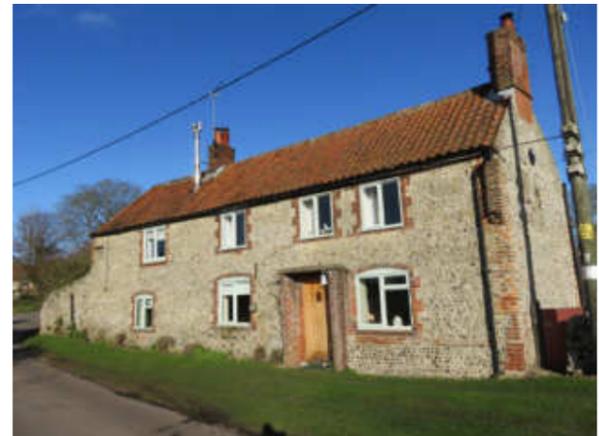
Address / Building Name	Church Cottage
Street-by-Street Assessment	The Street
Status	Locally Listed
List Entry Link	N/A
Brief History	Pre-C19th
Brief Description	Two storey cottage with modern addition. The flint walls, which have brick dressings, appear to be coursed at the upper level only and are punctuated by iron ties. The clay pantile roof has two red brick chimneys and a modern metal flue. The modern red brick porch has a utilitarian mid-twentieth century light fitting.

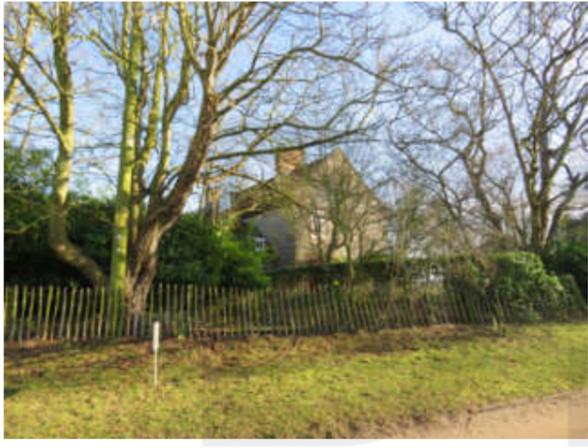
Address / Building Name	Church Farm House
Street-by-Street Assessment	The Street
Status	Locally Listed
List Entry Link	N/A
Brief History	Pre-C19th
Brief Description	Two storey farmhouse of flint with red brick dressings and casement windows. The clay pantile roof has a large red brick chimney.

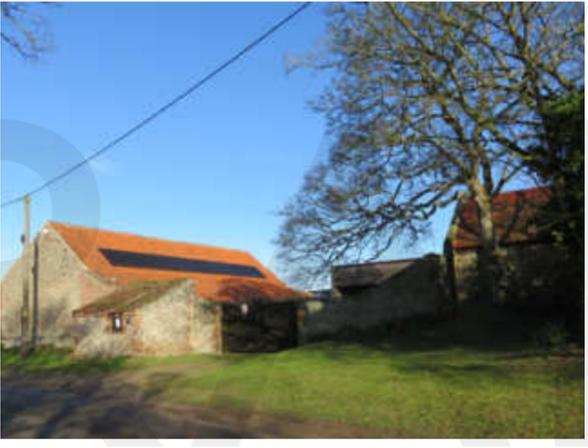
Address / Building Name	Church Farm Barn
Street-by-Street Assessment	The Street
Status	Locally Listed
List Entry Link	N/A
Brief History	Pre-C19th
Brief Description	Double height barn arranged perpendicular to road. The walls are flint with red brick apart from a corrugated, coated sheet metal extension. The clay pantile roof takes the form of a catslide roof over the red brick lean-to part of the barn. The roof over the left hand outbuilding is sheet metal also. There is a timber cartshed at the rear which forms part of the group. A simple but very historic lean-to sits along the road.

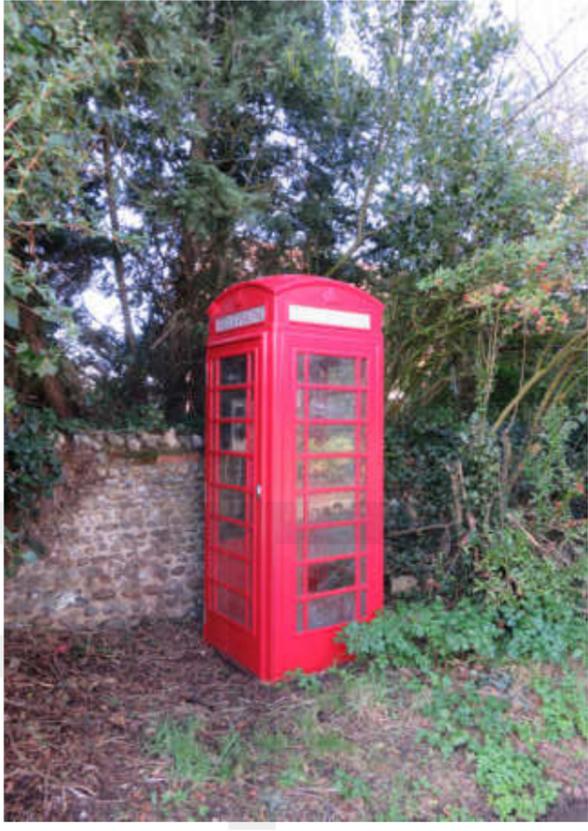
Address / Building Name	K6 Telephone box
Street-by-Street Assessment	The Street
Status	Locally Listed
List Entry Link	N/A
Brief History	Early C20th
Brief Description	Red painted telephone box of K6 designed by George Gilbert Scott.

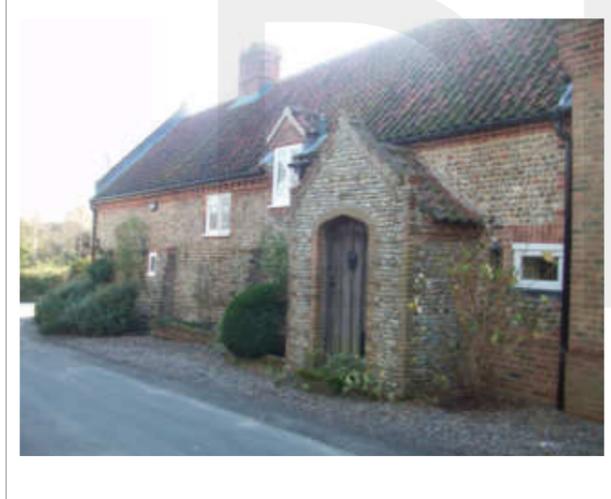
Address / Building Name	Hall Lane House
Street-by-Street Assessment	Hall Lane
Status	Locally Listed
List Entry Link	N/A
Brief History	Probably C18 with C20 alterations

Brief Description L-shaped flint and brick house with brick dentil cornice. There is a great variety of patterns and materials used in the walls, suggesting considerably redevelopment over time. The north range is a later addition. The porch and possibly the dormer look to have been built in the early twentieth century. There is also considerable variety to the windows, which are general casement. The north extension has timber windows with plain glass whereas those in the historic range are leaded.

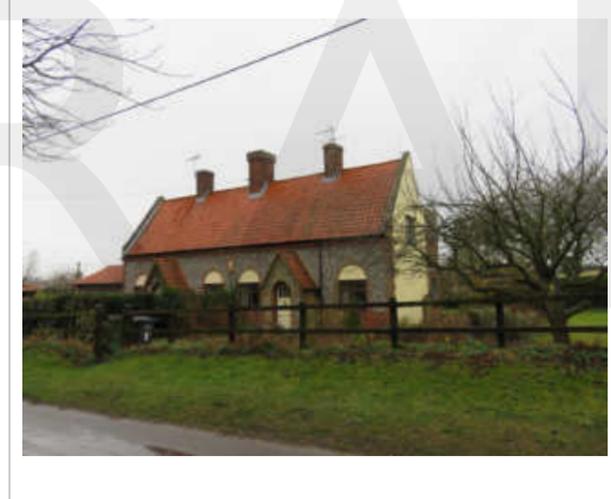
Address / Building Name	8 and 9 Hall Lane
Street-by-Street Assessment	Hall Lane
Status	Locally Listed
List Entry Link	N/A
Brief History	1914

Brief Description Pair of single storey cottages with attics under steeply pitched roof surmounted by three red brick chimneys. The Walls are predominantly flint with red brick dressings except for the gabled ends, which are rendered. Front windows under semi-circular arches infilled with render. Steeply pitched roofs to porches with semi-circular arched front doors. Date stone 1914. Designed by Norwich based architect Stanley J. Wearing.

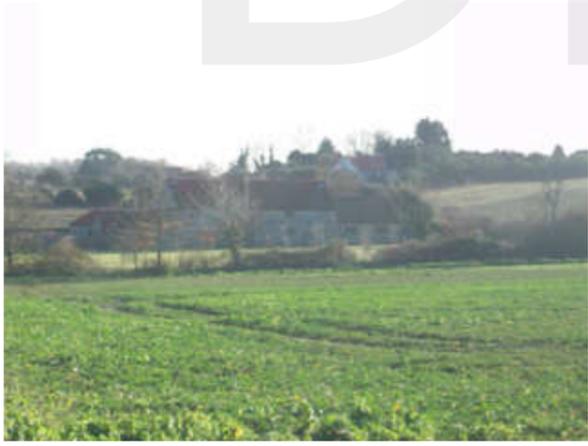
Address / Building Name	Church Barn, Chapel Lane
Street-by-Street Assessment	Chapel Lane
Status	Locally Listed
List Entry Link	N/A
Brief History	Pre-C19th
Brief Description	Large historic threshing barn converted to domestic dwelling. Not included as listed: attached twentieth century outbuilding range converted to a separate dwelling: The Boatshare.

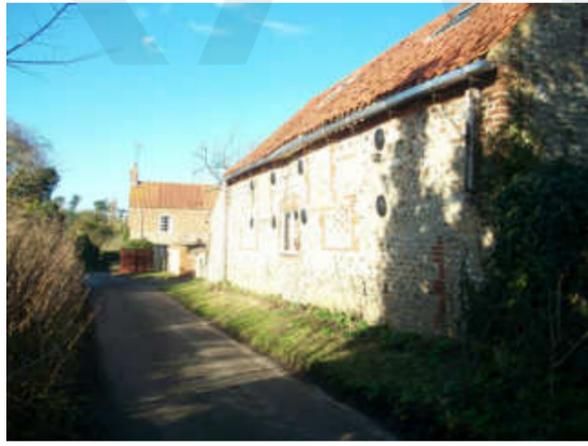
Address / Building Name	Double House
Street-by-Street Assessment	Chapel Lane
Status	Locally Listed
List Entry Link	N/A
Brief History	C18th and early C19th, incorporating earlier fabric
Brief Description	Triple range perpendicular to the road: two ranges of two storeys under roofs of different heights and one single storey range. Three red brick chimneys at each end of the two main ranges and between them; a fourth chimney adorns the single storey range. Clay pantile roofs with solar panels on the single storey range. The south elevation is mostly red brick with some brown brick to the lower storey of the west range. Flat brick arches except one round arch above front elevation windows. Sash windows in the front elevation and east rear range, mostly eight over eight but in different styles West rear range has casement windows. Rear wall predominantly flint and rebuilt in brick. Iron pattresses.

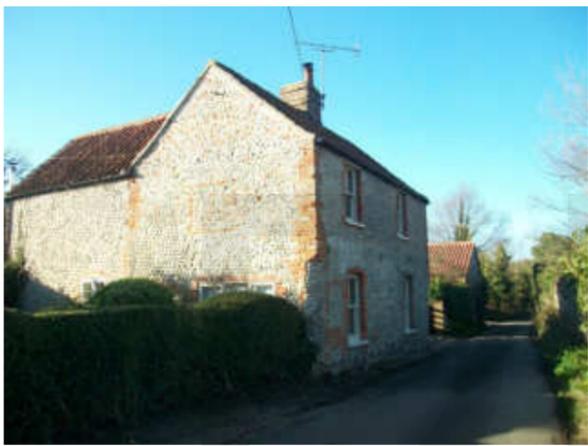
Address / Building Name	White House
Street-by-Street Assessment	Chapel Lane
Status	Locally Listed
List Entry Link	N/A
Brief History	Probably C18th
Brief Description	Two bay, two storey flint and brick house with rear extension. Four historic sash windows (two over two) to front, casement windows to rear. Three iron wall pattresses. The pantile roof has one pink brick central chimney stack.

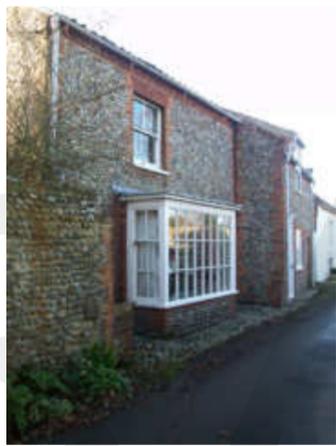
Address / Building Name	Myrtle Cottage
Street-by-Street Assessment	Chapel Lane
Status	Locally Listed
List Entry Link	N/A
Brief History	Late C19
Brief Description	Two storey flint and brick cottage with different flints at first floor level suggesting a vertical extension. bay window The large bay shop window looks to be a replacement. There is one fixed historic window at the front of the house.. Single storey white rendered addition to north. The cottage has a brick dentil cornice and a brick chimney.

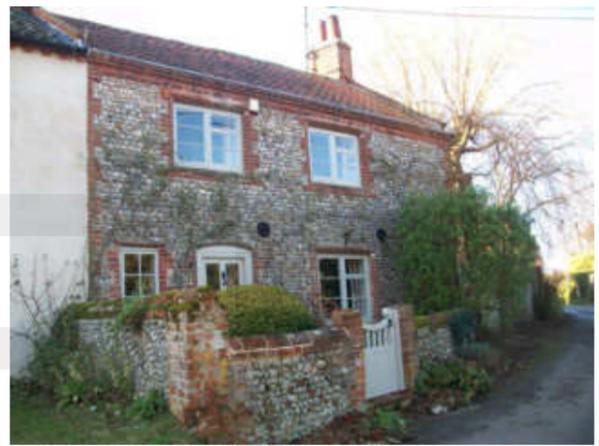
Address / Building Name	Rose Cottage
Street-by-Street Assessment	Chapel Lane
Status	Locally Listed
List Entry Link	N/A
Brief History	Early C19th
Brief Description	Two storey cottage of flint with red brick dressings and a clay pantile roof with a red brick chimney. Some of the casement windows may be early nineteenth century. The walls are supported with two iron pattresses. The cottage is enclosed by a historic garden wall.

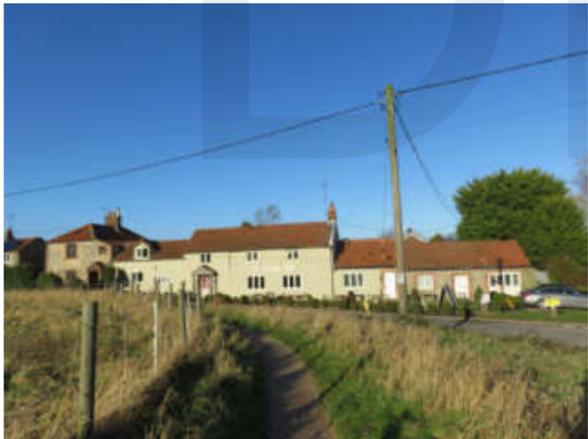
Address / Building Name	Green Farm
Street-by-Street Assessment	Blakeney Road
Status	Locally Listed
List Entry Link	N/A
Brief History	C17th/Early C18th
Brief Description	Eighteenth century farmhouse in poor condition, though seemingly containing original fabric. Two storey house with steeply pitched roof covered with Dutch pantiles and two small chimneys. Attached is a one and a half storey range with attic dormers, a red clay pantile roof and one chimney. Also a mid twentieth century flat roofed extension. Windows are casements. There are no windows in the street gable elevation, which is marked by a later red brick chimney stack insertion as well as other red brick detailing evidencing change. The farmhouse forms the east side of a yard around which are arranged a barn and other outbuildings (see below).

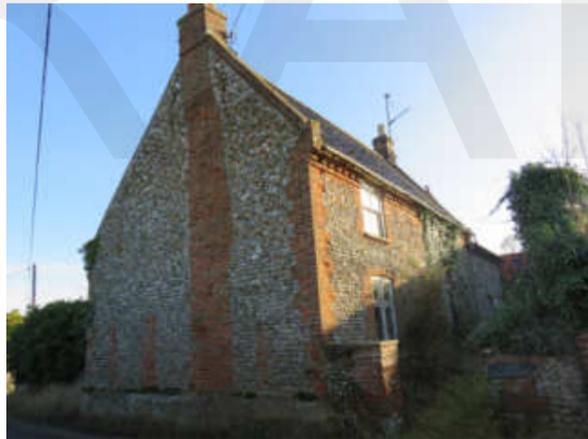
Address / Building Name	Green Farm outbuildings
Street-by-Street Assessment	Blakeney Road
Status	Locally Listed
List Entry Link	N/A
Brief History	Mid C19th
Brief Description	Series of outbuildings attached to Green Farm. To the south-east is a red brick outbuilding with flint gable wall, dentil cornice and half moon windows. Separated by an access track is a red brick double height barn with red clay pantile roof and metal sheeting covering the opening. Parallel to the road are two roofless flint and brick outbuildings.

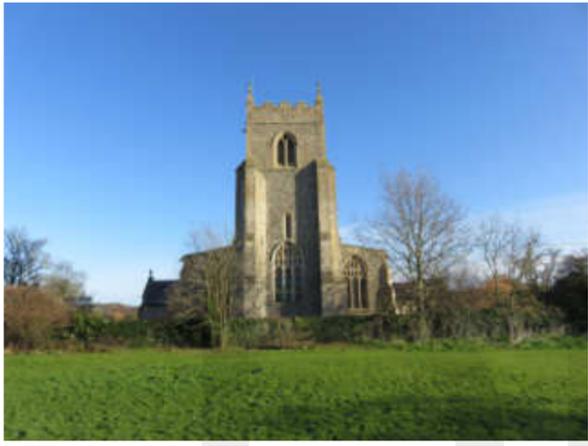
Address / Building Name	Church of St Mary
Street-by-Street Assessment	Village Green and Bridgefoot Lane
Status	Listed Building Grade I
List Entry Link	https://www.historicengland.org.uk/listing/the-list/list-entry/1373501
Brief History	C14th west tower 1437 nave, north, south aisles C15th north and south porches
Brief Description	Medieval parish church with later alterations. Flint with stone dressings. Tower, nave, two aisles, chancel, and both north and south porches.

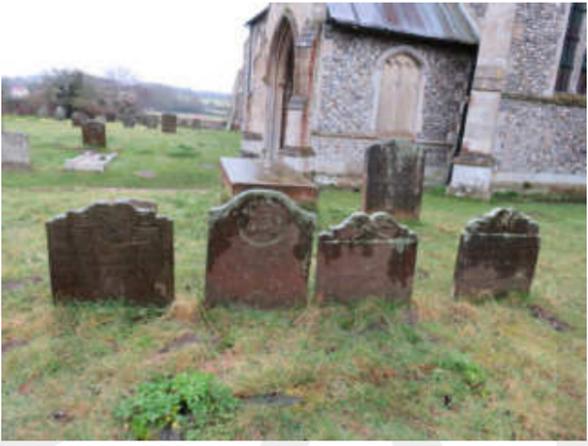
Address / Building Name	Row of Memorial Stones N of Church Tower
Street-by-Street Assessment	Village Green and Bridgefoot Lane
Status	Listed Building Grade II
List Entry Link	https://www.historicengland.org.uk/listing/the-list/list-entry/1170670
Brief History	1725 1736 1724 1731
Brief Description	Row of four carved, eighteenth century headstones in limestone.

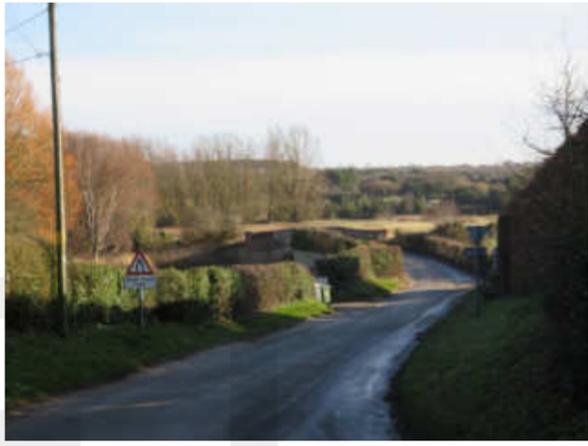
Address / Building Name	Wiveton Bridge
Street-by-Street Assessment	Village Green and Bridgefoot Lane
Status	Scheduled Ancient Monument
List Entry Link	https://www.historicengland.org.uk/listing/the-list/list-entry/1003157
Brief History	c.1500
Brief Description	Single span, pointed arch stone bridge with (possibly eighteenth century) red brick flanking walls and piers with stone capping. Area of SW corner may be side of C15th Chapel.

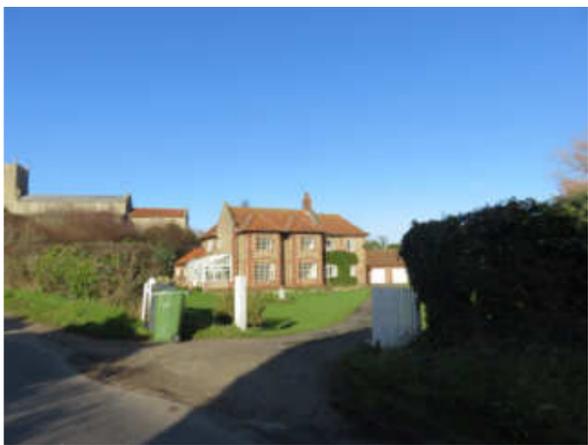
Address / Building Name	Stonebridge House
Street-by-Street Assessment	Village Green and Bridgefoot Lane
Status	Locally Listed
List Entry Link	N/A
Brief History	1930
Brief Description	Substantial Elizabethan revival style house of flint with brick dressings including 'HS 1930' in brick in the gable. Two projecting bays to main façade. Clay pantile roof with one red brick chimney. West roof is hipped. The house has a two storey extension to the east. Two storey cross wing with single storey lean-to extension to the rear. Modern conservatory to the west.

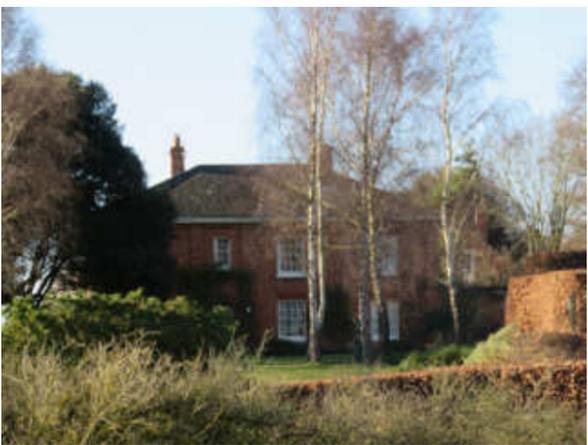
Address / Building Name	Old Rectory
Street-by-Street Assessment	Village Green and Bridgefoot Lane
Status	Locally Listed
List Entry Link	N/A
Brief History	Late C19th/early C20th
Brief Description	Two storey, neo-classical, red brick house with symmetrical elevations and a hipped slate roof. Two red brick chimneys. Set in substantial landscaped grounds.
