Holt

Conservation Area Appraisal and Management Plan

Final Draft for Adoption: April 2021

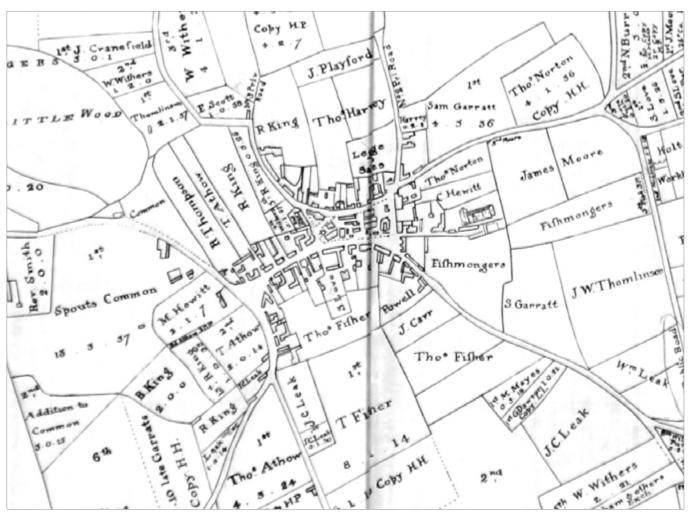
Plan of the Parish of Holt with part of Letheringsett in the County of Norfolk, 1810 (Norfolk Record Office: C/Sca2/165

In 1810, the open fields and commons were divided and allotted under the Holt and Letheringsett Inclosure Award, as indicated by the enclosure map of 1810. This map shows the landowners in the parish of Holt, of which there were a number owing to the size of the settlement. These included the Worshipful Company of Fishmongers, who managed the school and owned other land, and Thomas Fisher who owned land at the town centre and at the peripheries. The marketplace had grown with a number of additional buildings added since the late eighteenth century.

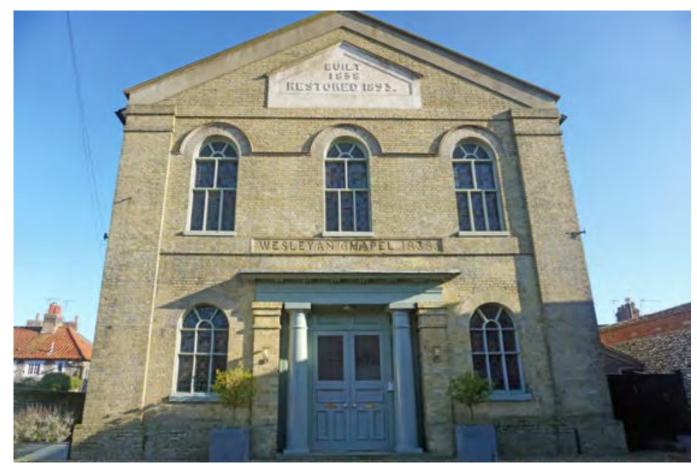
Wesleyan Chapel on New Street built 1838

Methodism was present in Holt from the late eighteenth century; William Hardy of Letheringsett Hall established a Wesleyan Society in 1813 and funded the building of a chapel, long known as the Chancery buildings, now two houses Nos. 18 and 20 Albert Street. A larger Wesleyan Chapel was built in New Street in 1838 (restored in 1893 as indicated in the date stone), today converted into a house. The associated burial ground was converted by the town council into a public garden opposite Chapel Yard in 1992. A faction in the church led to the establishment of a Methodist Free Society, for whom a church at the top of Letheringsett Hill was built, designed by Thomas Jekyll, an important Norwich architect, in 1862. The patron was William Cozens-Hardy, a notable local Methodist who lived at Letheringsett Hall. By the end of the century this had become a United Methodist Church. There was also a Primitive Methodist Chapel off Bull Street.

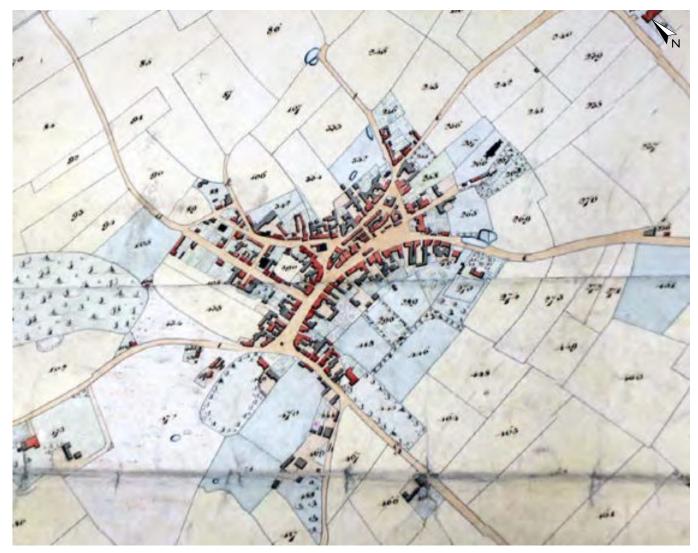
Tithe Map, Parish of Holt, 1839 (Norfolk Record Office: DN/TA 494)

The Tithe Map of Holt, which dates to 1839, shows New Street, running north-west from the High Street, had been laid out in the early-nineteenth century. The Shirehall, built in the eighteenth century, sat at the crux of the town centre (now called Shirehall Plain) as an island building to the north of the other market buildings. The Market Place had become more crowded, or the area more accurately detailed. Further detail to the houses on the streets bounding the Market Place shows their narrow frontages and relatively close grain. The streets on the peripheries, such as New Street, featured more capacious plots, many of which were undeveloped. Many of the houses and buildings shown on the Tithe Map of 1839 still remain. A mill is shown on the Tithe Map to the south-east of Holt on the Hempstead Road, with a mill pond adjacent. The now known as Hempstead Mill. The mill and its associated Mill House were built in 1830 by Richard John Gurney and was at the time known as Holt Mill.¹¹

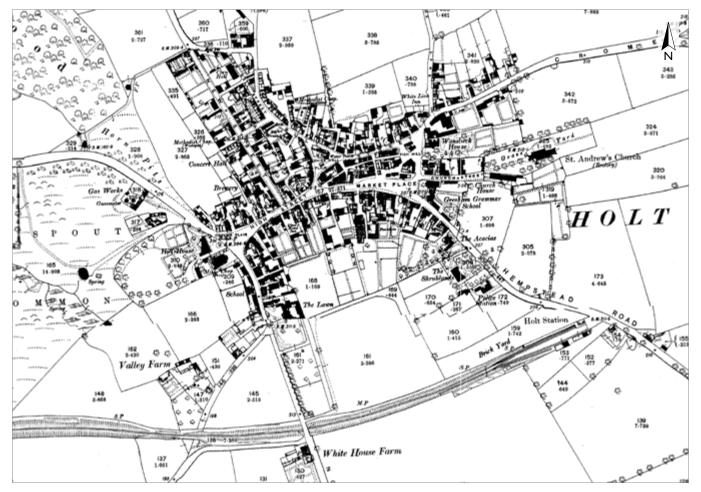
1881-1887 1: 2,500 OS map © Crown Copyright 2020. All rights reserved. Licence number 100020449.

The 1881-1887 OS map provides the first geographically accurate illustration of Holt. The map demonstrates Holt's size and status as a prosperous market town with important local industries. The recently arrived railway line lay to the south of the town and was important in widening Holt's market and disseminating goods further afield. The settlement was still orientated around the Market Place with the Grammar School to the east and the church further to the east. The Old Rectory was the other side of town, at the western end of Spout Common (outside the Conservation Area boundary). The town centre incorporated the three Methodist chapels built in that century (Wesleyan, Primitive and Free), a number of inns (including the eighteenth-century White Lion Inn and the King's Head Inn) and a concert hall. The police station was marked on what was then Hempstead Road, near Holt Station. Several farms occupied the land just to the south of the town such as Valley Farm and White House Farm. Industries at the western peripheries of the town included a brewery and a gas works on Spout Common, and to the south of the town, a brick works.

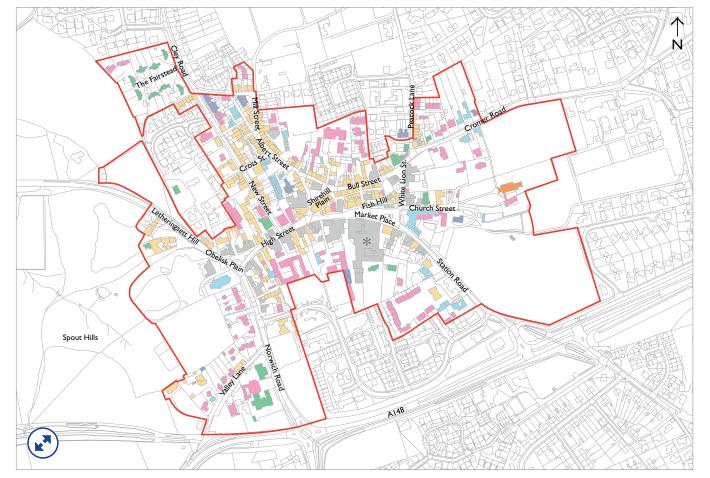
Historic Development Plan © North Norfolk District Council. Reproduced by permission of Ordnance Survey © Crown copyright and database right [2009]. All rights reserved. Ordnance Survey Licence number 100018623. This plan is not to scale.

This plan indicates the age of the existing built fabric of the main buildings and structures in Holt. It is mostly based on a comparison of historic maps with limited verification through viewing of the existing building from the street. Some buildings may have been constructed in phases but generally only the main phase is shown here. Some buildings may have been partially rebuilt or substantially repaired since they were first built but their footprint was unchanged and so the change is not obvious in map comparisons. Where this is the case, generally the building is coloured for the earliest date that it appears on the map.

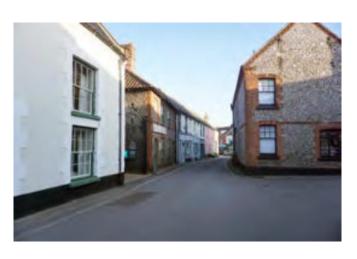
View 07

View looking north along White Lion Street, giving a general impression of the retail streetscape.

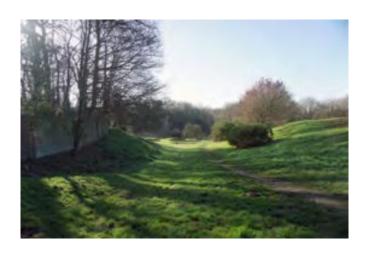
View 22

View west over fields to the Spout Hills area.

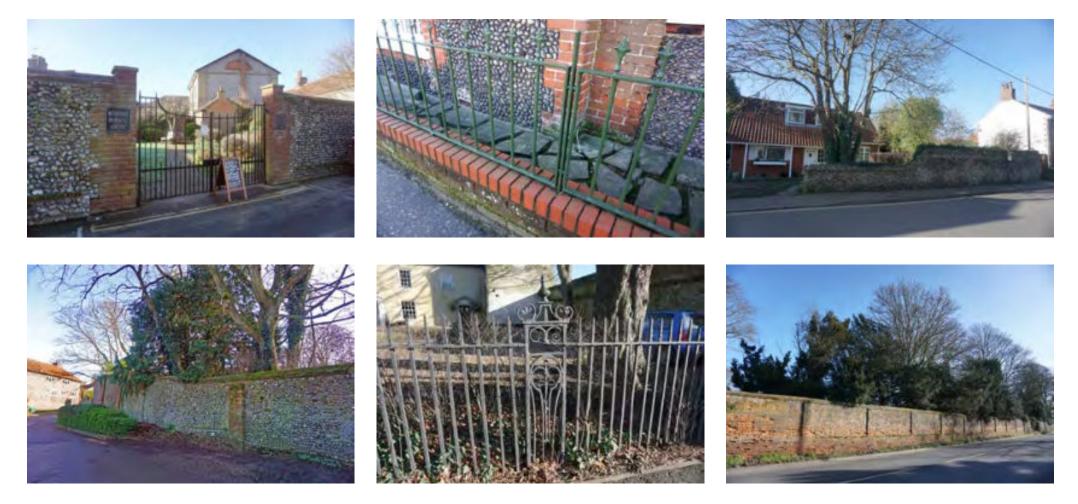
Boundary Treatments

As buildings are positioned close together and up against the pavements on the main commercial streets in the town centre, there are few boundary treatments present. On the roads branching out from the centre, however, there are boundary walls and some hedges. Walls are either low to mid-height where they are located around front gardens, while others are a tall height. Most are either red brick, flint or a combination of the two. Occasionally gault brick is used, such as at the former Wesleyan Chapel, and at the Methodist Church bricks are used in a polychrome pattern in the boundary wall. Some of the walls are quite substantial and run for long lengths around historic properties, such as the large house at No. 3 Obelisk Plain.

There are several low walls which are topped with decorative metal railings. Post holes in stones to the south of the Old School House also indicate there were formerly railings enclosing small areas here, though the railings have been lost. Hedges are more prevalent to the east around playing fields. Trees also help to define boundaries in some places, sitting in rows behind walls.

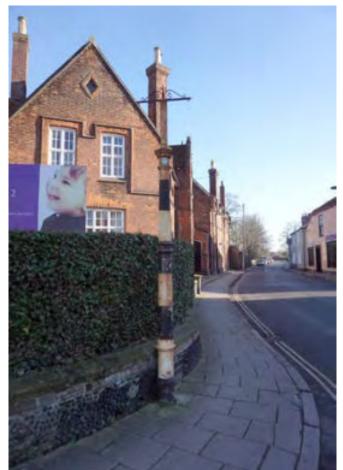
Metal signpost outside the Old School House

An historic metal signpost sits outside the Old School House. It is cast iron, painted in black and white, with a crossbar at the top, though no signs hang from this at present.

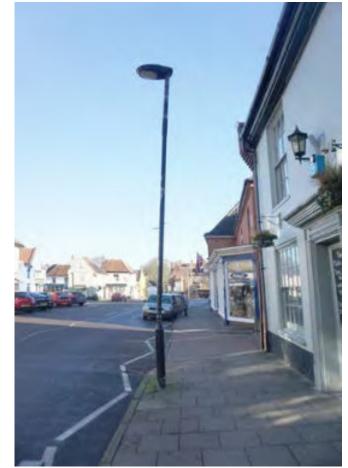
Modern lamppost on the High Street

Generally, the street lighting in Holt consists of fairly basic stainless steel modern lampposts, sometimes painted black, which are utilitarian and spoil the setting of the Conservation Area and adjacent listed buildings/ features. There are a few examples of modern lampposts in a traditional style, made of cast iron, in Appleyard, which make a positive contribution to the setting. At the churchyard there is one historic lamp sited on the southern gate pier, which is an attractive features.

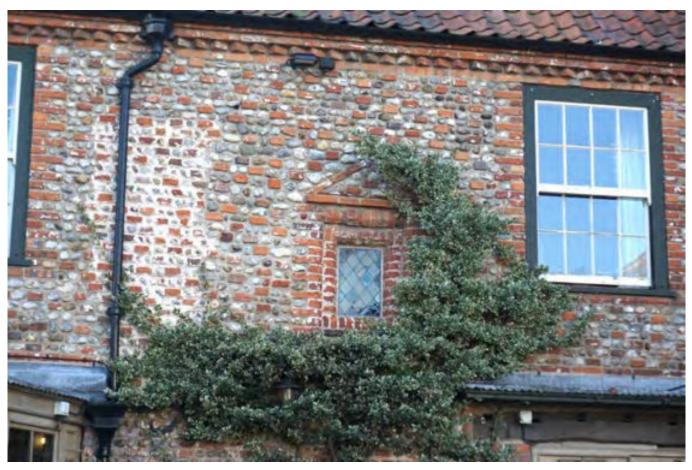
Flint and brick chequer pattern and small sixteenth century window on Byfords, Shirehall Plain

There are few architectural references pre-1708 in the Conservation Area. Cottages in Chapel Yard and Nos. 1, 3, and 5 Shirehall Plain (now Byfords) are thought to have survived and the 1708 fire and may date from around 1550, though the Chapel yard buildings were refaced in the Victorian period so no earlier detail is visible externally. The façade of Byfords is flint with alternate red brick headers, creating a chequer pattern; a walling technique more common on buildings earlier than the Georgian period. The original windows would have been casements but most of these have been replaced with Georgian sashes. However, two small leaded windows survive with brick surrounds that date to the sixteenth century. One has a small triangular pediment above which shows an early influence of the Classical style.

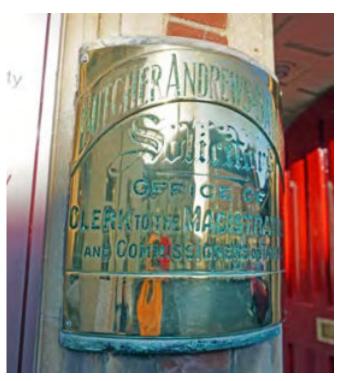
Brass name plate for solicitors' firm who used to occupy No. 15 Market Place

No.15 Market Place is late-Victorian or Edwardian, contrasting with the surrounding Georgian style. It is a narrow building with stone to the ground floor, forming the shop window, and half-timbering to the upper floor with a central gable. It was originally designed as a bank and similar bank buildings can be found in Cromer and Sheringham.

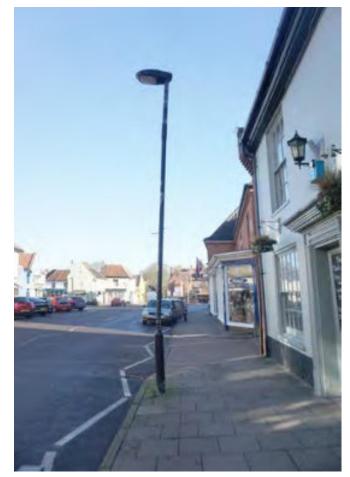
Basic modern lamppost which had been damaged and is now leaning

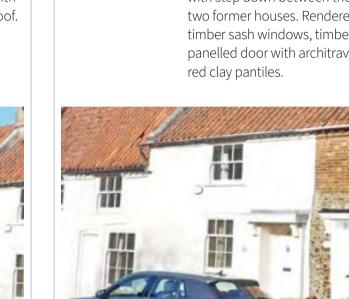
Address / Building Name	50 High Street
Status	Grade II
List Entry Link	https://historicengland. org.uk/listing/the-list/list- entry/1049311
Brief History	C18
Brief Description	Two terraced houses incorporated in one. Two storey, with step down between the two former houses. Rendered, timber sash windows, timber panelled door with architrave, red clay pantiles.

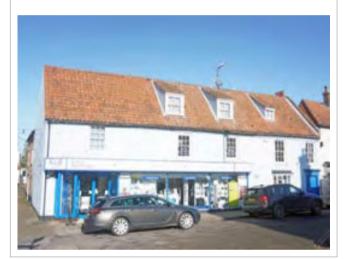
Address / Building Name	26 and 28 High Street
Status	Grade II
List Entry Link	https://historicengland. org.uk/listing/the-list/list- entry/1049309
Brief History	C19, GF No.26 rebuilt late-C20
Brief Description	Two shops. Two storeys, both rendered with red clay pantiles. Timber sash windows to first floor. Shop front to No.28 is timber with door to side and three windows adjacent, flanked by pilasters and topped by a fascia and retractable canvas awning. Ground floor of No.26 completely rebuilt late-C20 in red brick with dark timber frame to windows. This and the plastic printed fascia sign above are unsympathetic.

- Poor quality shop front to Nos. 40-42 High Street (Kings & Barnhams) with inappropriate printed fascia sign and overly large windows
- Unsympathetic printed fascia panel to No. 28
 High Street (Bakers and Larners Home Furnishing Centre). The modern ground floor shop front is also uninspiring.
- Unsympathetic printed fascia panel to No.7 High Street, though shop front is otherwise good quality.
- Boundary wall between Nos. 33 and 37 is in poor condition

- Repair boundary wall between Nos. 33 and 37 using appropriate conservation materials and techniques.
- Better quality signage for the shops at Nos. 40-42 and No. 28, such as painted or individually applied lettering, would improve the appearance of the shop fronts. Alternatively, the shop fronts could be replaced with ones of a more sympathetic design.

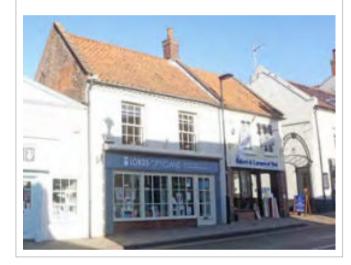
Address / Building Name	24 High Street
Status	Grade II
List Entry Link	https://historicengland. org.uk/listing/the-list/list- entry/1373736
Brief History	Late C18
Brief Description	End terrace shop. Two storeys, red clay pantiles with some black glazed. Unsympathetic pebbledash render. Timber sash window to first floor. Timber shop front with simple pilasters and fascia to ground floor.

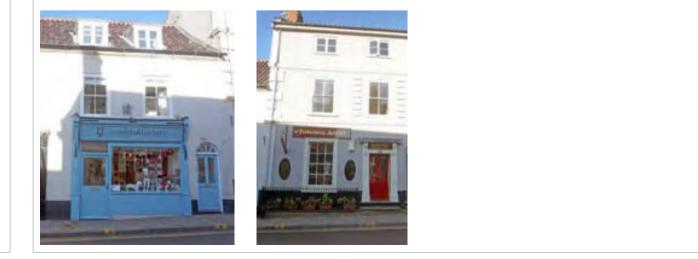
Address / Building Name	20 and 22 High Street
Status	Grade II
List Entry Link	https://historicengland.org.uk/listing/the-list/list-entry/1049308
Brief History	Late C18
Brief Description	No.22 two storey with catslide dormers indicating attic floor. Unsympathetic pebbledash render. Timber sash windows to first and second floors. Good timber shop front with pilasters, fascia, stall riser and features indicating historic retractable awning. Timber and glazed door to right with semi-circular fanlight.
	No.20 is left hand side of a larger building with No. 18. Three storeys, brick painted, with quoins and string courses also in brick. Timber sash windows, timber and glazed recessed door in architrave, railings around front area.

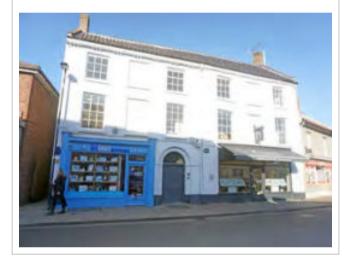
Address / Building Name	6 and 8 High Street
Status	Grade II
List Entry Link	https://historicengland. org.uk/listing/the-list/list- entry/1049307
Brief History	Early C19
Brief Description	Two shops. Three storeys, brick painted, black glazed pantiles, timber sash windows with four blind windows. Shop fronts on ground floor either side of an arched entrance with timber panelled door and fanlight over. Shop front to No. 8 timber framed with pilasters and fascia. To No.6 shop front is more modern in style though not inappropriate, with retractable canvas awning.

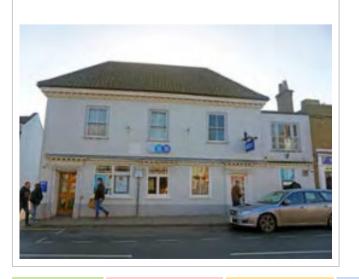
Address / Building Name	13 and 15 High Street
Status	Grade II
List Entry Link	https://historicengland. org.uk/listing/the-list/list- entry/1169480
Brief History	C18
Brief Description	House converted into two shops. Two storeys with attic denoted by dormers. Red brick with quoin and dentil details. Timber sash windows, Classical doorcase with timber panelled door and fanlight over. Matching shop fronts flanking door, likely C20 but good quality. Pilasters and fascia, side doors, decorative mullions to sides and

signage. Central timber plank door between shop fronts.

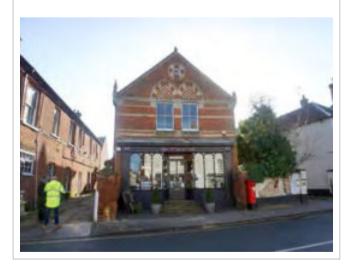
Address / Building Name	33 High Street
Status	Grade II
List Entry Link	https://historicengland. org.uk/listing/the-list/list- entry/1169500
Brief History	Mid C19
Brief Description	Shop. Gable end facing street in polychrome brick with Gothic feel. Timber sash windows. Good timber shop front to ground floor with central door and decorative arched timber mullions to the windows.

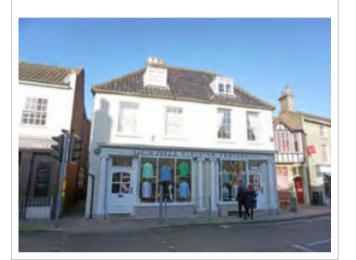
Address / Building Name	11 and 13 Market Place
Status	Grade II
List Entry Link	https://historicengland. org.uk/listing/the-list/list- entry/1049321
Brief History	C18
Brief Description	Shop (formerly two converted into one). Two storey with attic denoted by dormers, hipped roof with black glazed pantiles, timber sash windows, good shop front on ground floor featuring ionic columns, slender columned mullions and side doors.

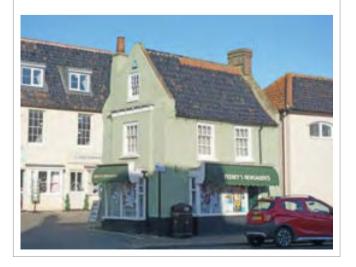
Address / Building Name	35 Market Place
Status	Grade II
List Entry Link	<u>https://historicengland.</u> org.uk/listing/the-list/list- entry/1169578
Brief History	C18 and later
Brief Description	Shops. Main part two storeys, red pantile roof, painted brick, timber sash windows, modern shop front to ground floor u=with unsympathetic signage. Single storey lean-to shop to right hand side with timber and glazed door and casement window to shop.

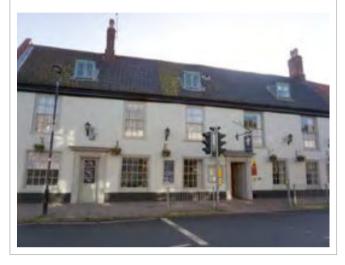
Address / Building Name	Feathers Hotel
Status	Grade II
List Entry Link	https://historicengland. org.uk/listing/the-list/list- entry/1169534
Brief History	C18
Brief Description	Public house. Two storeys with attics denoted by dormer. Mix of red clay and black glazed pantiles. Rendered, timber sash windows, two timber panelled doors win architraves.

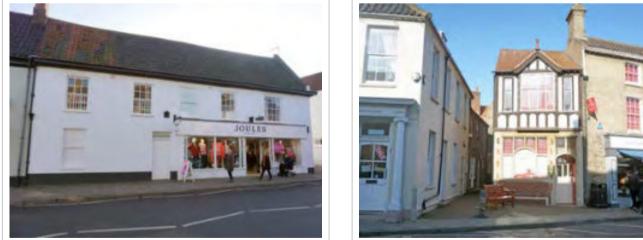
Address / Building Name	2 Market Place
Status	Grade II
List Entry Link	<u>https://historicengland.</u> org.uk/listing/the-list/list- entry/1049317
Brief History	C18
Brief Description	Shop. Two storey. Mix of red clay and black glazed pantiles. Rendered, timber sash windows. Timber shop front to right hand side of ground floor, timber door to left of this with louver over.

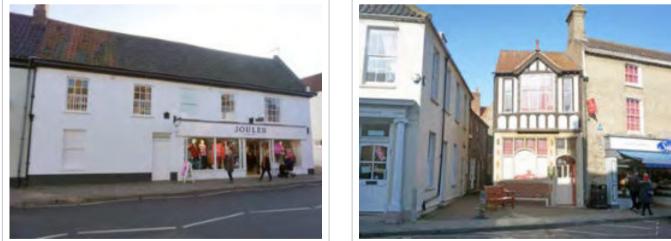
Address / Building Name	15 Market Place
Status	Locally Listed
List Entry Link	N/A
Brief History	Late Victorian or Edwardian
Brief Description	Office. Narrow two storey building. Stone and red brick to ground floor, mock timber framing to first floor, red clay tile roof. Stone or timber mullioned windows, with leaded toplights. Recessed door with brass name plate of original occupiers to right.

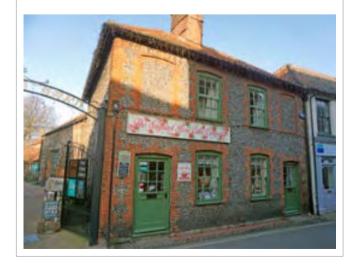
13 Albert Street
Locally Listed
N/A
Early C19
Former shop now house. Two storey, red brick, red clay pantile roof, brick chimney. Timber sash windows to first floor with one blind window. Attractive timber shop front to the ground floor with central recessed entrance and timber sash windows either side.

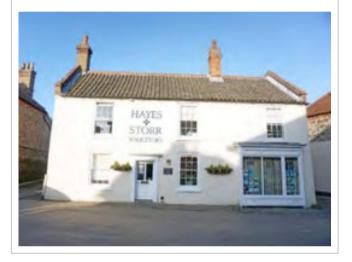
Address / Building Name	39 Bull Street
Status	Grade II
List Entry Link	https://historicengland. org.uk/listing/the-list/list- entry/1049339
Brief History	C18
Brief Description	Shop with ranges behind probably originally stables, now residence. Two storey. Rendered. Hipped red clay pantile roof. Mixture of window designs, mainly different forms of casement window, all timber. Timber shop fronts to south and east sides.

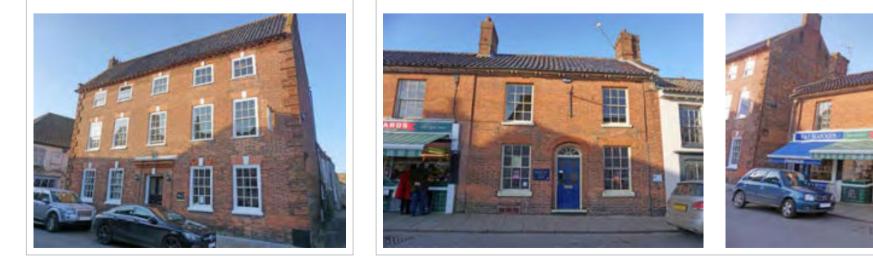
Address / Building Name	45 and 47 Bull Street
Status	Grade II
List Entry Link	https://historicengland.org.uk/listing/the-list/list-entry/1049340
Brief History	Early C19
Brief Description	Office and shop. Both two storey, red brick, black glazed pantile roof, brick chimneys, timber sash windows. No. 45 has two shops to ground floor with mid-late C20 shop fronts, retractable canvas awnings. Printed fascias above could be improved by being painted timber. No.47 retains windows to ground floor with central timber and glazed door with fanlight under brick arch.

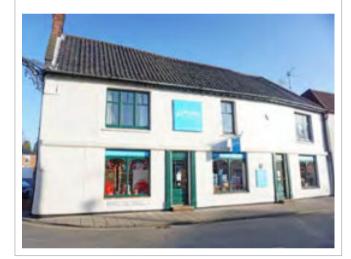
Address / Building Name	White Lion Public House
Status	Grade II
List Entry Link	https://historicengland. org.uk/listing/the-list/list- entry/1049292
Brief History	C18 and later
Brief Description	Former public house, now shop Two storeys. Rendered, black glazed pantile roof with brick chimney. Timber casement windows to first floor and widened timber shop windows on ground floor. Two timber and glazed doors flanked by fluted pilasters. Distinctive hanging pub sign on corner in metal with decorative ironwork.

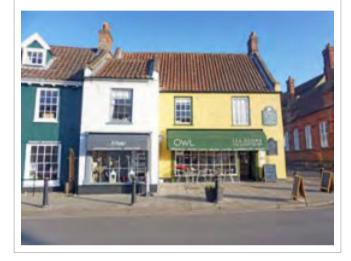
Address / Building Name	Janaway House
Status	Grade II
List Entry Link	https://historicengland. org.uk/listing/the-list/list- entry/1169650
Brief History	C18
Brief Description	Two shops. Two storeys with smaller element projecting out on left hand side containing one of the shops. Rendered, red clay pantile roof, brick chimneys. Timber sash windows timber shop fronts with Dutch canopies.

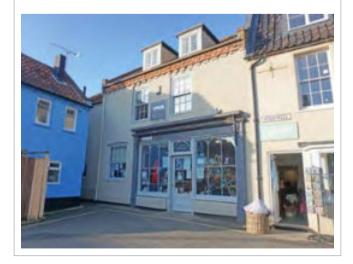
Address / Building Name	1 Fish Hill
Status	Grade II
List Entry Link	https://historicengland. org.uk/listing/the-list/list- entry/1049346
Brief History	C18 and later
Brief Description	Shop. Two storey with attic floor denoted by dormers. Rendered with brick cornice. Timber sash windows. Timber shop front with arched detail to mullions and central timber and glazed door.

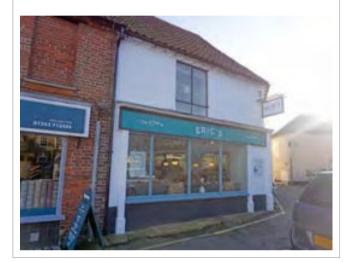
Address / Building Name	Premises occupied by Spar Foodmarket (No. 4 Fish Hill)
Status	Grade II
List Entry Link	https://historicengland. org.uk/listing/the-list/list- entry/1049347
Brief History	C18 and later
Brief Description	Restaurant. Two storeys. Rendered, red clay pantile roof. Metal casement window to north, timber sash windows to west. Timber shop fronts with timber and glazed door to west.

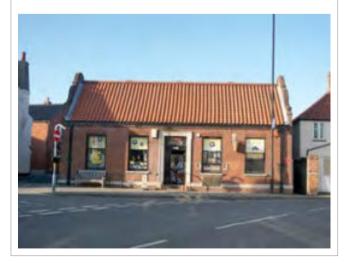
Address / Building Name	Former Post Office
Status	Locally Listed
List Entry Link	N/A
Brief History	Inter-War
Brief Description	Former post office, now shop. Single storey. Red brick, red clay pantile roof. Dutch gables to east and west ends. Central door with stone architrave. Modern timber door. Timber sash windows to left, timber windows with adaptations to right. Stickers/signage in windows is unsympathetic.

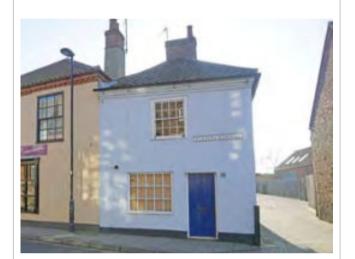
Address / Building Name	Shrublands
Status	Grade II
List Entry Link	https://historicengland. org.uk/listing/the-list/list- entry/1373768
Brief History	Early C19
Brief Description	House. Two storey. Gault brick, pantile roof, brick chimneys. Timber sash windows, timber panelled door with fanlight.

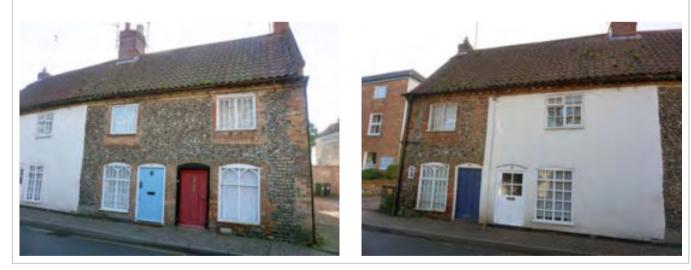
12 – 18 Station Road

Building Name	
Status	Grade II
List Entry Link	https://historicengland.org.uk/listing/the-list/list-entry/1049290
Brief History	C18
Brief Description	Row of four cottages. Two storeys. Nos. 12, 14, and 18: flint with brick dressings, timber panelled doors, interesting metal framed casement windows with pointed arch details, except ground floor No. 12 which is timber framed with pointed arch. No. 16 rendered, timber and glazed door, timber casement windows. All red clay pantiles and brick chimneys.

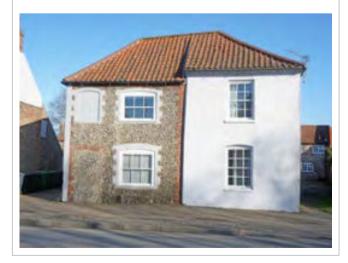
Address / Building Name	37 and 39 Norwich Road
Status	Grade II
List Entry Link	https://historicengland. org.uk/listing/the-list/list- entry/1049285
Brief History	Probably C18 – C18/19 additions to rear
Brief Description	Two houses. Two storeys. Rendered, red clay pantile roof, brick chimneys, timber sash windows, timber panelled doors in simple architraves.

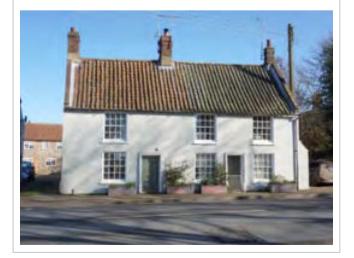
Address /	5 Norwich Road
Building Name	
Status	Grade II
List Entry Link	https://historicengland. org.uk/listing/the-list/list- entry/1049284
Brief History	C18 or early C19
Brief Description	House. Two storey. Rendered, with flint south wall. Red clay pantile roof with brick chimneys. Timber sash windows, timber panelled door with timber doorcase.

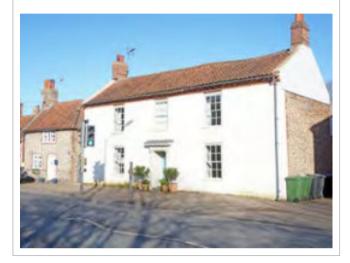
Address / Building Name	Bacon's House
Status	Grade II
List Entry Link	https://historicengland. org.uk/listing/the-list/list- entry/1049286
Brief History	Early C18, owned in 1703. C19 additions
Brief Description	Two houses. Two storeys with attic floor denoted by dormers. Rendered, slate roof, brick chimneys, timber sash windows, timber panelled door with fanlight and pedimented architrave to left, timber and glazed door with pedimented architrave to right.

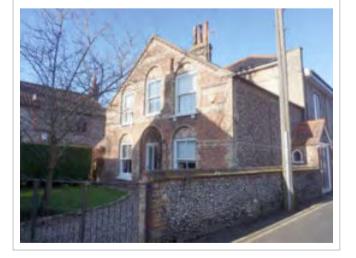
Address / Building Name	28 and 30 Albert Street
Status	Grade II
List Entry Link	https://historicengland. org.uk/listing/the-list/list- entry/1373749
Brief History	Mid C19
Brief Description	Two houses. Two storey. Flint with red brick dressings, red clay pantile roof, brick chimneys, timber sash windows, timber and glazed doors. No. 30 has flint and brick boundary wall. No. 28's front garden has been replaced with parking bay.

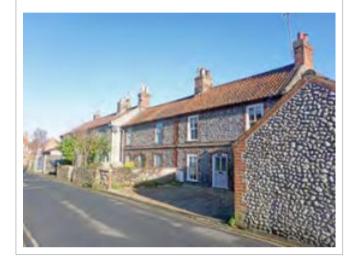
Address / Building Name	29 Albert Street
Status	Grade II
List Entry Link	https://historicengland. org.uk/listing/the-list/list- entry/1049335
Brief History	Early C19
Brief Description	House, part of a terrace of four. Two storey. Flint with gault brick dressings, black glazed pantile roof, gault brick chimney, timber sash windows, timber and glazed door, flint and brick boundary wall to front garden.
