Letheringsett and Little Thornage

Conservation Area Appraisal and Management Plan Final Draft for Adoption: April 2021

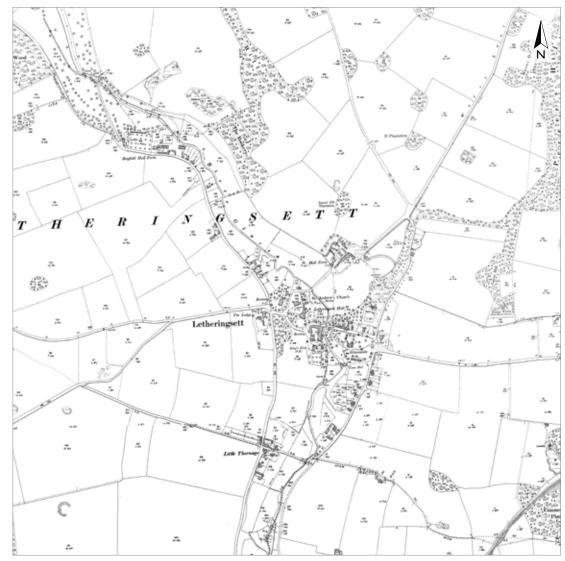
1905-1906 1:2,500 OS map, © "Crown Copyright and Landmark Information Group Ltd" (All rights reserved, 2019)

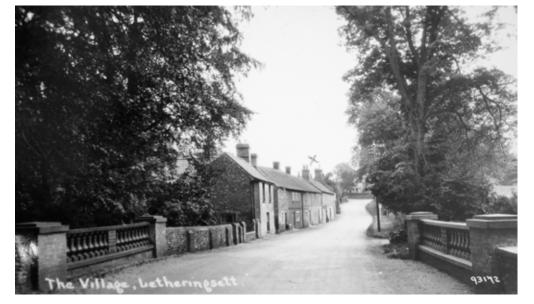
The photograph below shows a view from William Hardy Junior's 1818 bridge looking east along the Holt Road with terraced cottages on the left-hand side, which pre-date the Tithe Maps (1834 and 1838). In the 1930s, the brewery site was being rented by Warne & Bicknell, a motor haulage firm, when the brewery building was burnt in 1936, causing it to be pulled down. The brewery lost its north range fronting the road and its original L-shaped outline.

The Village, Letheringsett, c. early/mid twentieth century (Norfolk Heritage Centre: C/LET)

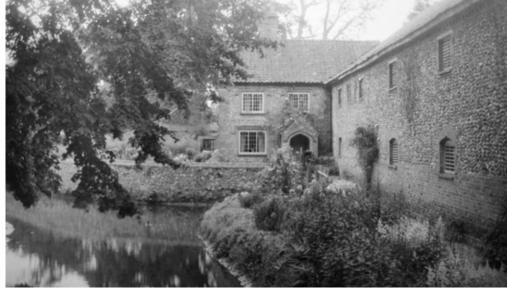
View of the south end of the brewery and maltings showing the River Glaven in front, 1946 (Norwich Heritage Centre: C/LET 22474)

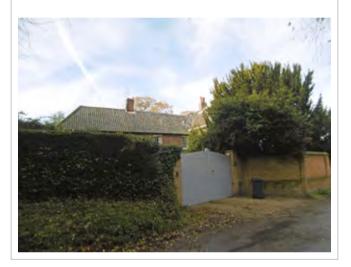
Address / Building Name	Letheringsett Lodge
Street-by-Street Area	Thornage Road
Status	Grade II
List Entry Link	<u>https://historicengland.</u> org.uk/listing/the-list/list- entry/1049835
Brief History	House dating to 16th and 18th centuries. Iron letters JB on each gable for John Burrell (1734 – 86).
Brief Description	Flint with brick dressings, black glazed pantiles, T-plan. Front range facing north of 7 irregular bays, 2 storeys and attic having 2 ridgelines, bays mainly 3 – 5 mainly in brick forming a polygonal projection with polygonal roof.

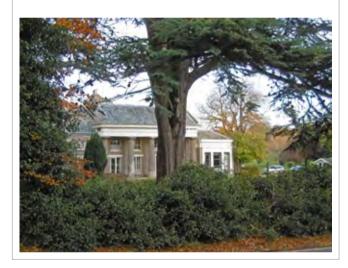
Address / Building Name	The Tun House c. 25m west of the Malt Kilns and Brewery
Street-by-Street Area	Holt Road
Status	Grade II
List Entry Link	<u>https://historicengland.</u> org.uk/listing/the-list/list- entry/1152290
Brief History	Dated 1814. Converted to residential use in recent years.
Brief Description	Storage building of former brewery. Brick and flint, hipped pantile roof with central lantern. Square, gault brick to west and south, rusticated bands to base, battered walls oversailing cornice. West façade with two semi-circular headed panels of pebble flint, string course at impost level to brick central and clasping pilasters. Cast iron plaque in central spandrel inscribed WH/1814 (William Hardy 1770 – 1842).
(20.10-C (200)

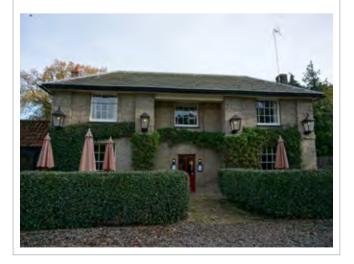
Address / Building Name	The King's Head public house
Street-by-Street Area	Holt Road
Status	Proposed Locally Listed
List Entry Link	N/A
Brief History	1805, rebuilt by William Hardy Junior when he diverted the Holt Road around new pleasure grounds for Letheringsett Hall
Brief Description	Two storeys, three bays wide. Georgian style. Stock brick with slate roof. Timber sash windows and timber door with glazed upper panels. Recessed central bay. Proposed for inclusion on the Local List as a key social building within the village, for its elegant Georgian style and its link with William Hardy Junior.

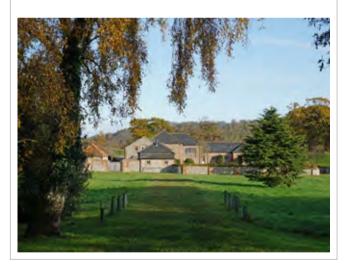
Address / Building Name	Summerhouse in grounds of Letheringsett Hall
Street-by-Street Area	Garden Lane and Hall Farm
Status	Grade II
List Entry Link	https://historicengland. org.uk/listing/the-list/list- entry/1152241
Brief History	Mid 19th century
Brief Description	Rustic summerhouse in oak with a reed thatched roof. Y-tracery window of curved oak branches, 15th-century glass removed c1958 to Church of St. Andrew.
Address / Building Name	Stables at Hall Farm c10 m south-east of Hall Farmhouse
Street-by-Street Area	Garden Lane and Hall Farm
Status	Grade II
List Entry Link	https://historicengland. org.uk/listing/the-list/list- entry/1152233
Brief History	Mid 19th century
Brief Description	Stables, single storey, 4 bays, uncoursed flint with brick cornice and dentil dressings, tarred slate roof, 4 windows with semi-circular heads and cast iron glazing bars.
