SVC-300 – corrosion issue.

Dell Materials Science Laboratory
Global Supply Chain Quality Engineering

Report 7568
Materials Analysis

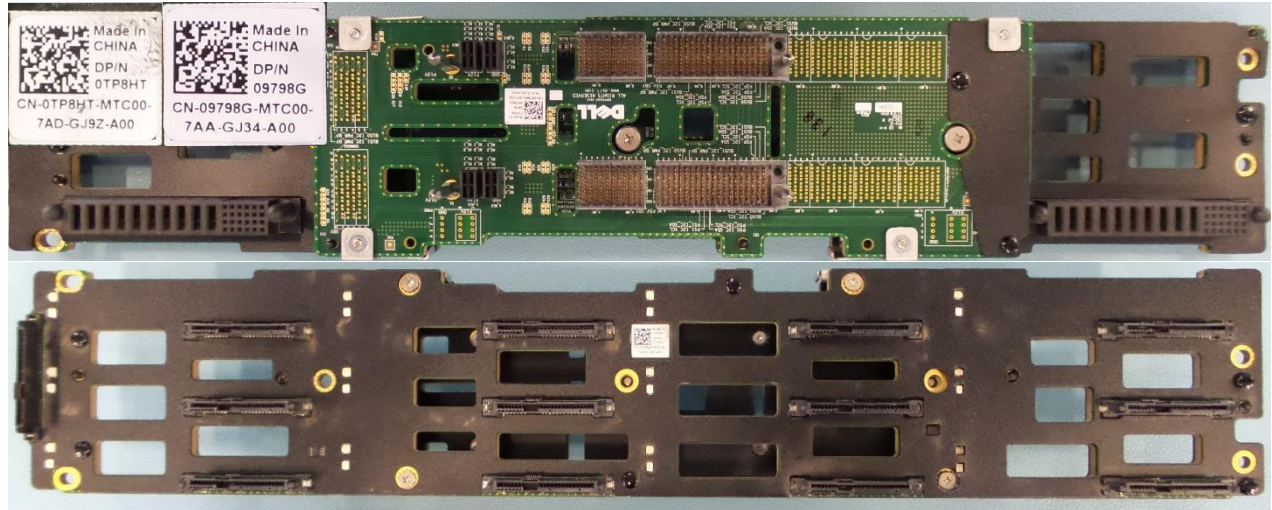
Photo 1. Representative overview and manufacturing details of the SVC-300 midplane assembly.

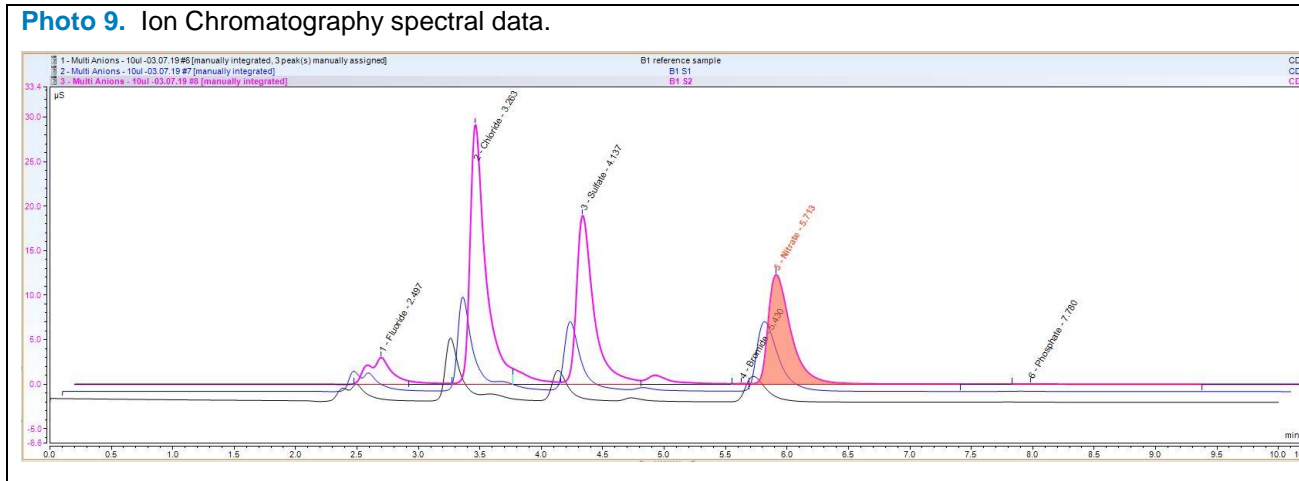
Table 1.

The overall levels of surface contamination in $\mu\text{g}/\text{in}^2$ for each anion detected are tabulated in Table 1 below.

Description	Fluoride	Chloride	Bromide	Nitrate	Phosphate	Sulphate	WOA
	Board 1 S1	22.7	130.8	ND	565.2	11.1	196.7
Board 1 S2	37.9	732.2	ND	978.2	18.1	664.3	249.5
Allowable limits	1*	3*	7*	3*	3*	3*	25*
